EQUIPMENT RECORDING SONAR MAPPED JULY 1968
MO. YR.
WATER ELEV. 99.95

Source: Wisconsin Department of Natural Resources 608-266-2621
Erler Lake – Washington County, Wisconsin DNR Lake Map
Date – Jul 1968 - Historical Lake Map - Not for Navigation
A Public Document - Please Identify the Source when using it.

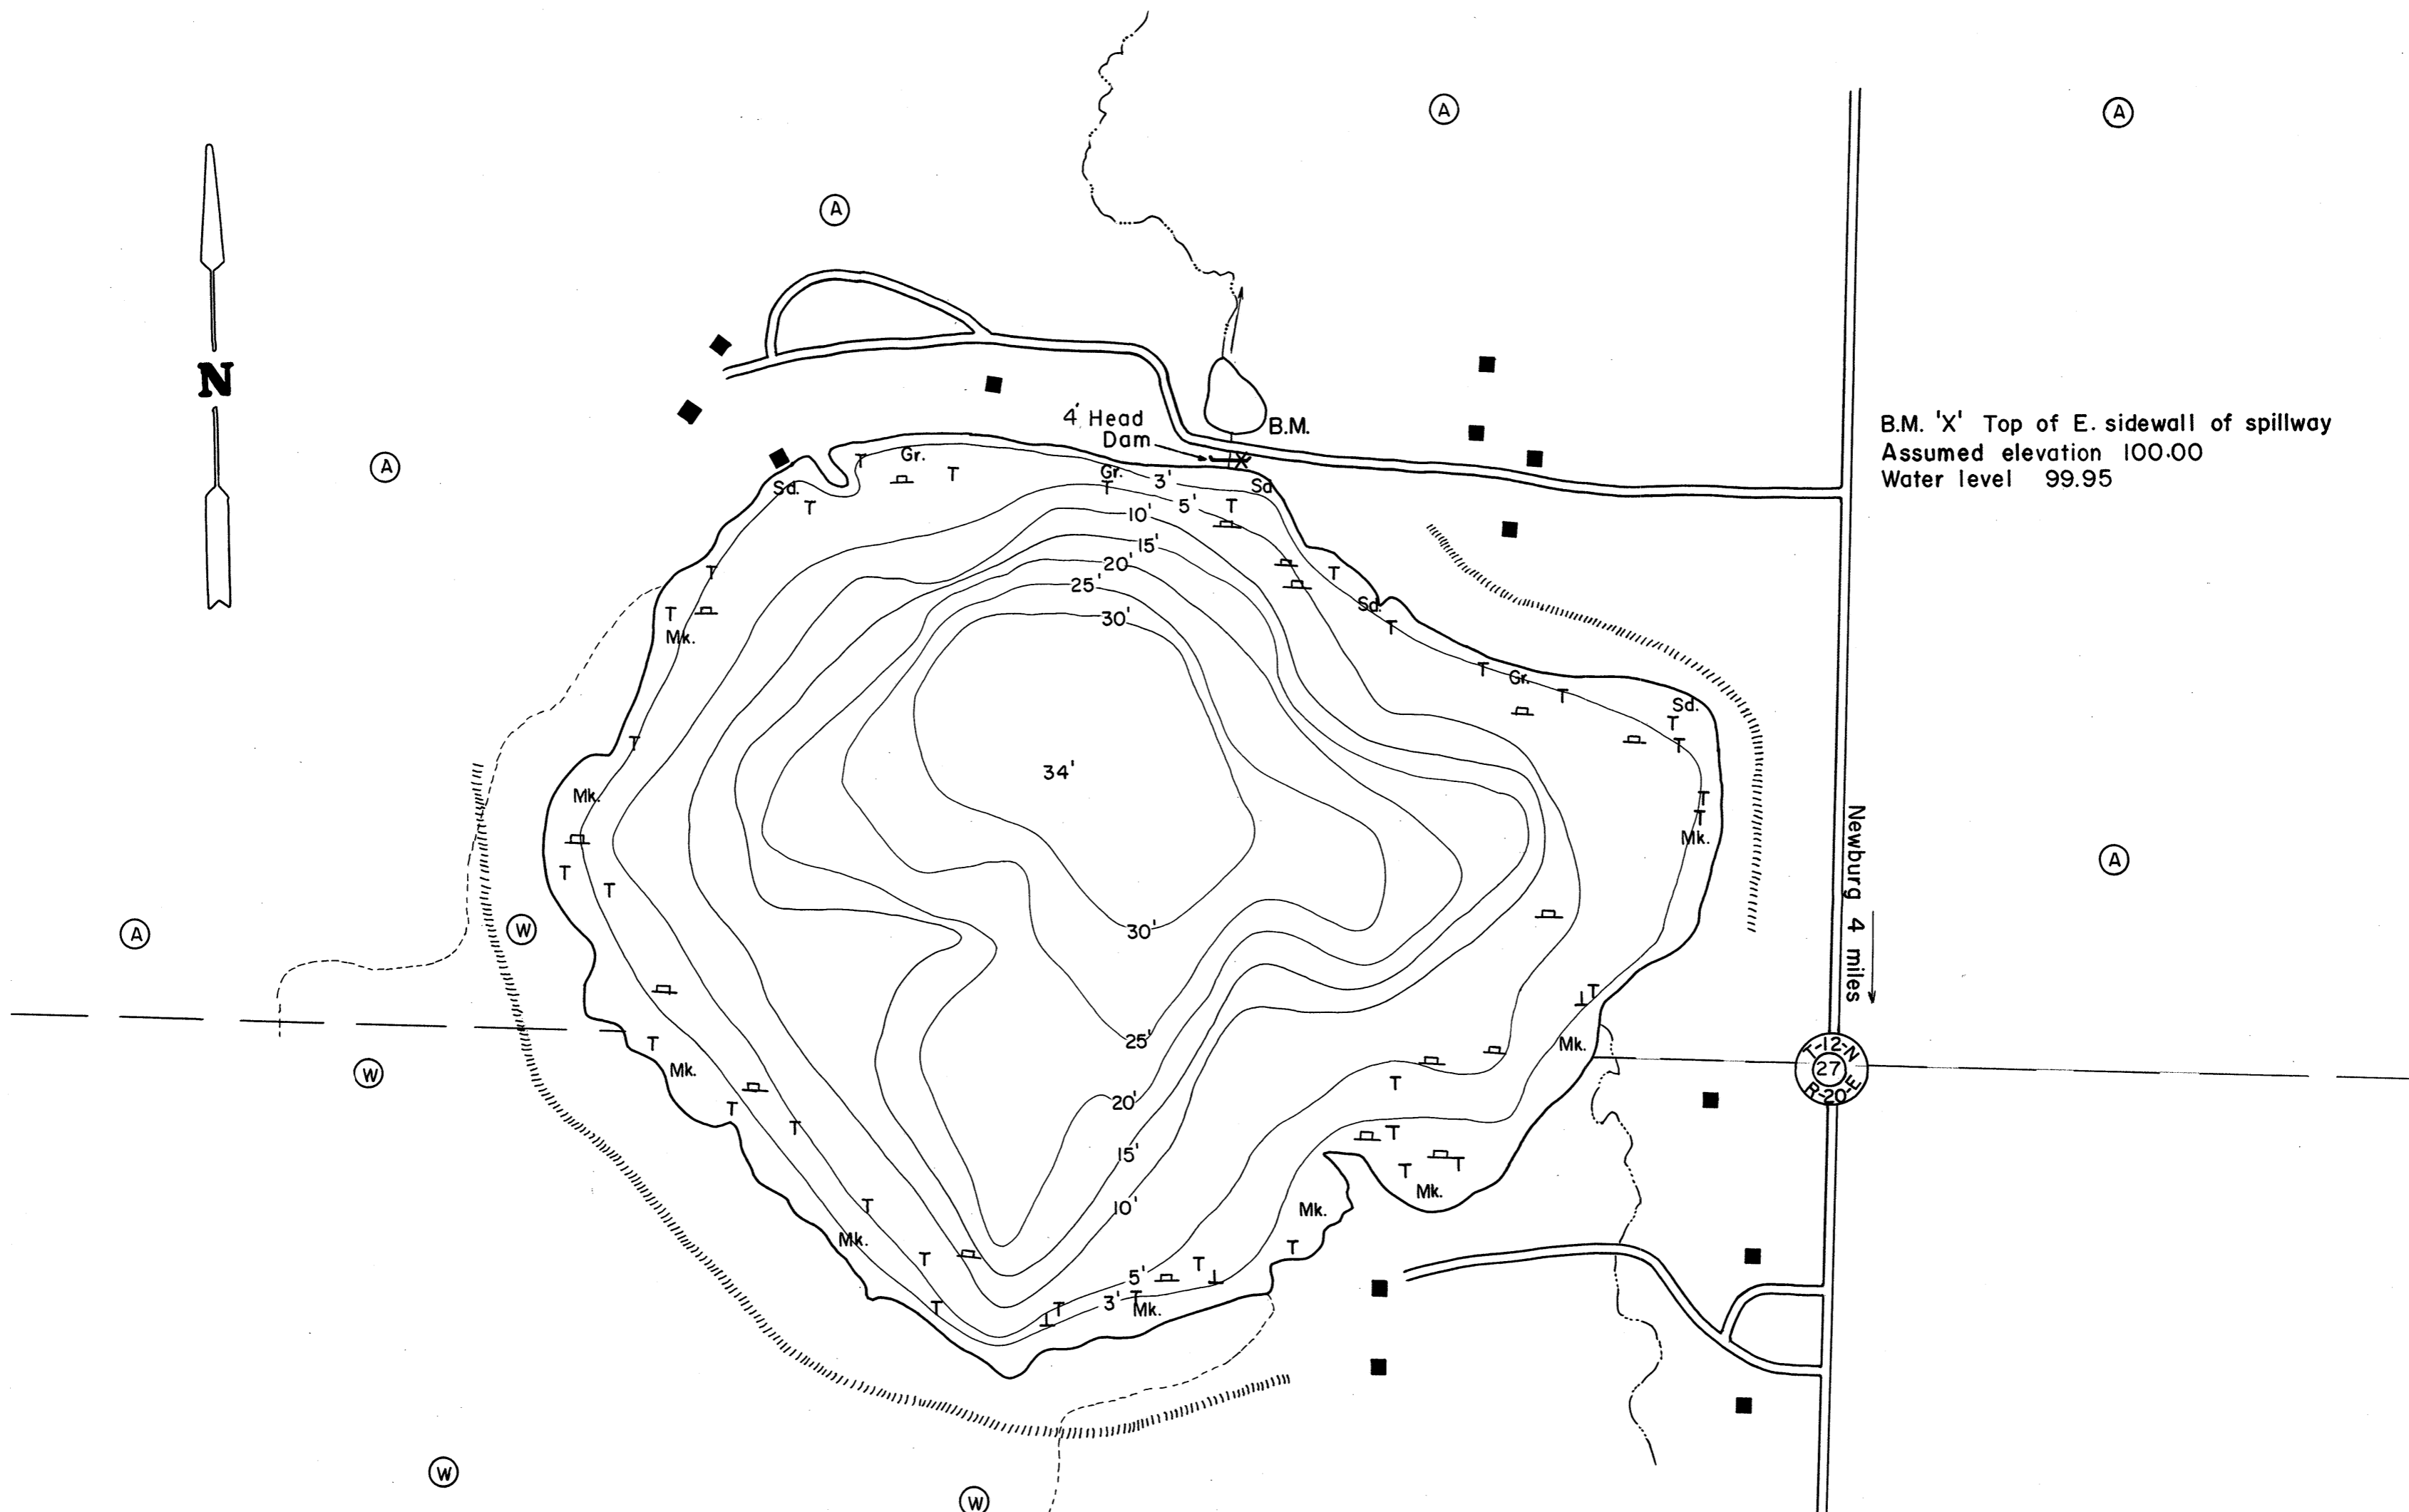
B.M. 'X' Top of E. sidewall of spillway
Assumed elevation 100.00
Water level 99.95

AREA 36.8 ACRES
UNDER 3 FT. 11.4 %
OVER 20 FT. 30.7 %
VOLUME 498.7 ACRE FT.
TOTAL ALK. 180 P.P.M.
SHORELINE 1.0 MILES
MAX. DEPTH 34 FEET
