EQUIPMENT RECORDING SONAR MAPPED

JUNE 1975
MONTH YEAR

Source: Wisconsin Department of Natural Resources 608-266-2621
Munger Lake – Oconto County, Wisconsin DNR Lake Map
Date - Jun 1975 - Historical Lake Map - Not for Navigation
A Public Document - Please Identify the Source when using it.

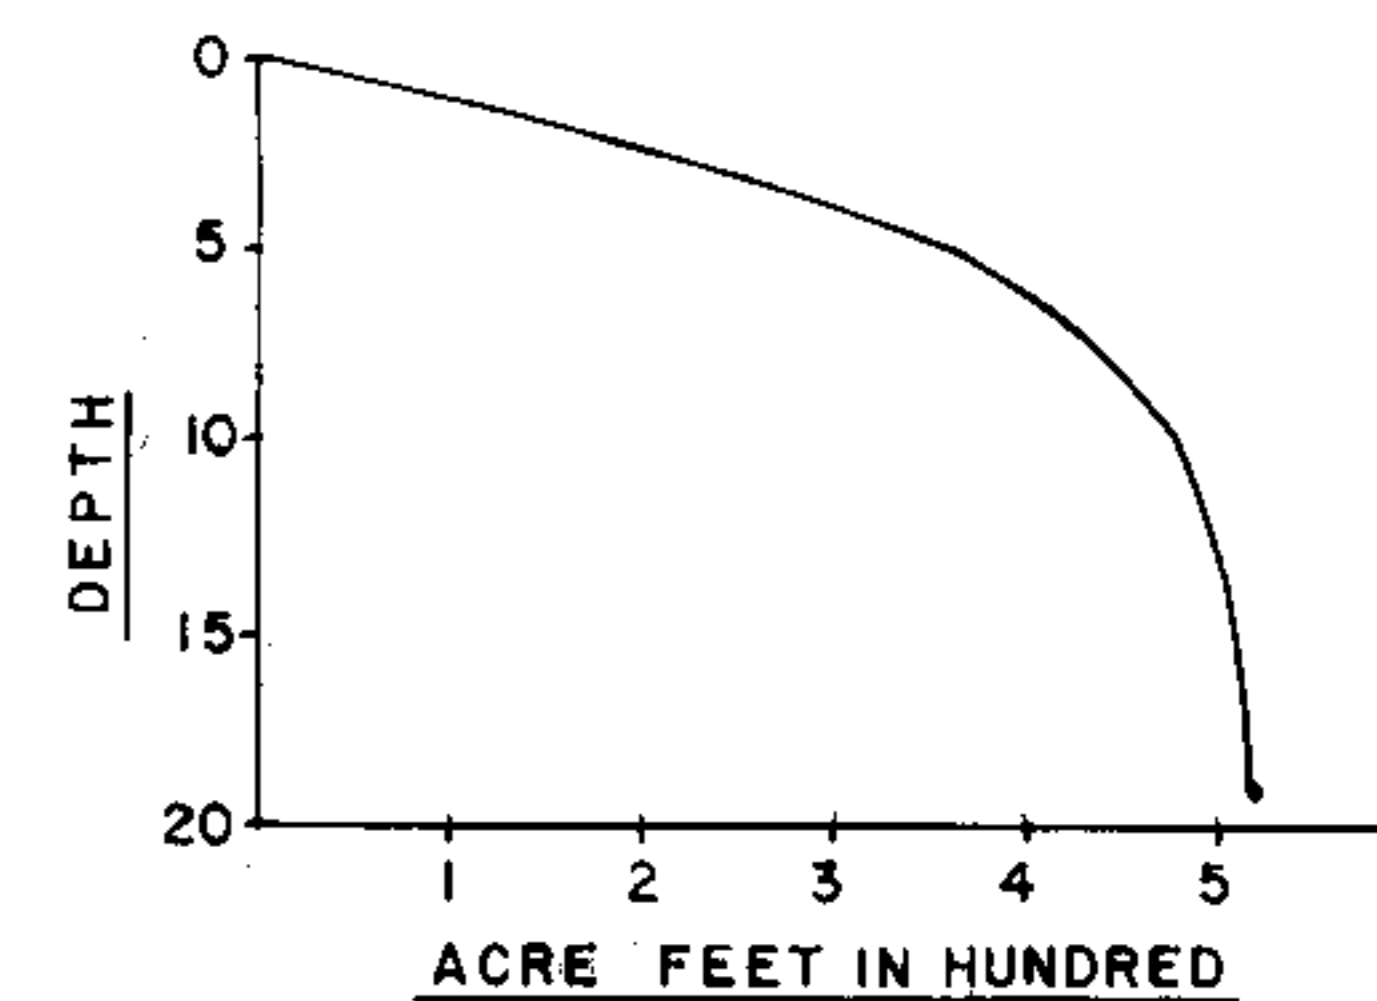
B.M. 'X' Spike in regulatory sign post
at public access on east side of lake
Assumed Elevation 100.00'
Water Elevation 94.00'

WATER AREA 96 ACRES
 UNDER 3 FT. 21 %
 OVER 20 FT. 0 %
 MAX. DEPTH 19 FEET.
 TOTAL ALK. 103 P.P.M.
 VOLUME 517 ACRE FT.
 MAIN SHORELINE 2.43 MI.
 ISLAND SHORELINE .095 MI.
