EQUIPMENT RECORDING SONAR MAPPED AUGUST 1938  
UPDATED AUGUST 1967

Source: Wisconsin Department of Natural Resources 608-266-2621  
Boulder Lake – Oconto County, Wisconsin DNR Lake Map  
Date - Aug 1967 - Historical Lake Map - Not for Navigation  
A Public Document - Please Identify the Source when using it.

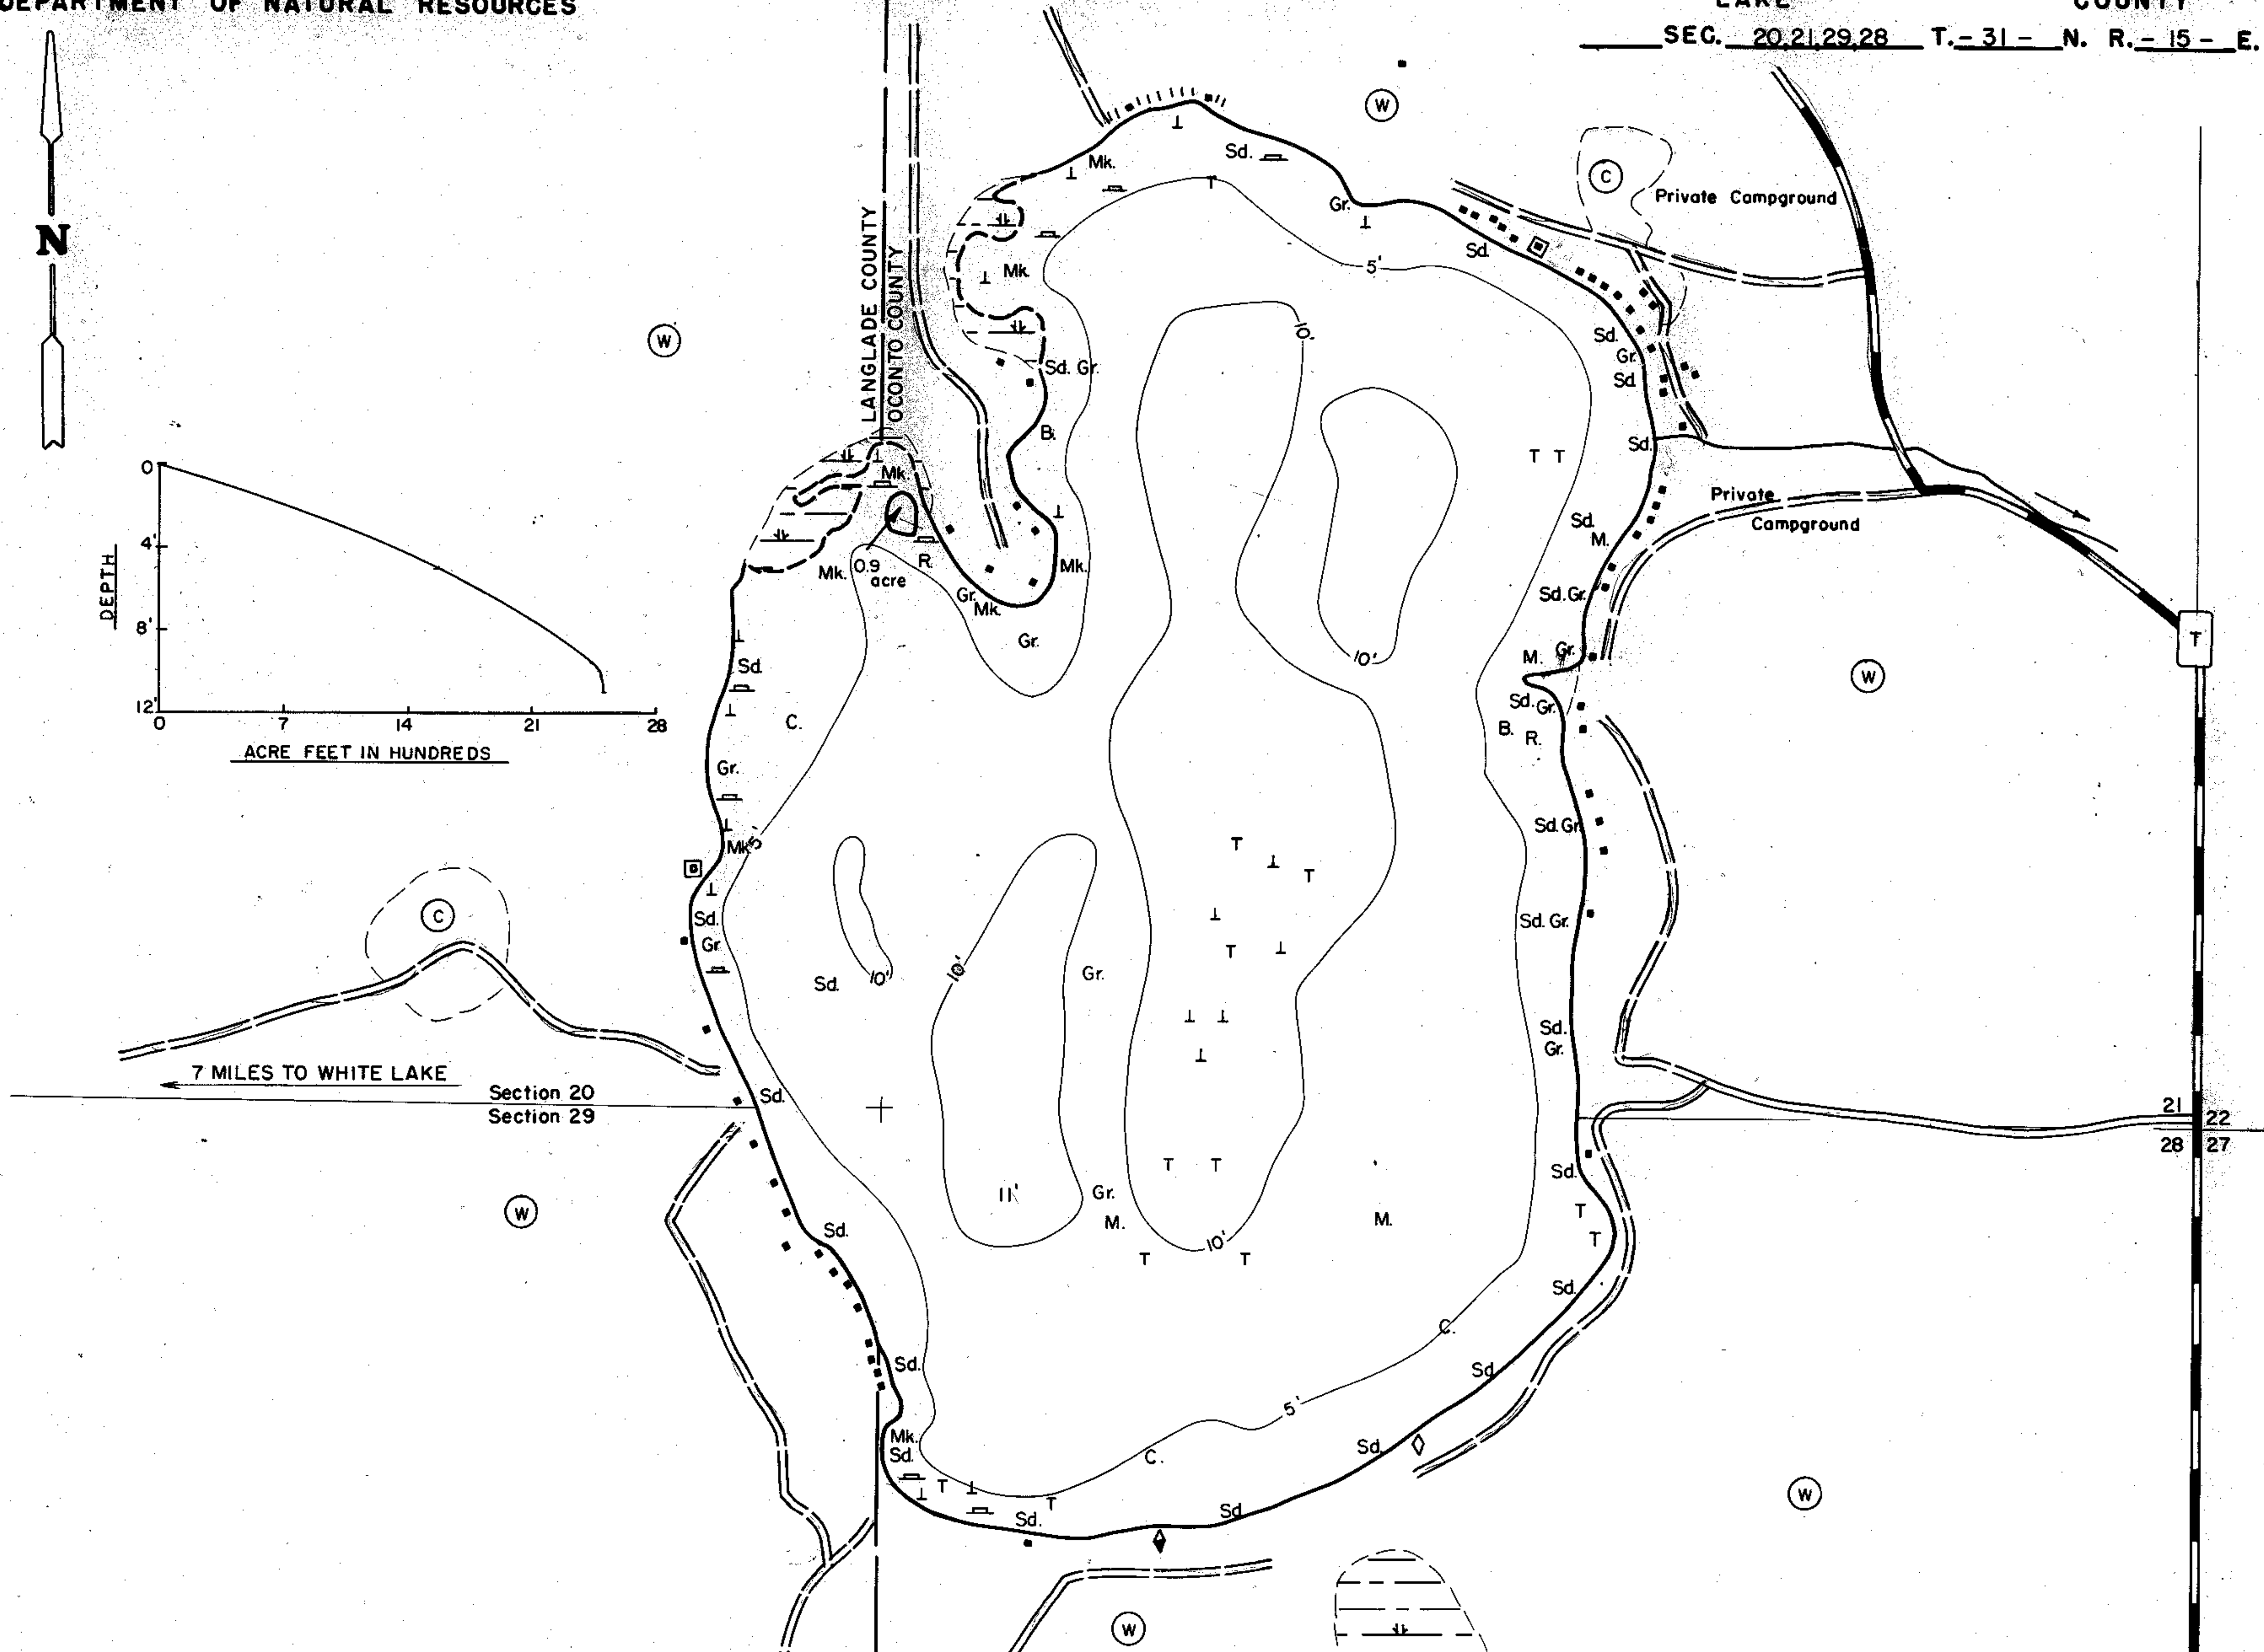
WATER AREA 362.3 ACRES  
 UNDER 3 FT. 15 %  
 OVER 20 FT. 0 %  
 MAX. DEPTH 11 FEET.  
 TOTAL ALK. 130 P.P.M.  
 VOLUME 2518.4 ACRE FT.  
 SHORELINE 3.8 MILES  
 3.7 MILES OF SHORELINE  
 EXCLUDING ISLAND
