LAKE SURVEY MAP

RADIGAN FLOWAGE LAKE DOUGLAS COUNTY
SEC. 3, 10, 11 T. 43 N. R. 15 W.

Source: Wisconsin Department of Natural Resources 608-266-2621
Radigan Flowage – Douglas County, Wisconsin DNR Lake Map
Date – Sep 1966 - Historical Lake Map - Not for Navigation
A Public Document - Please Identify the Source when using it.

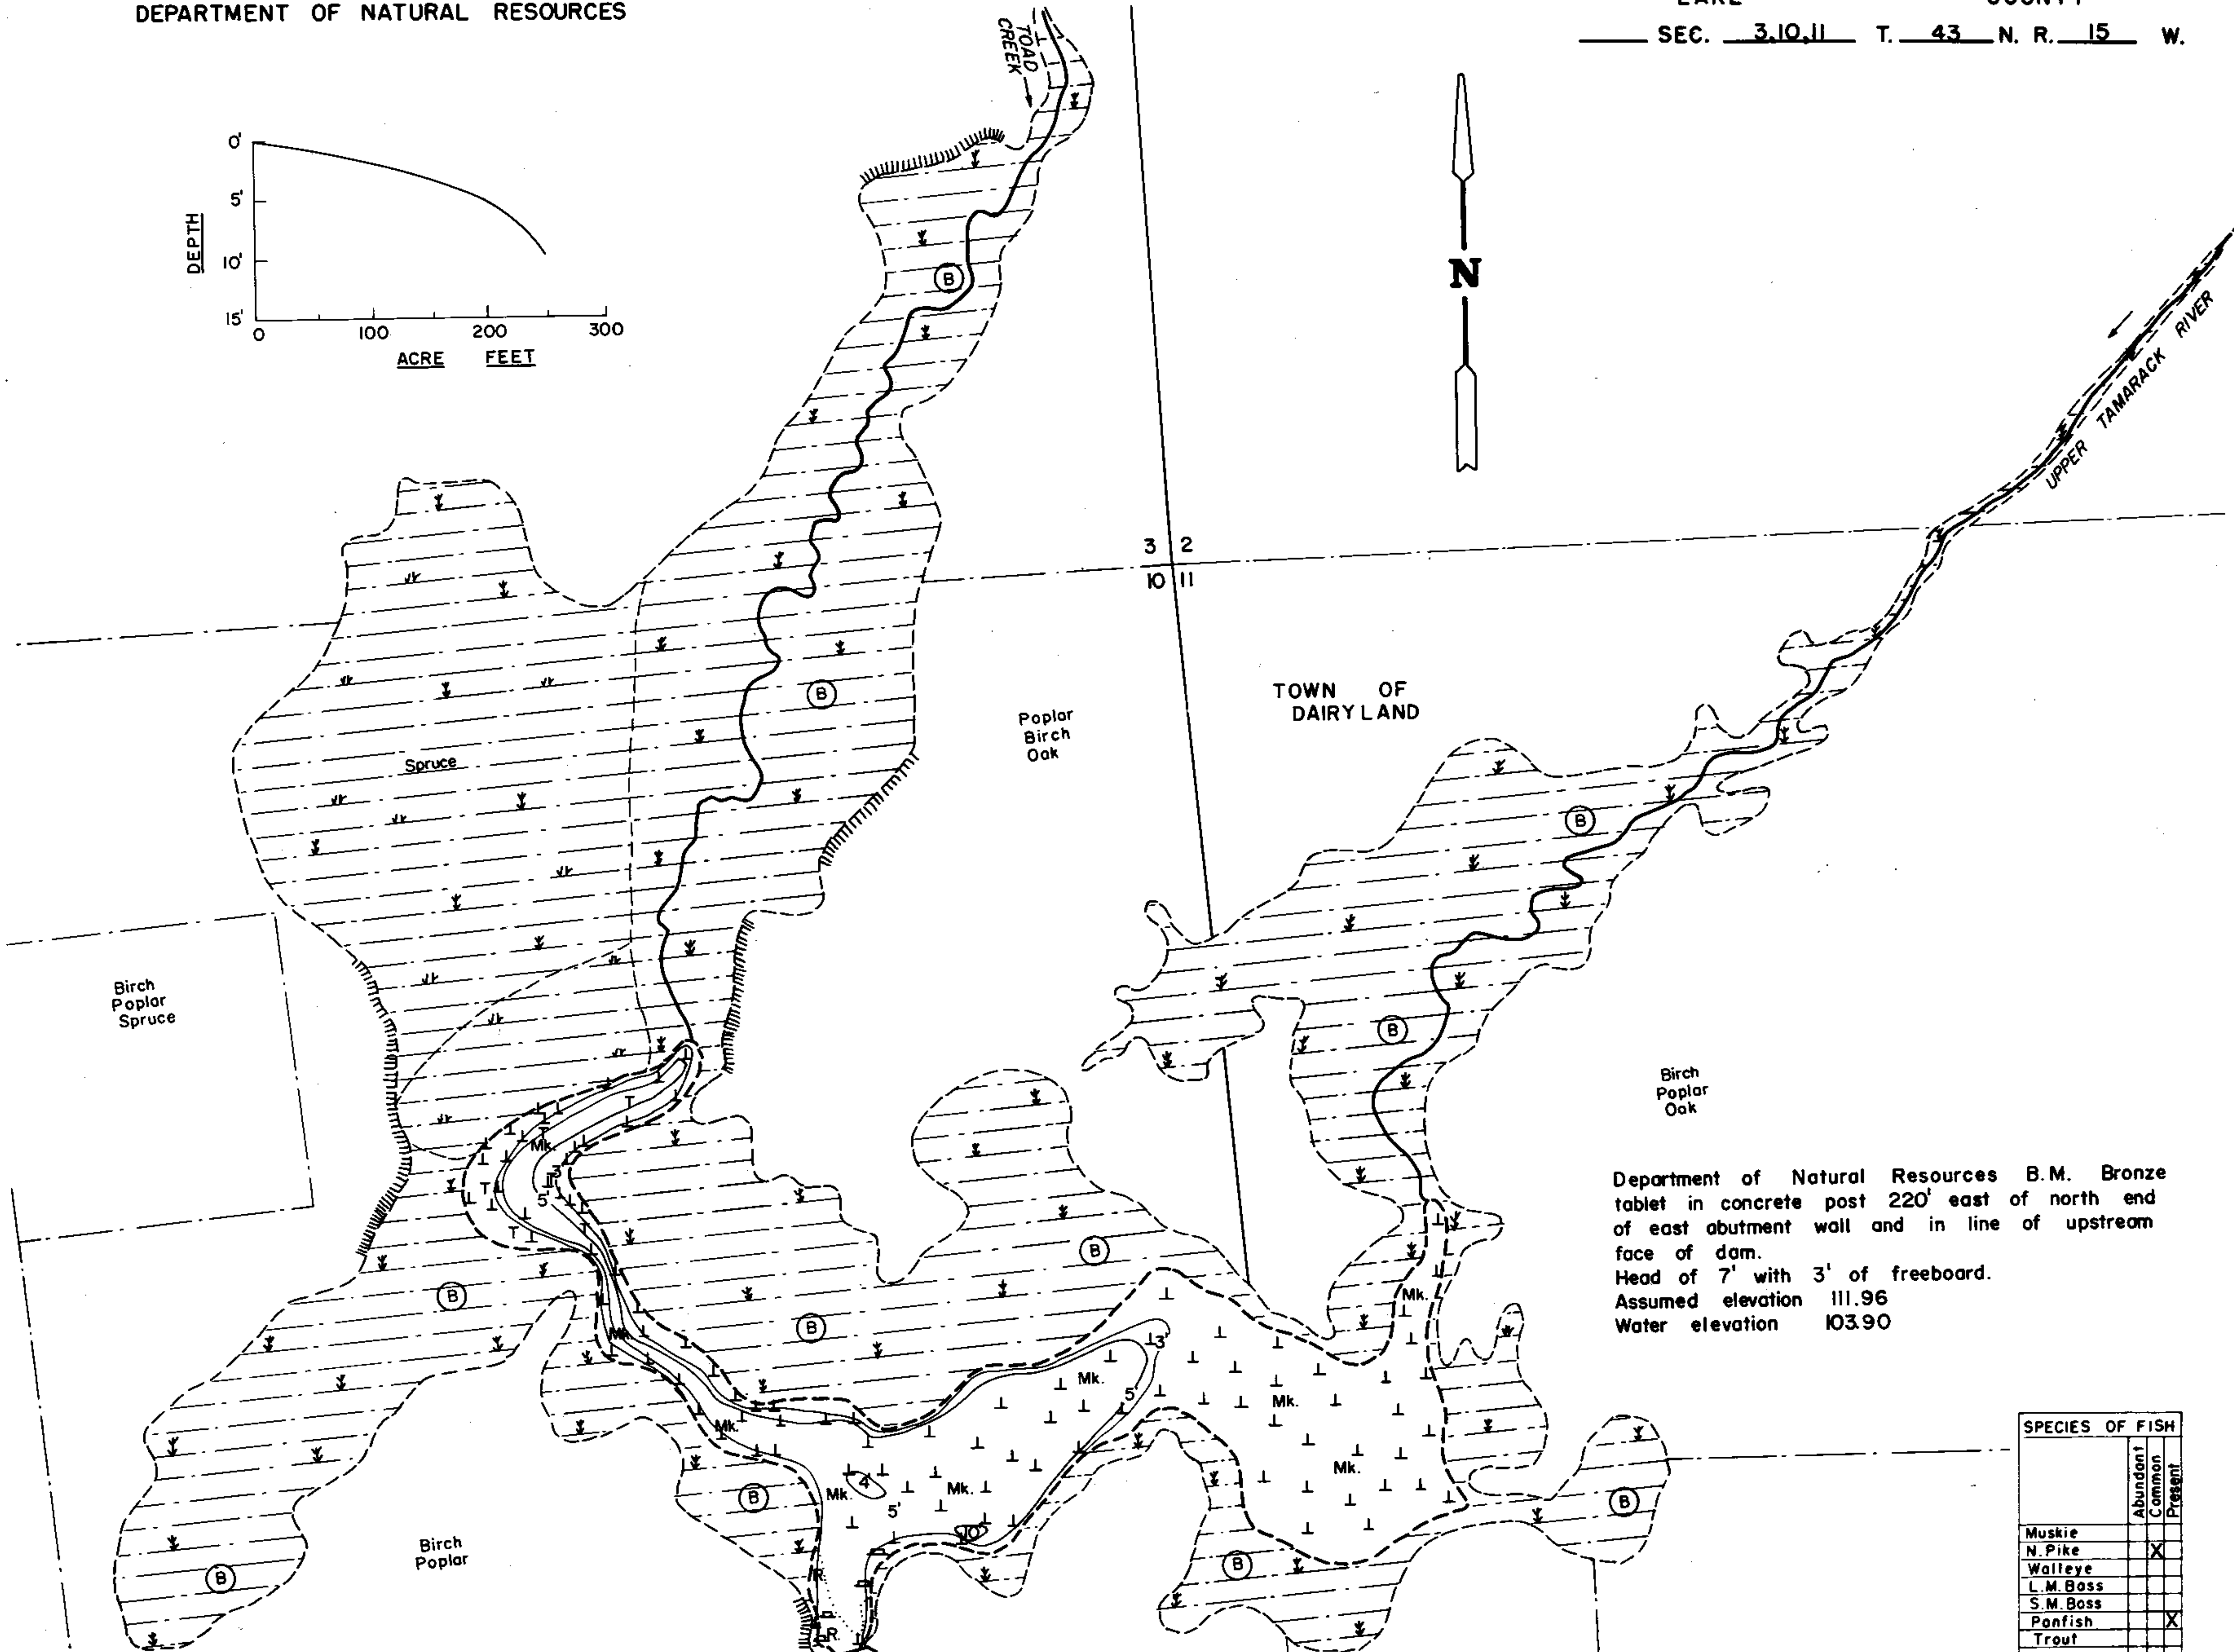
Department of Natural Resources B.M. Bronze tablet in concrete post 220' east of north end of east abutment wall and in line of upstream face of dam.
Head of 7' with 3' of freeboard.
Assumed elevation 111.96
Water elevation 103.90

WATER ELEV. 103.90'

AREA 61.62 ACRES
UNDER 3FT. 50.51 %
OVER 20FT. 0.0 %
VOLUME 248.9 ACRE FT.
TOTAL ALK. 30 P.P.M.
SHORELINE 2.9 MILES
MAX. DEPTH 10 FEET
