AREA 203.8 ACRES
UNDER 3FT. 30 %
OVER 20FT. 5 %
VOLUME 996.5 ACRE FT.
TOTAL ALK. 73 P.P.M.
SHORELINE 5.8 MILES
MAX. DEPTH 24 FEET

Source: Wisconsin Department of Natural Resources 608-266-2621
Bad River Slough – Ashland County, Wisconsin DNR Lake Map
Date – Oct 1966 - Historical Lake Map - Not for Navigation
A Public Document - Please Identify the Source when using it.

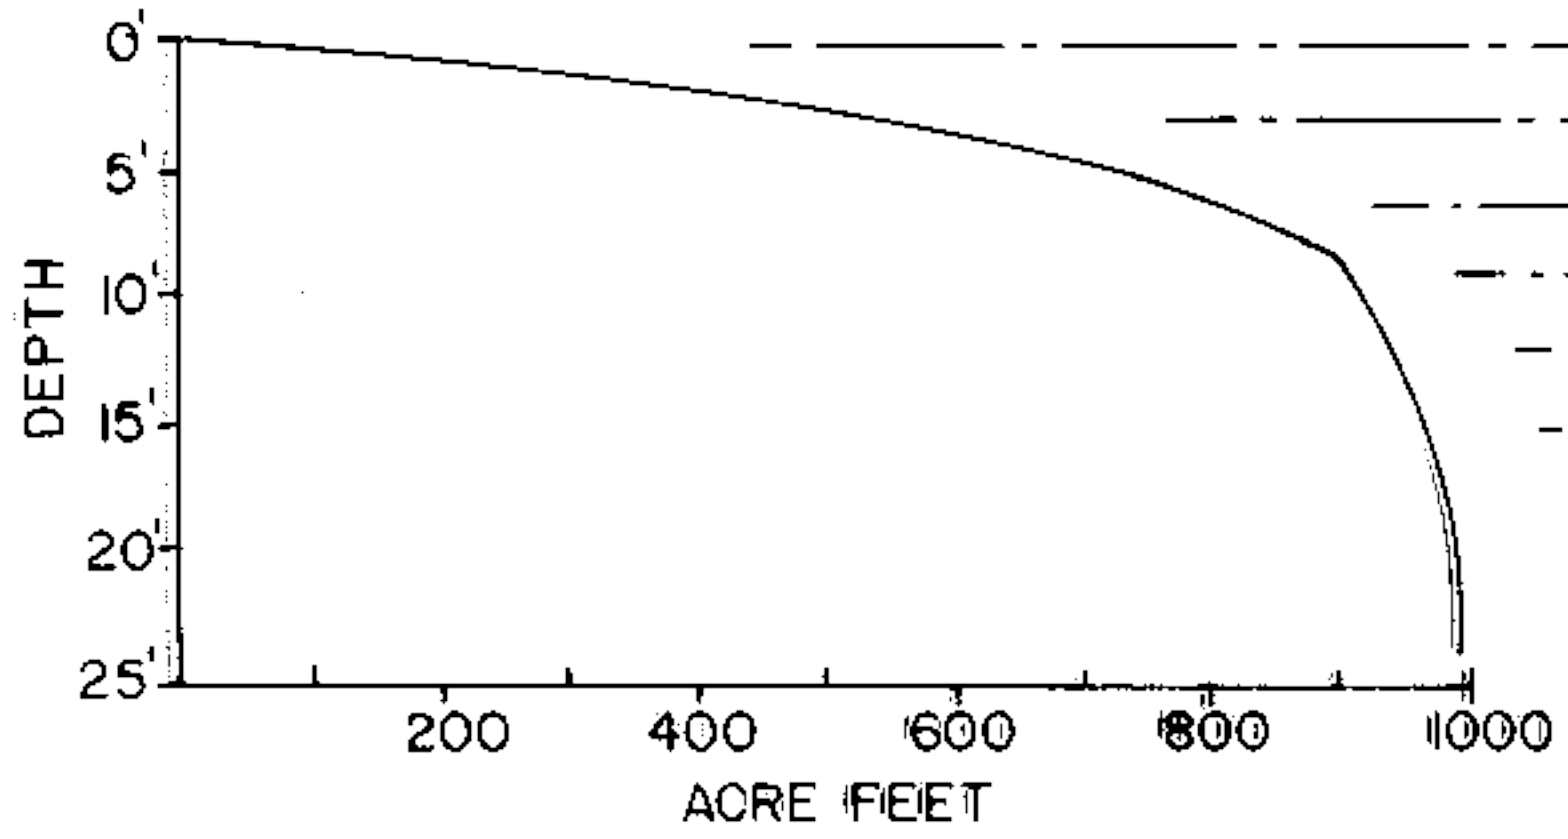
B.M. 'X' W.C.D. Spike in large white pine on N.E.
side of slough
Assumed elev. 100.0
Water elev. 95.0
