Environmental Impact Report

Proposed Golf Course – Town of Wilson

Kohler Company
Sheboygan, Wisconsin

Project No.: 193703078
April 9, 2015

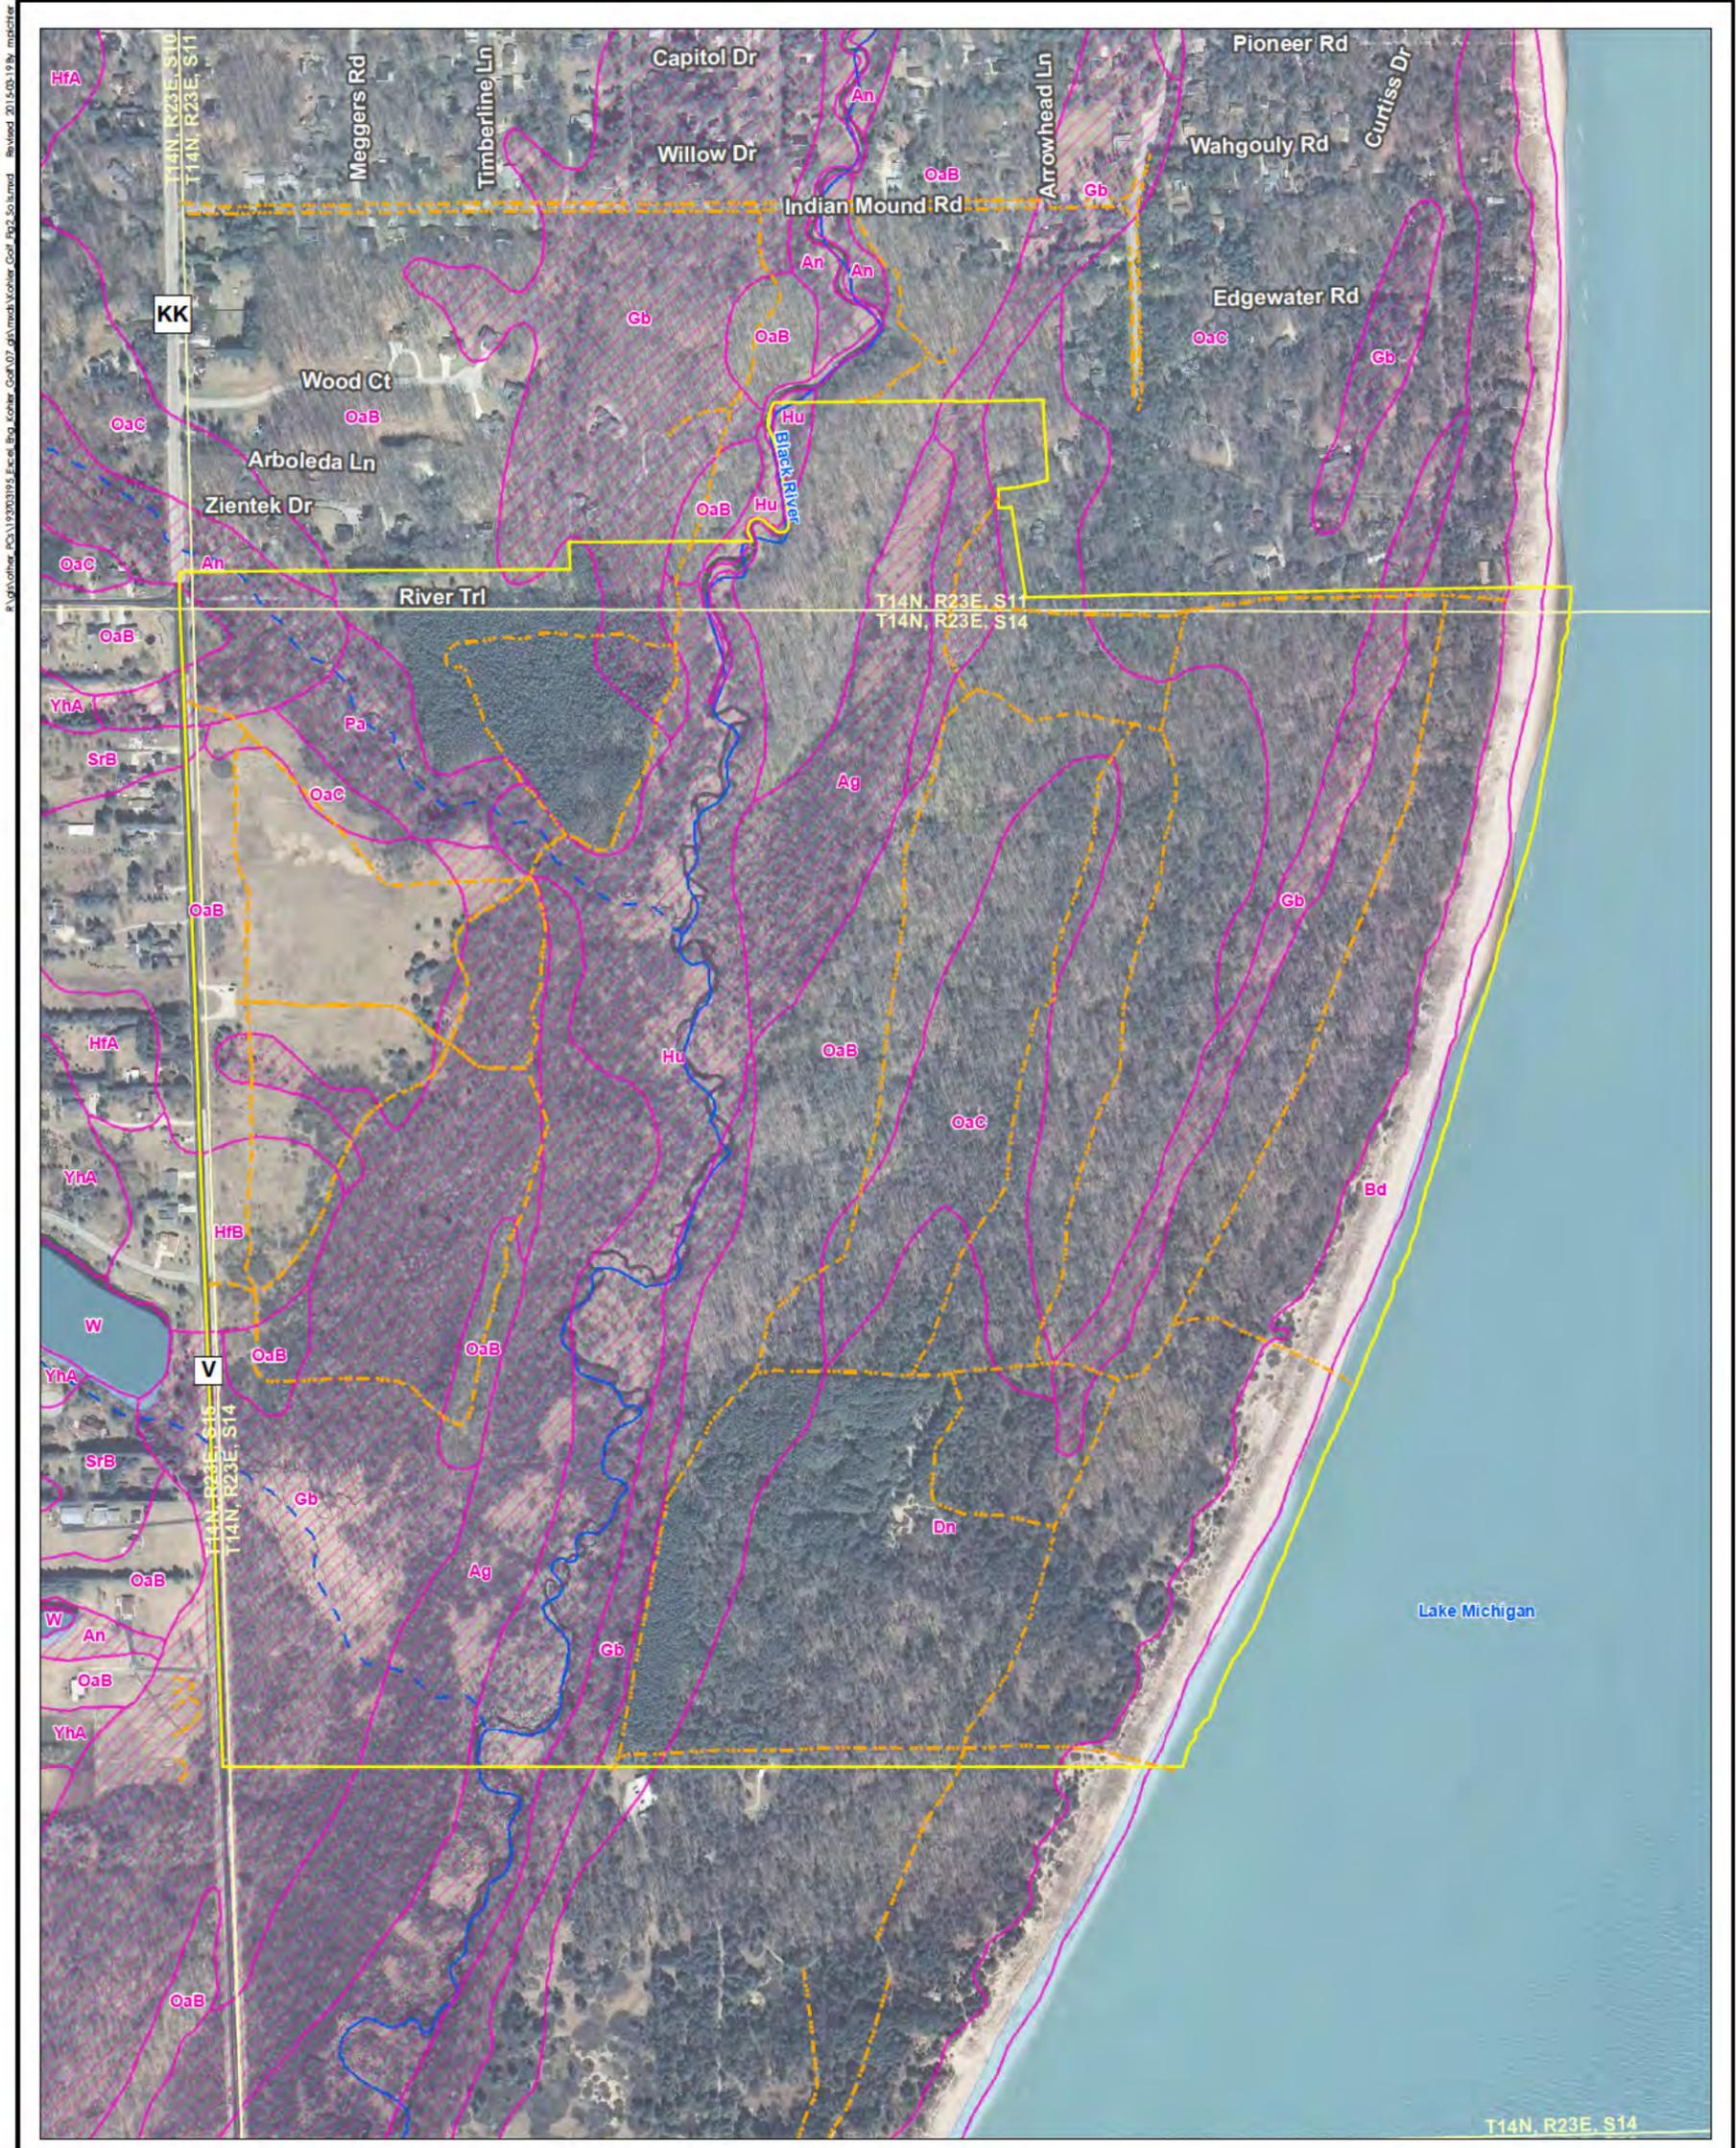
- Legend**
- Approximate Project Boundary
 - Existing Trail
 - NRCs Soil Survey Data
 - Predominantly Hydric Soils
 - Partially Hydric Soils
 - Non-Hydric Soils
 - DNR 24k Hydrography
 - Perennial Stream
 - Intermittent Stream
 - Waterbody

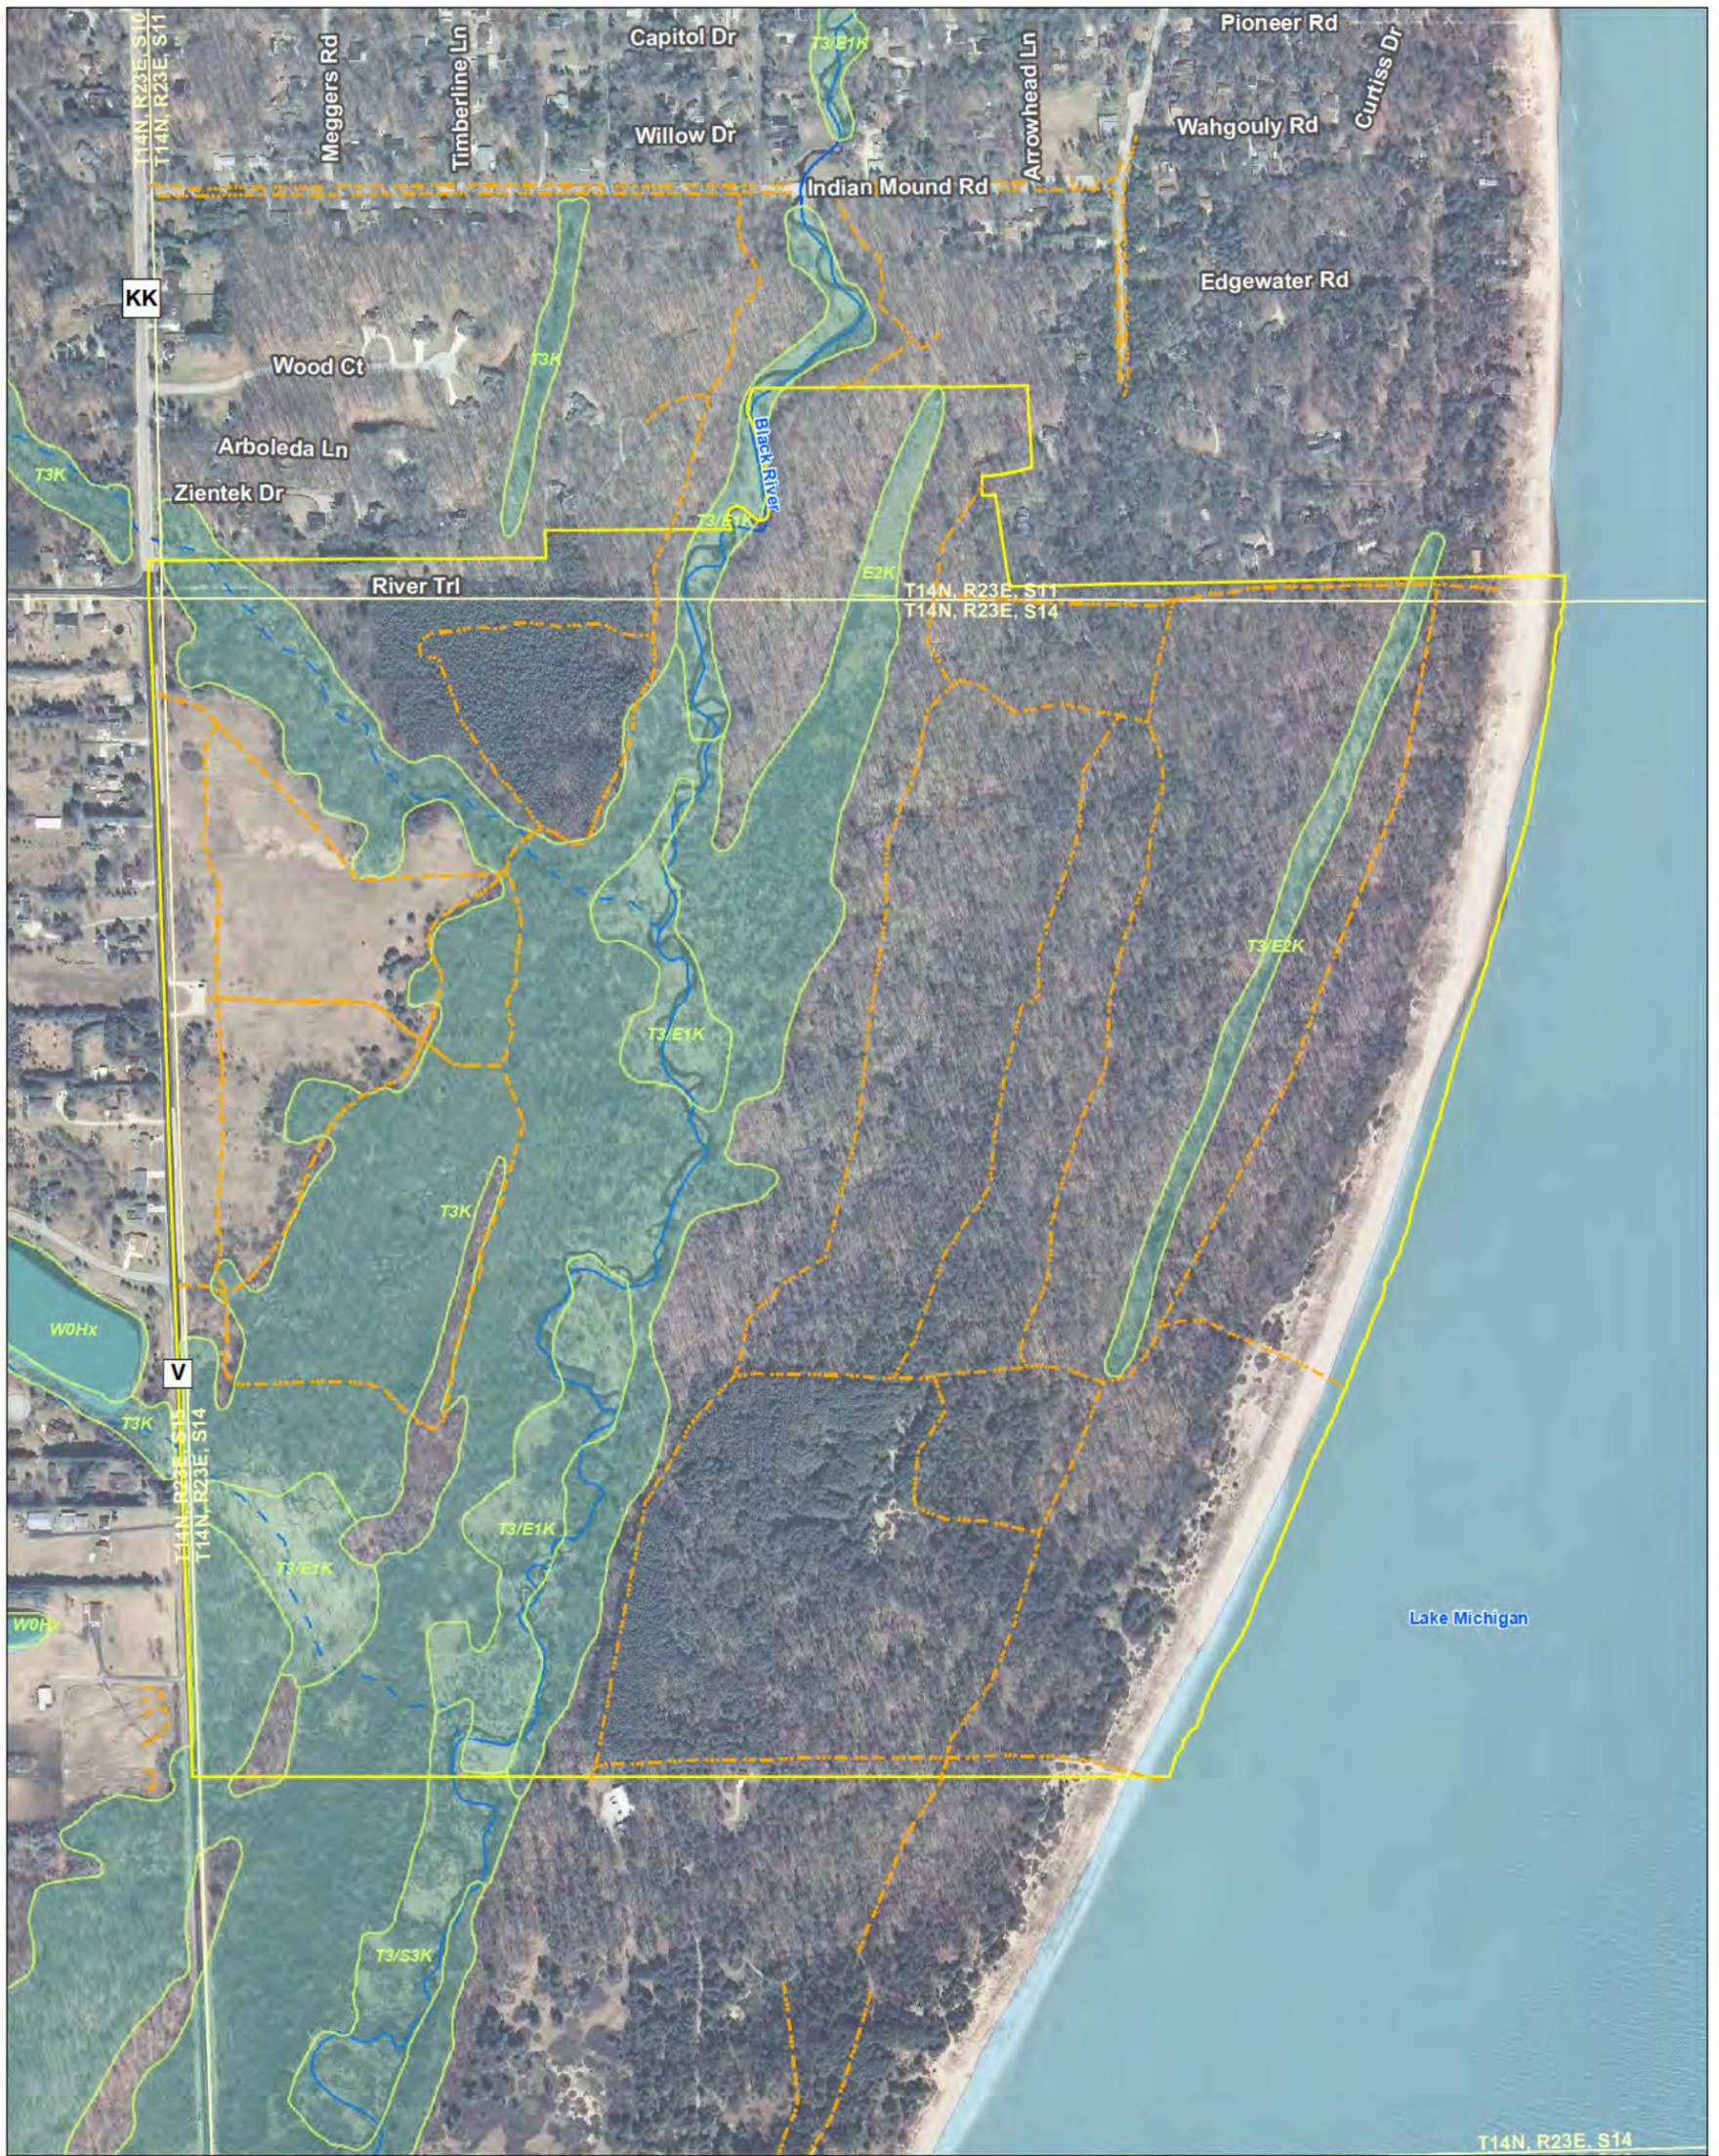
- Legend**
- Approximate Project Boundary
 - Existing Trail
 - Wisconsin Wetland Inventory
 - DNR 24k Hydrography
 - Perennial Stream
 - Intermittent Stream
 - Waterbody

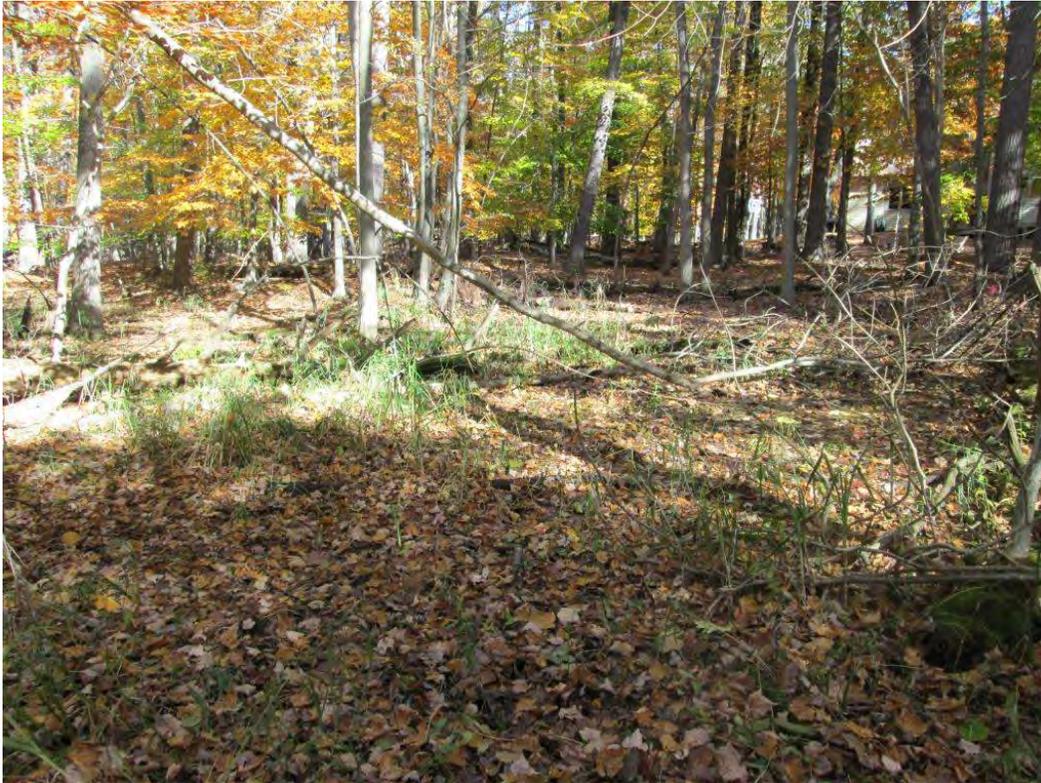
Photo 1: br-10c-w looking north, Mosaic Beech/Maple complex.

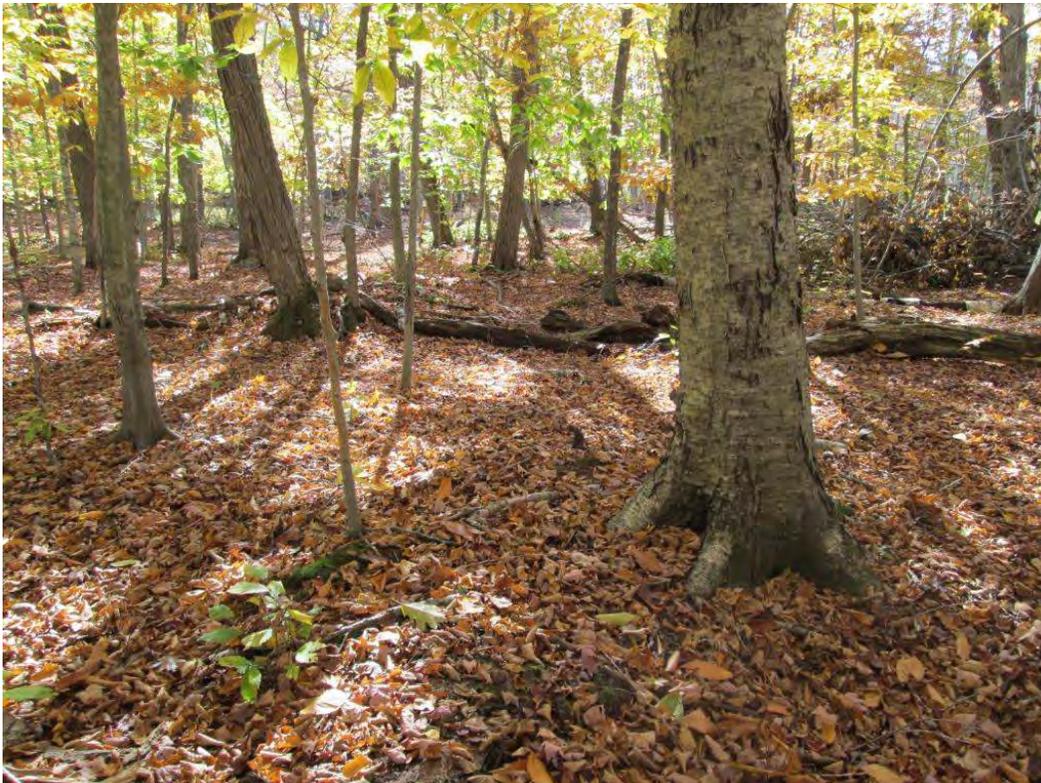
Photo 2: br-10d-u looking south, Mosaic Beech/Maple complex.

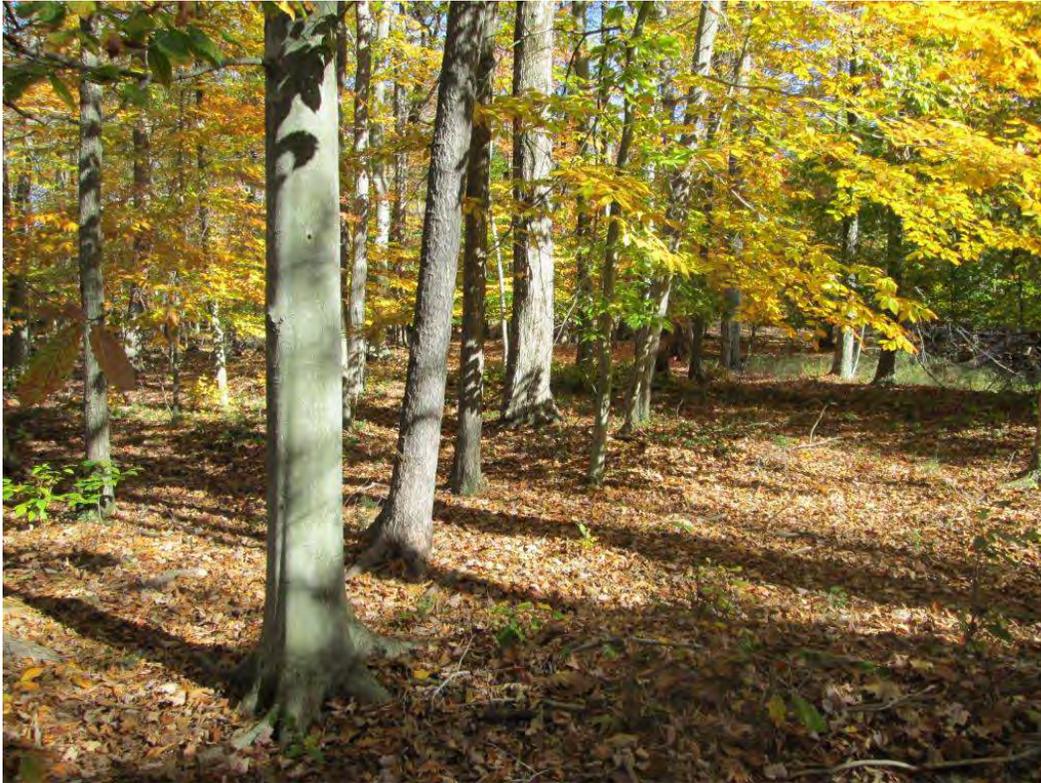
Photo 3: br-11b-u looking north, Mosaic Beech/Maple complex.

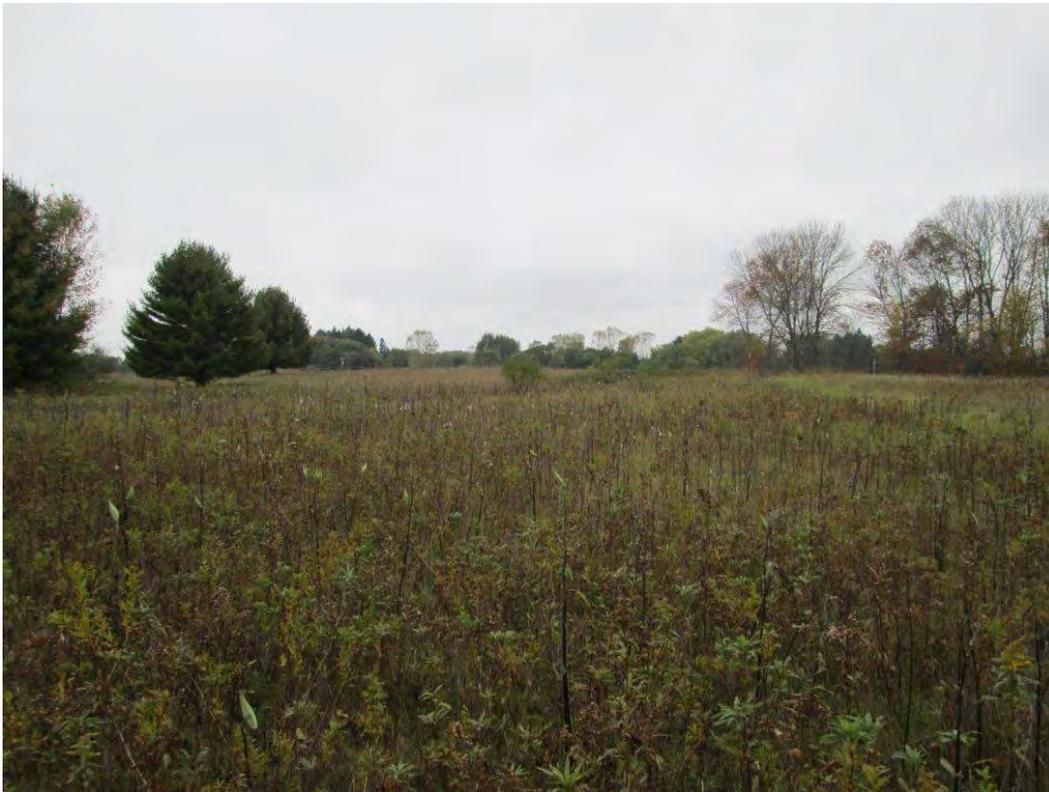
Photo 4: 14bu looking west, old fallow field.

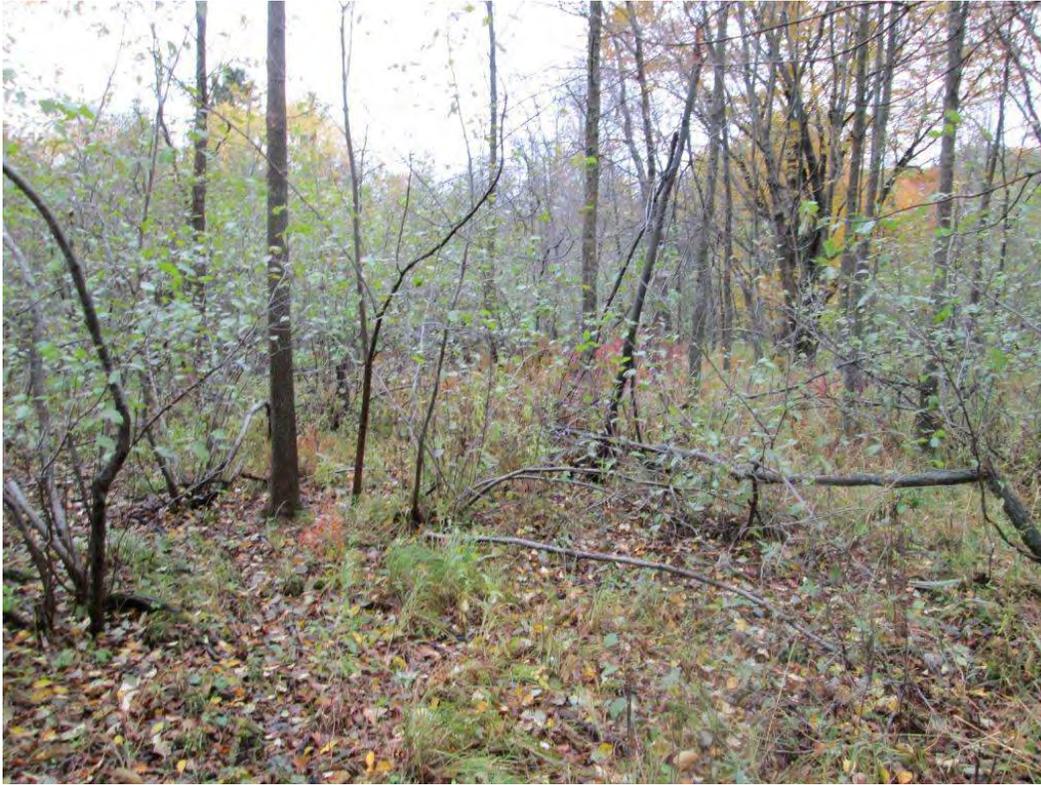
Photo 5: 17cw looking north, Alder thicket.

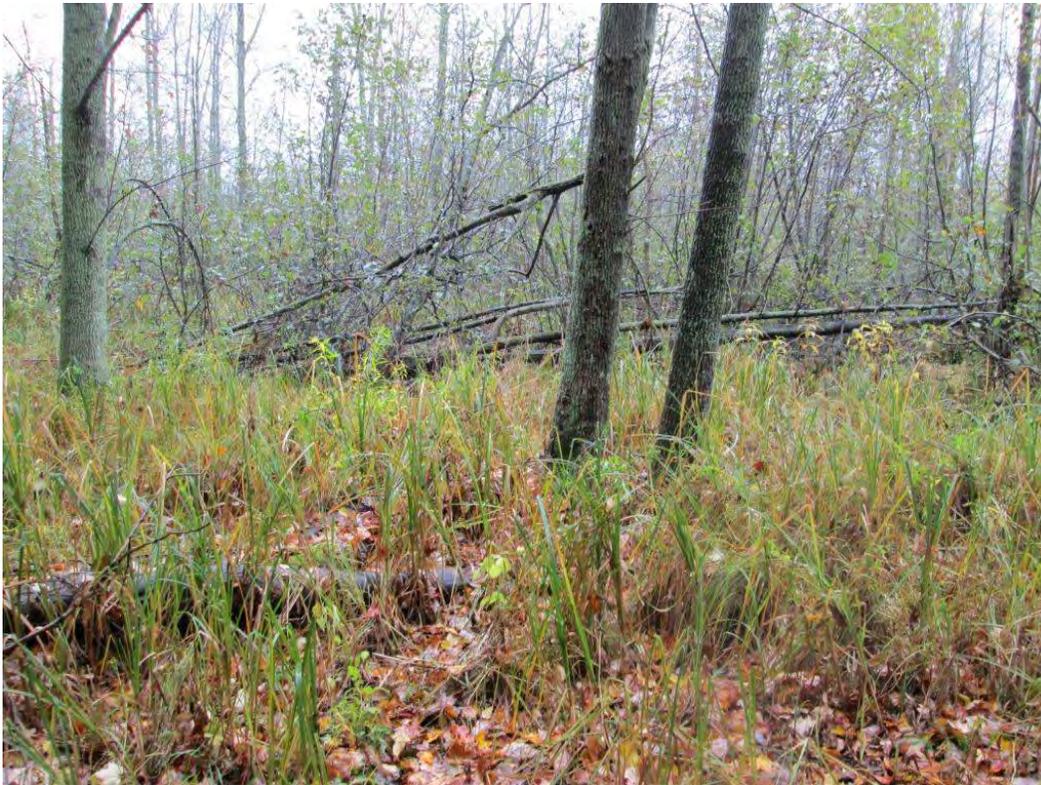
Photo 6: 10cw looking south, Alder thicket.

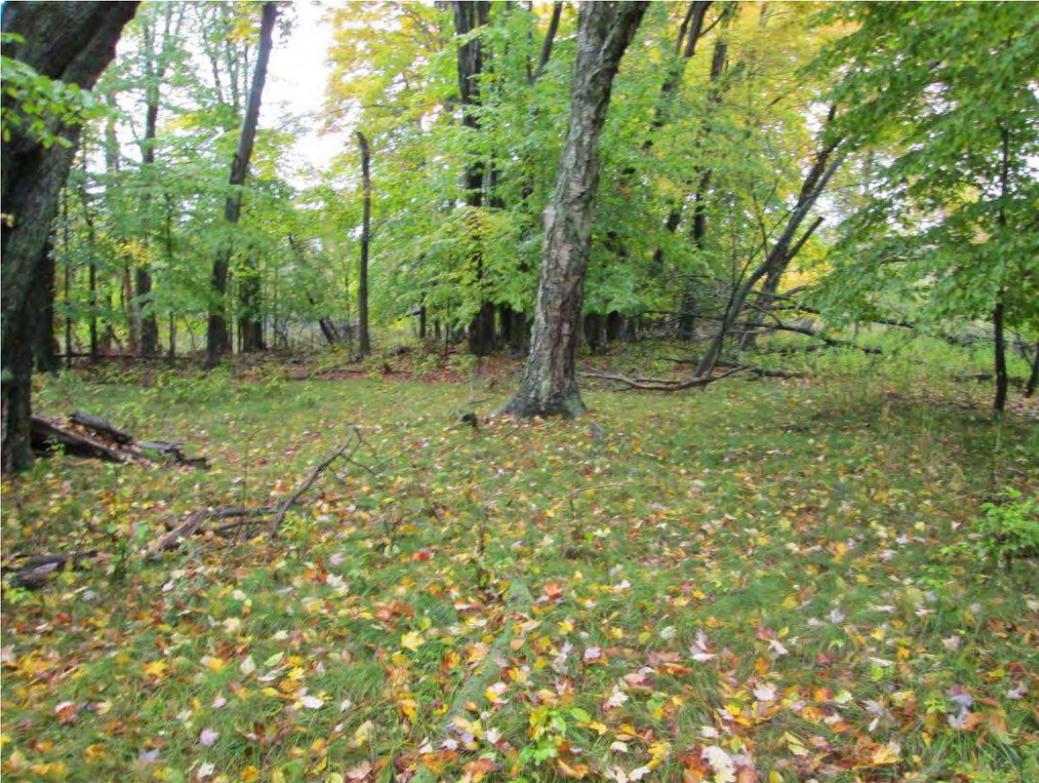
Photo 7: 10bu looking west, Upland forest.

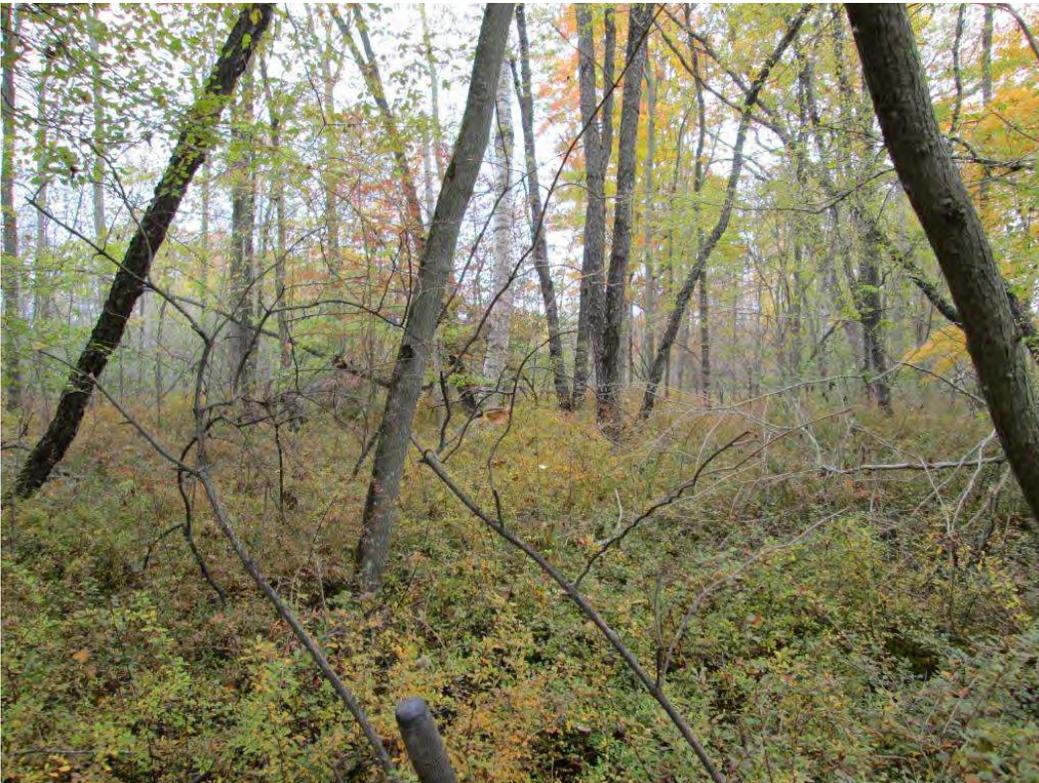
Photo 8: 22bu looking south, Mesic forest.

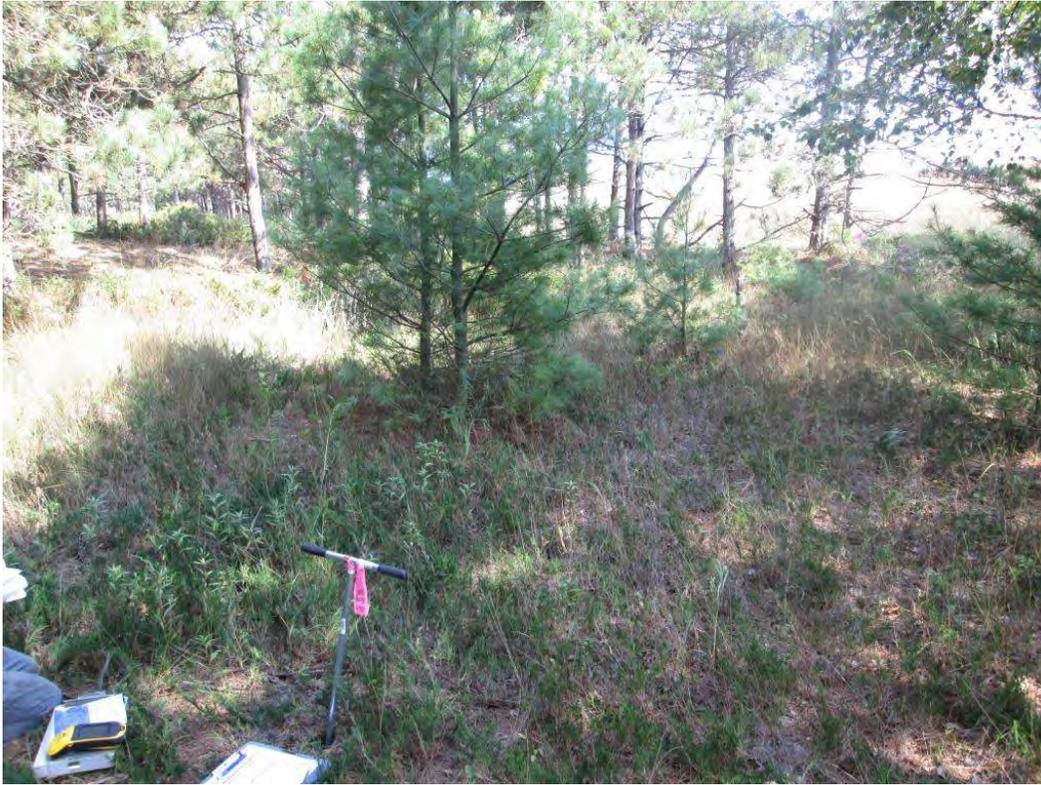
Photo 9: P40dw looking east, Seasonally flooded basin.

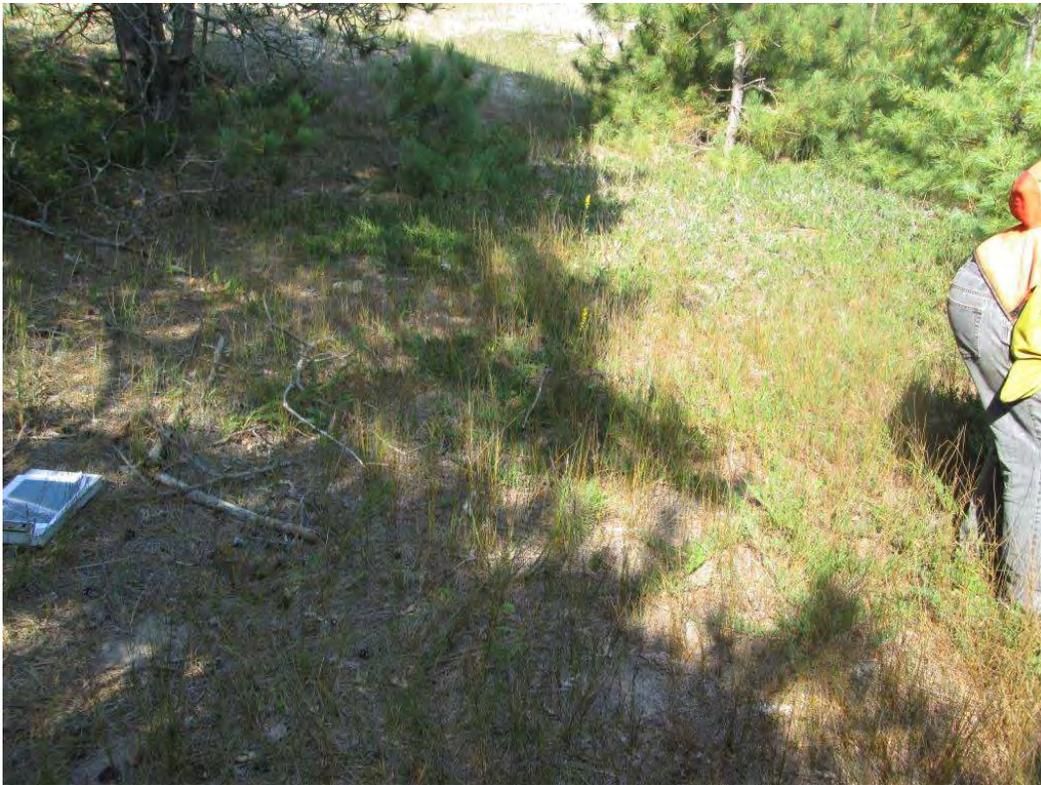
Photo 10: P36u looking north, Upland ridge.

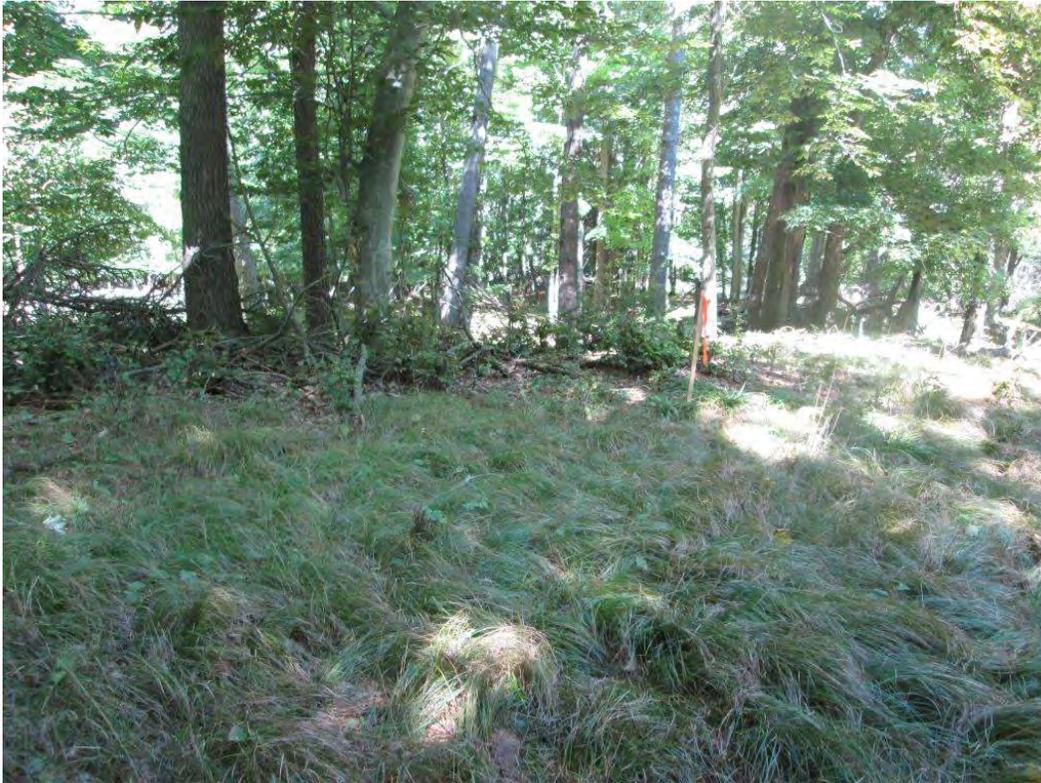
Photo 11: P33u looking north, Upland ridge.

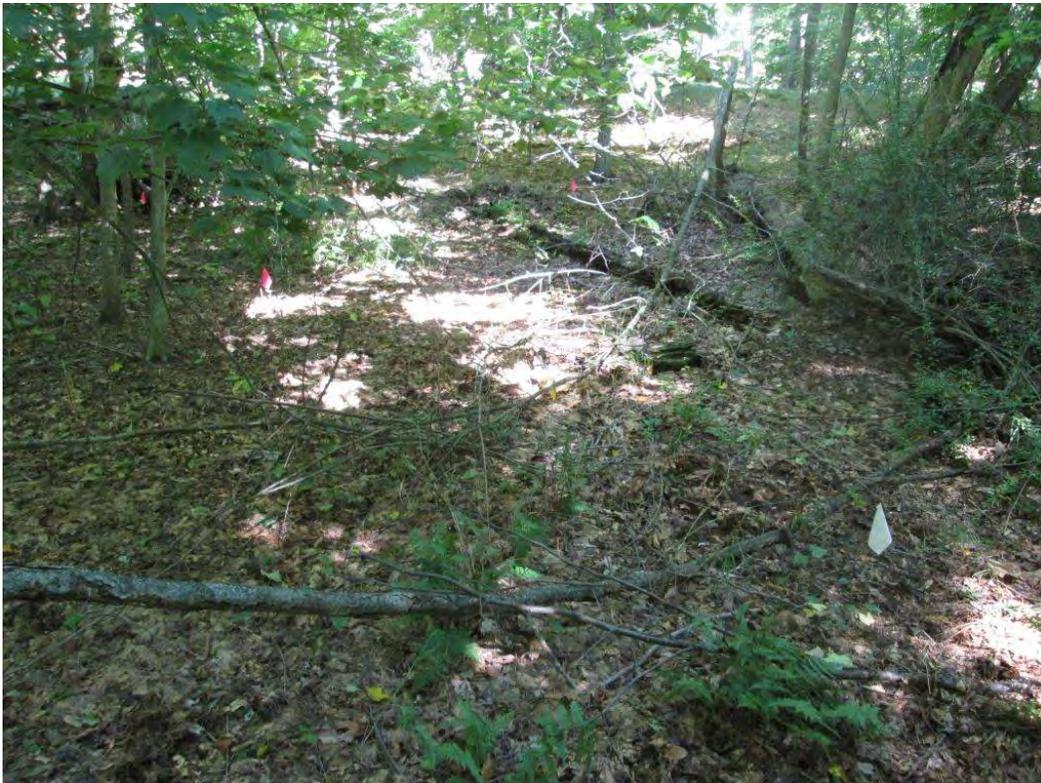
Photo 12: P33w looking north, Wetland swale complex.

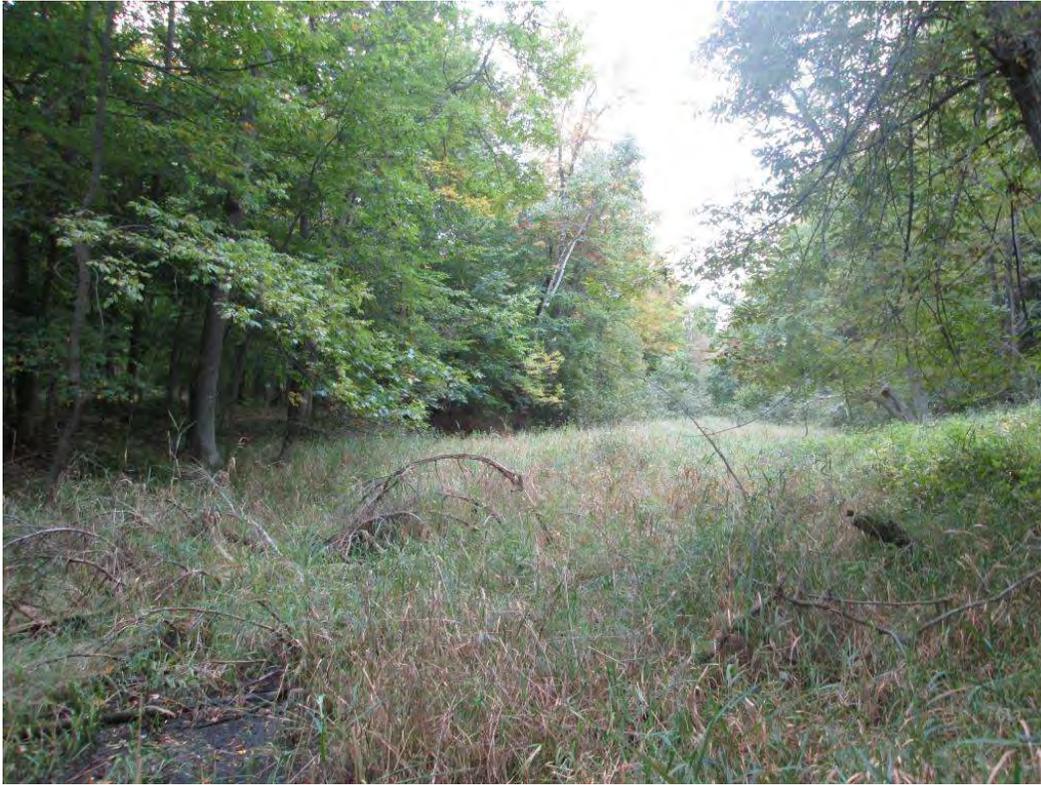
Photo 13: ne-2-w looking south, Wet meadow.

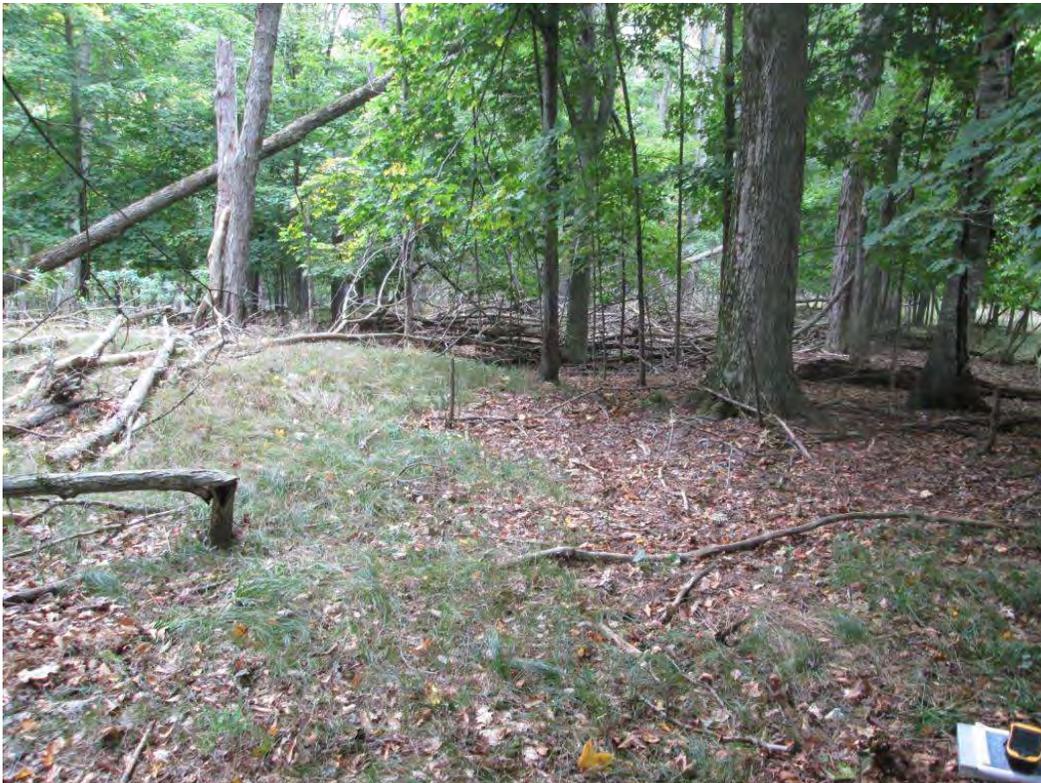
Photo 14: ne-2b-u looking north, Upland ridge.

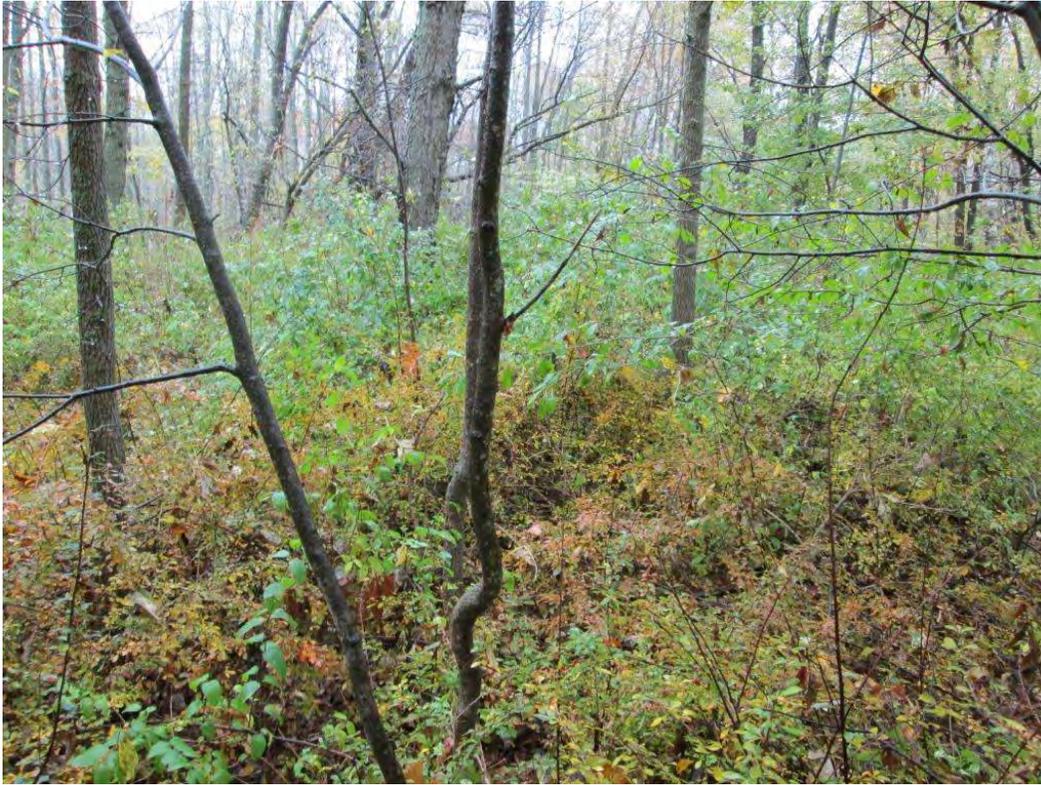
Photo 15: 21cu looking north, Upland ridge.

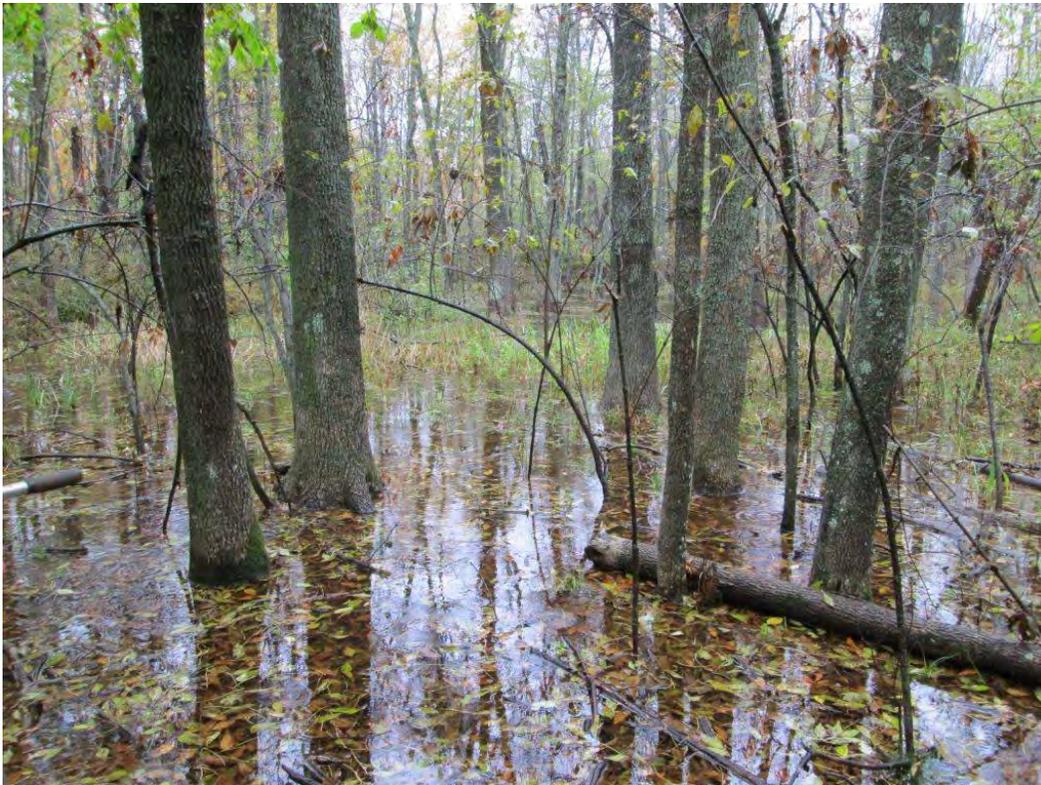
Photo 16: 21cw looking west, Hardwood swamp.
