**Reference: Kohler Company Proposed Golf Course – Wetland Delineation Report Addendum,
Town of Wilson, Sheboygan County, Wisconsin**

Reference: Wetland Delineation Report Addendum

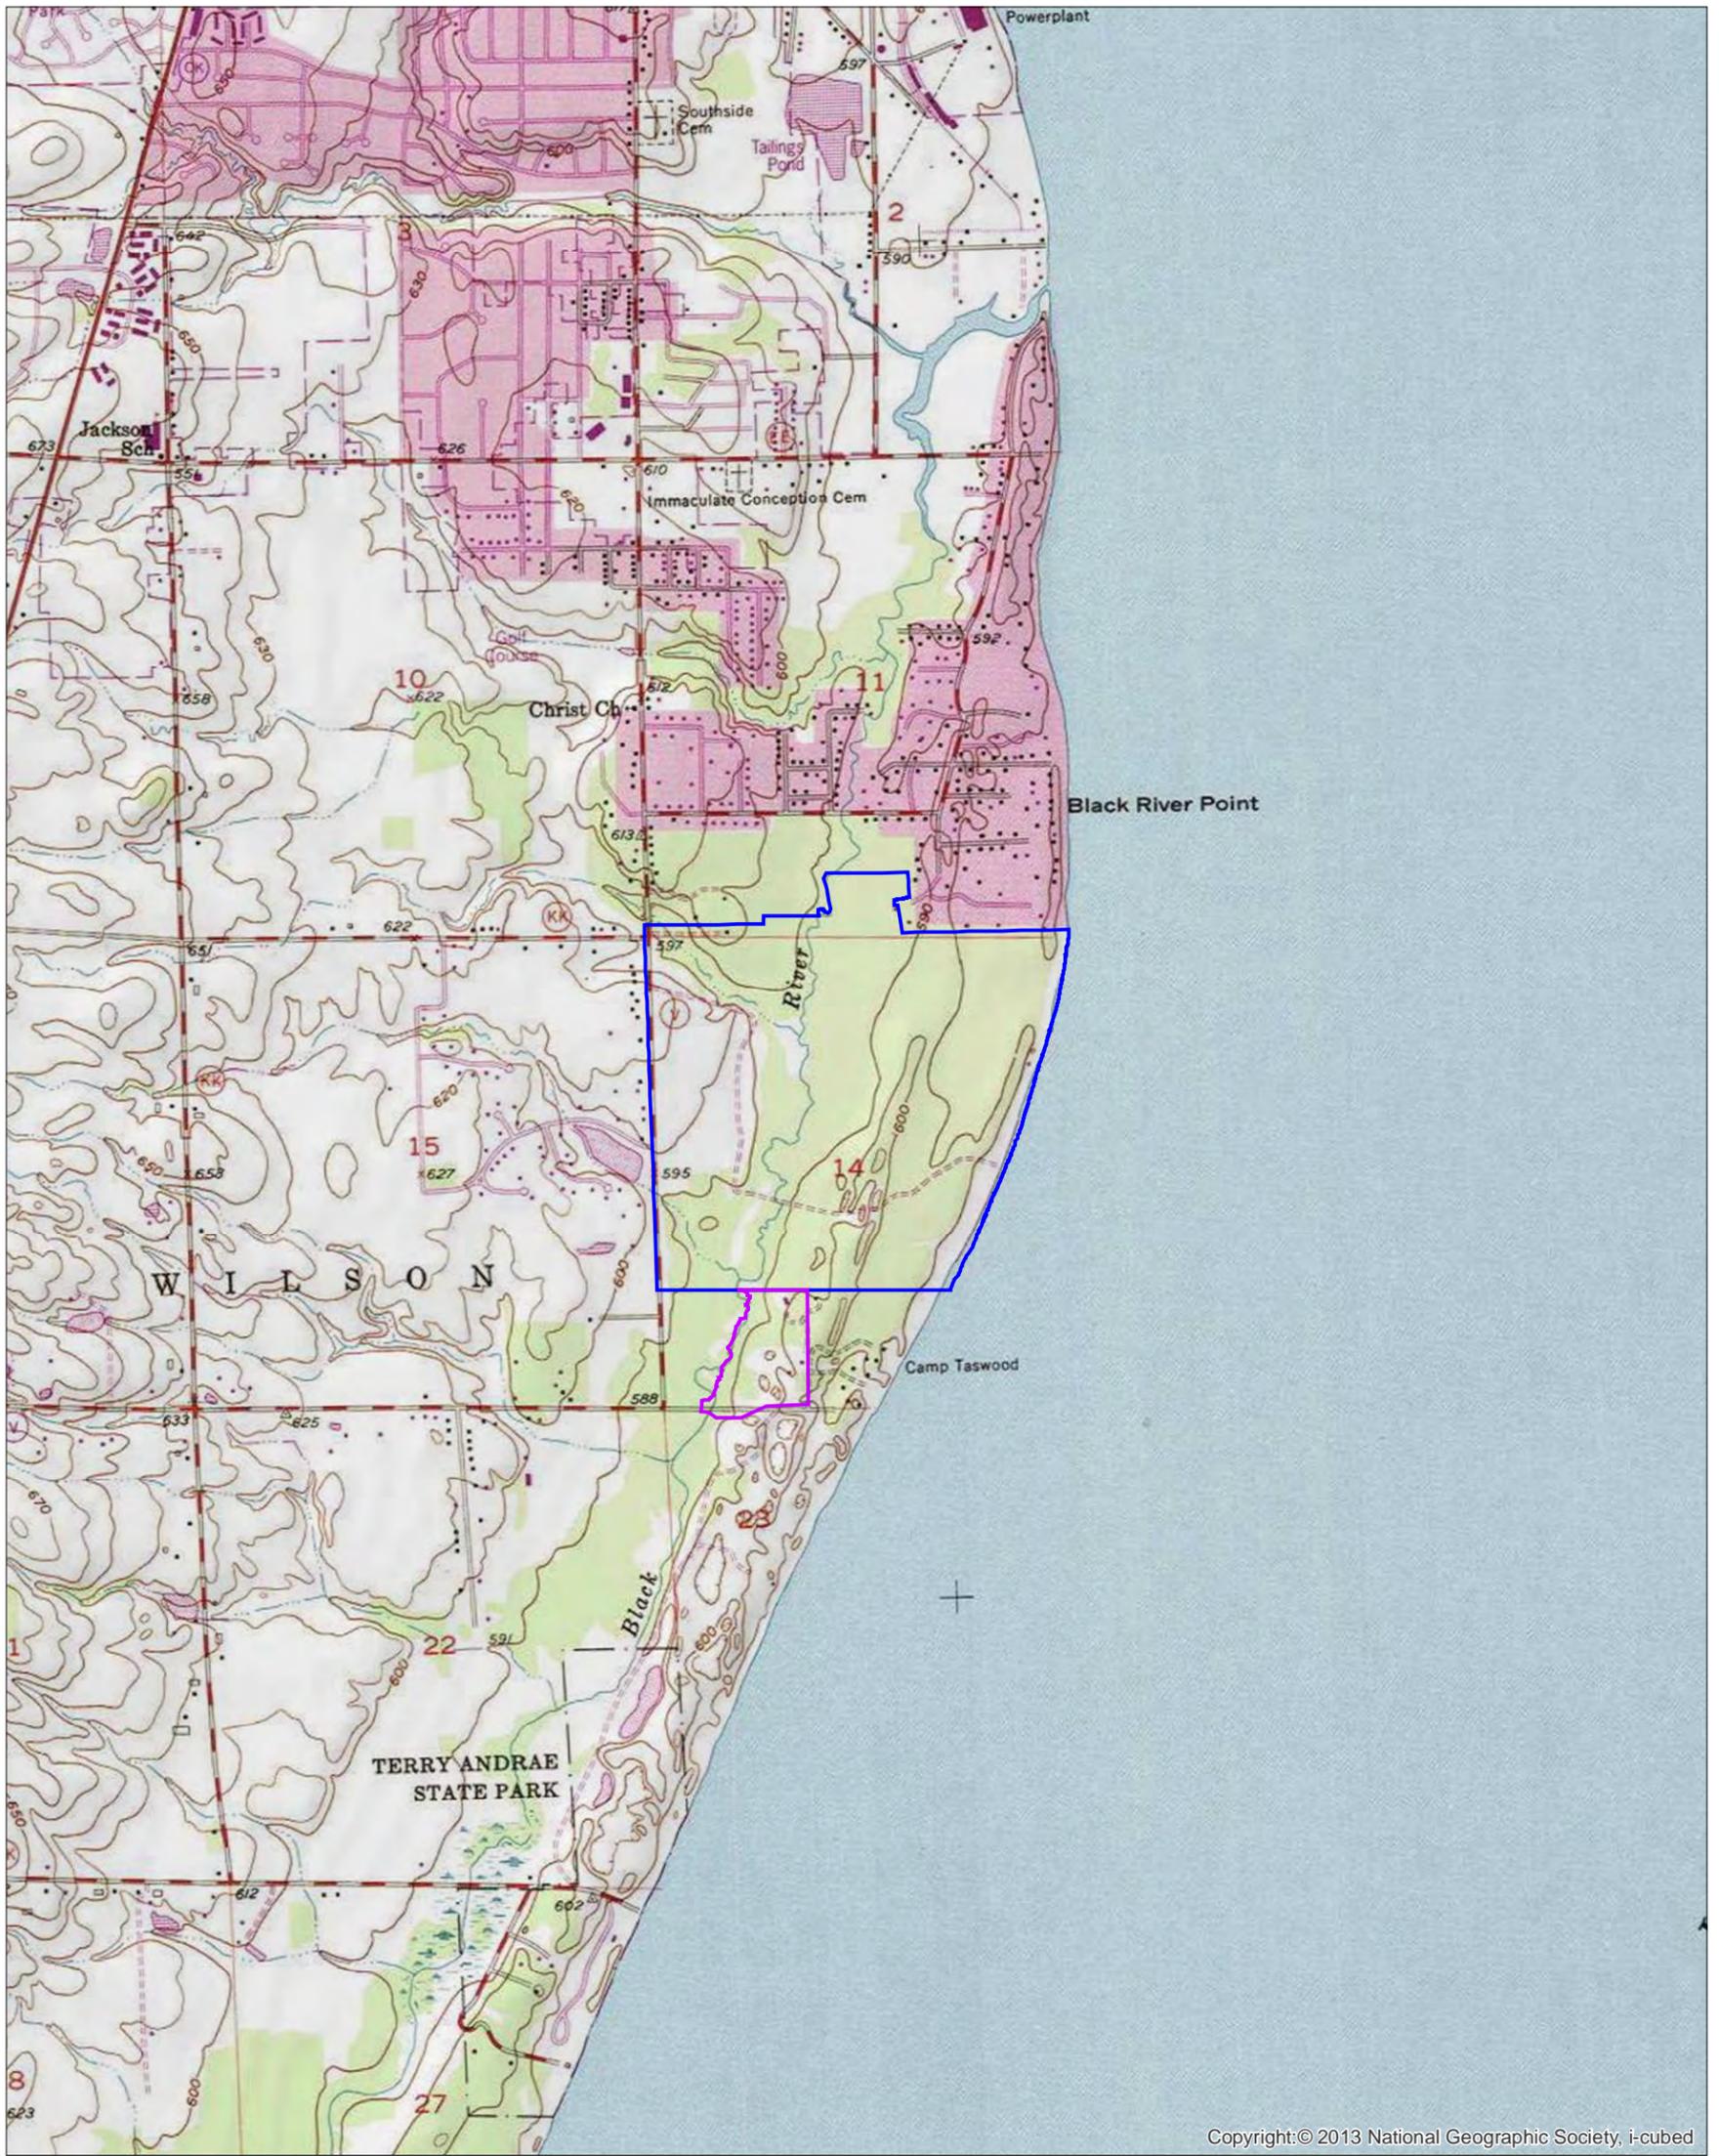
Figure No. **1**
 Title **Project Location and Topography**

Following submittal of the delineation report, an additional area of State owned property south of the original Project limits is being considered for the entrance road and maintenance facility locations (Figure 1). The purpose of this report addendum is to describe the methods and results of the wetland delineation within the additional survey area.

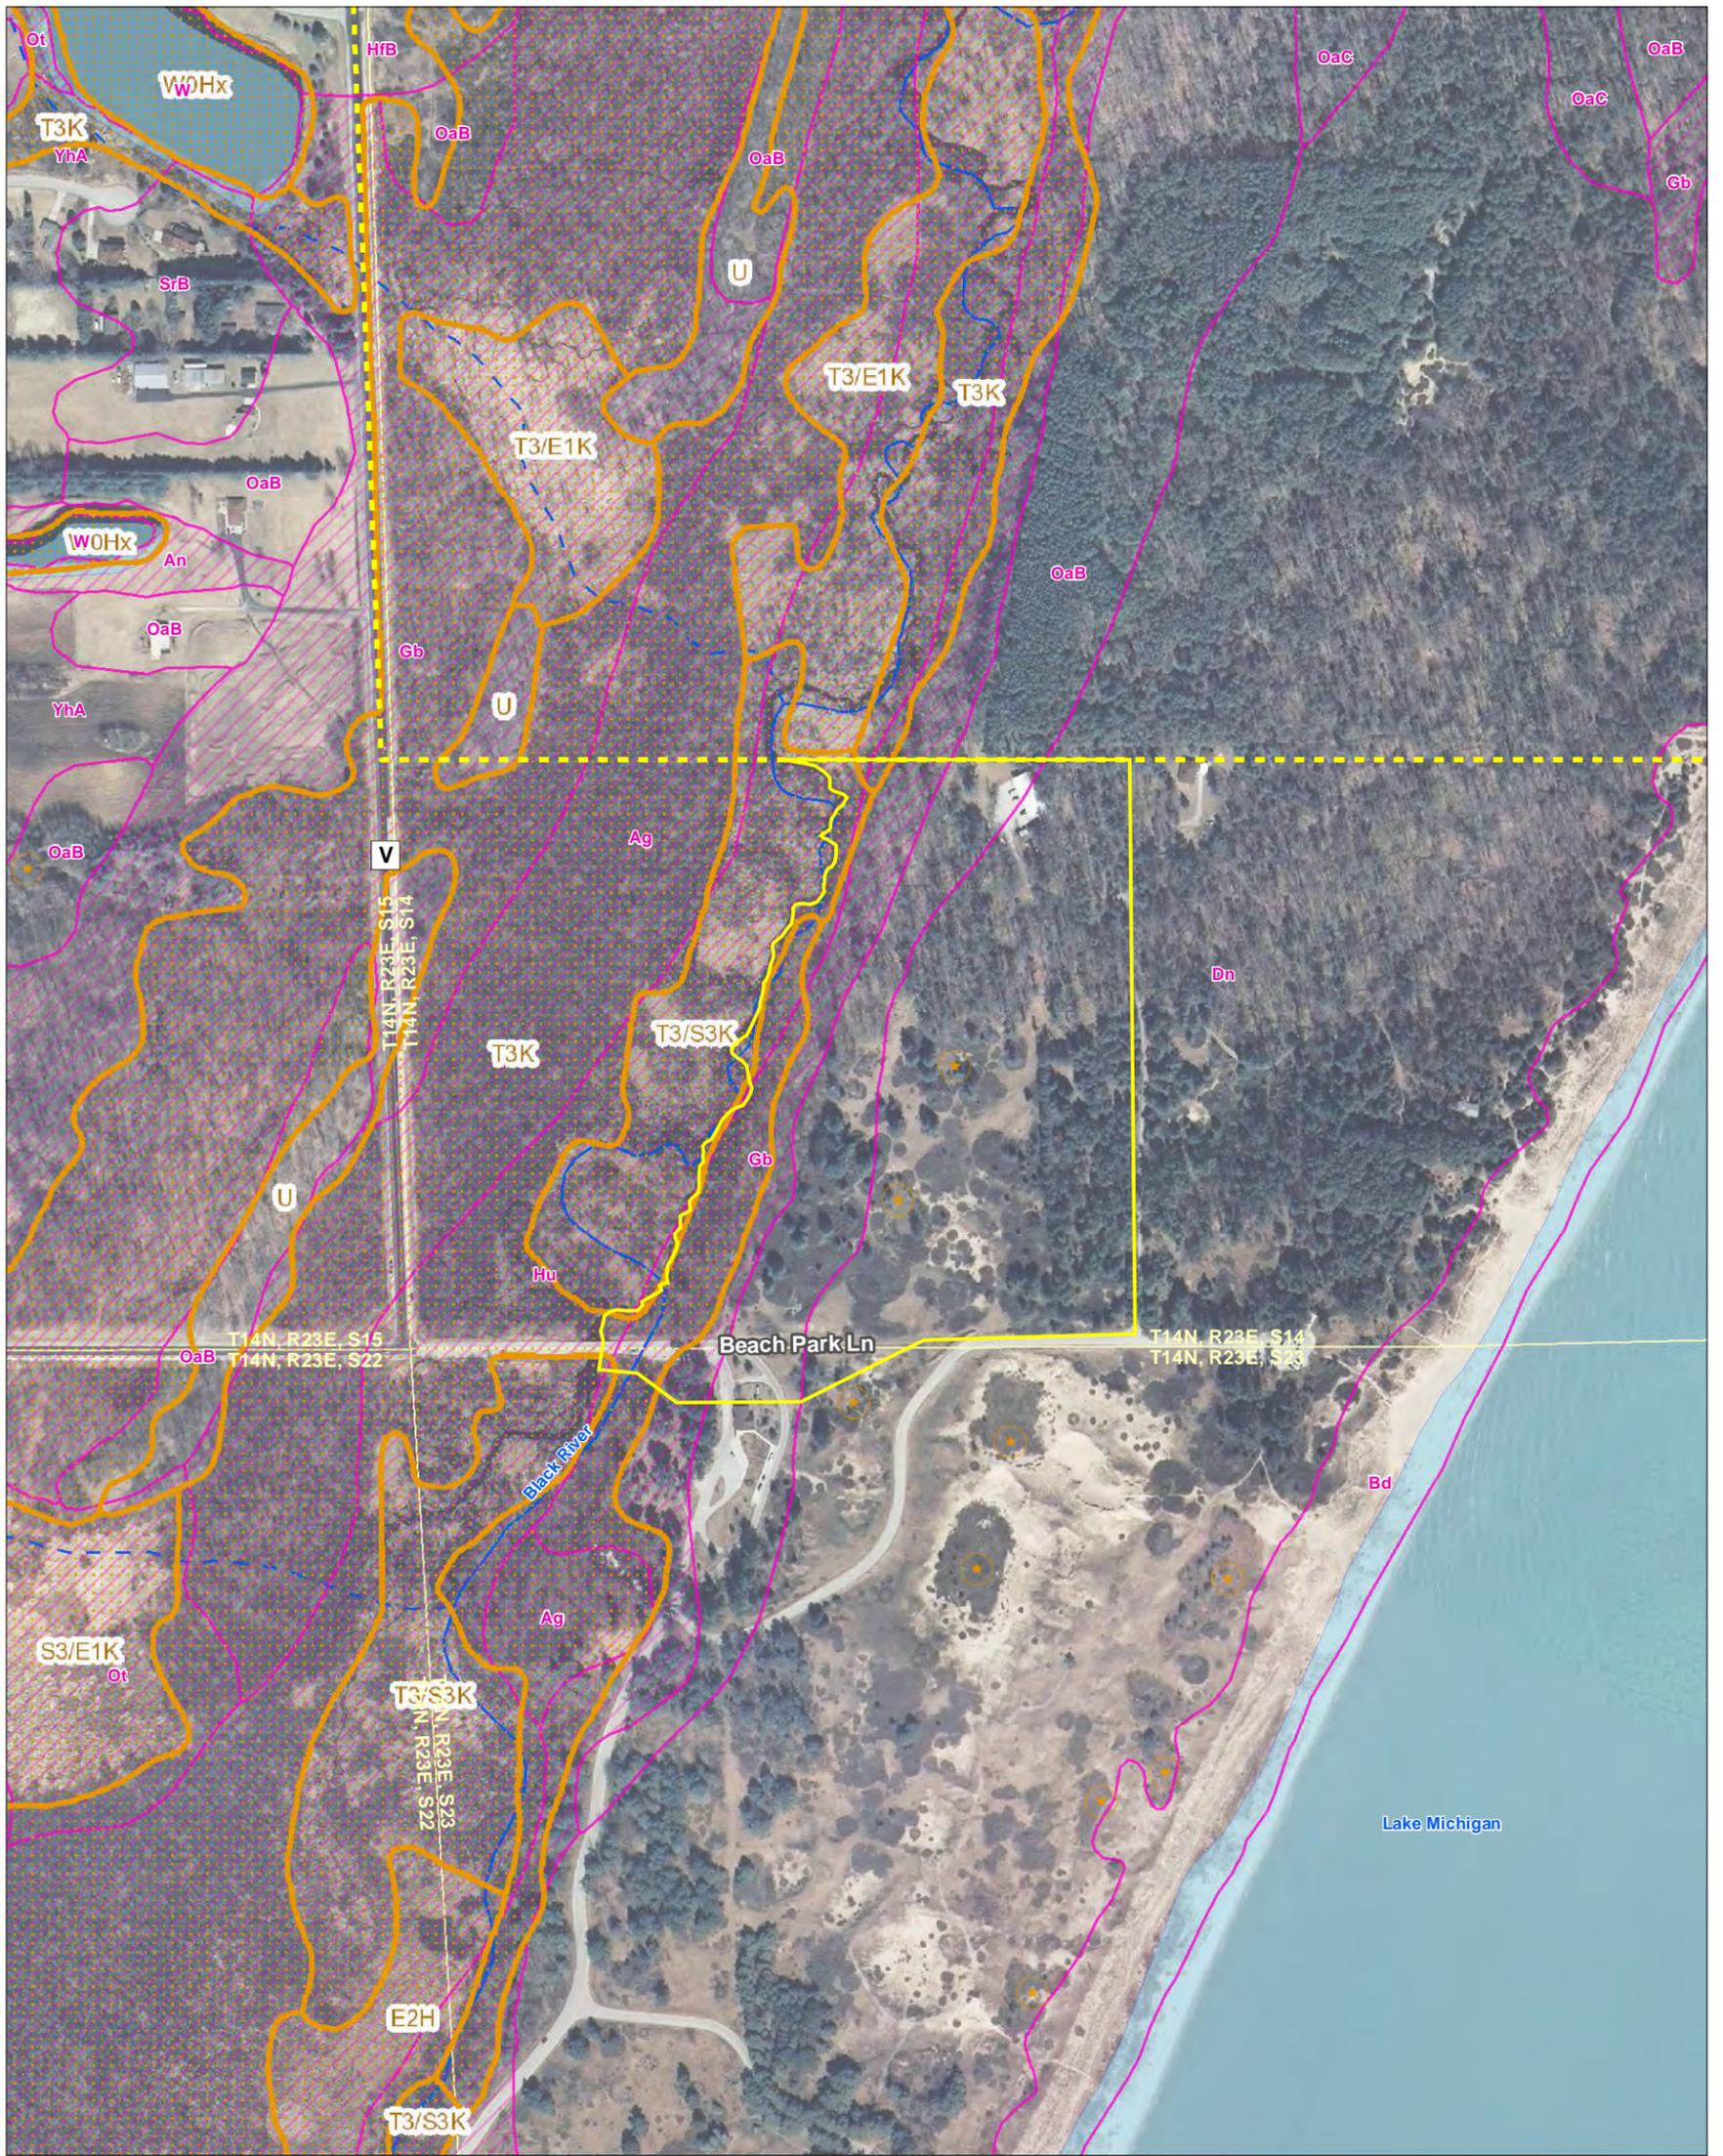
Figure No. **2**

The additional survey area is comprised of forested wetlands, sandy dunes and upland forest. Overall, the additional survey area has gentle rolling hills. Soils mapped within the survey area by the NRCS Soil Survey of Sheboygan County, Wisconsin are listed in Table 1 and shown on Figure 2.

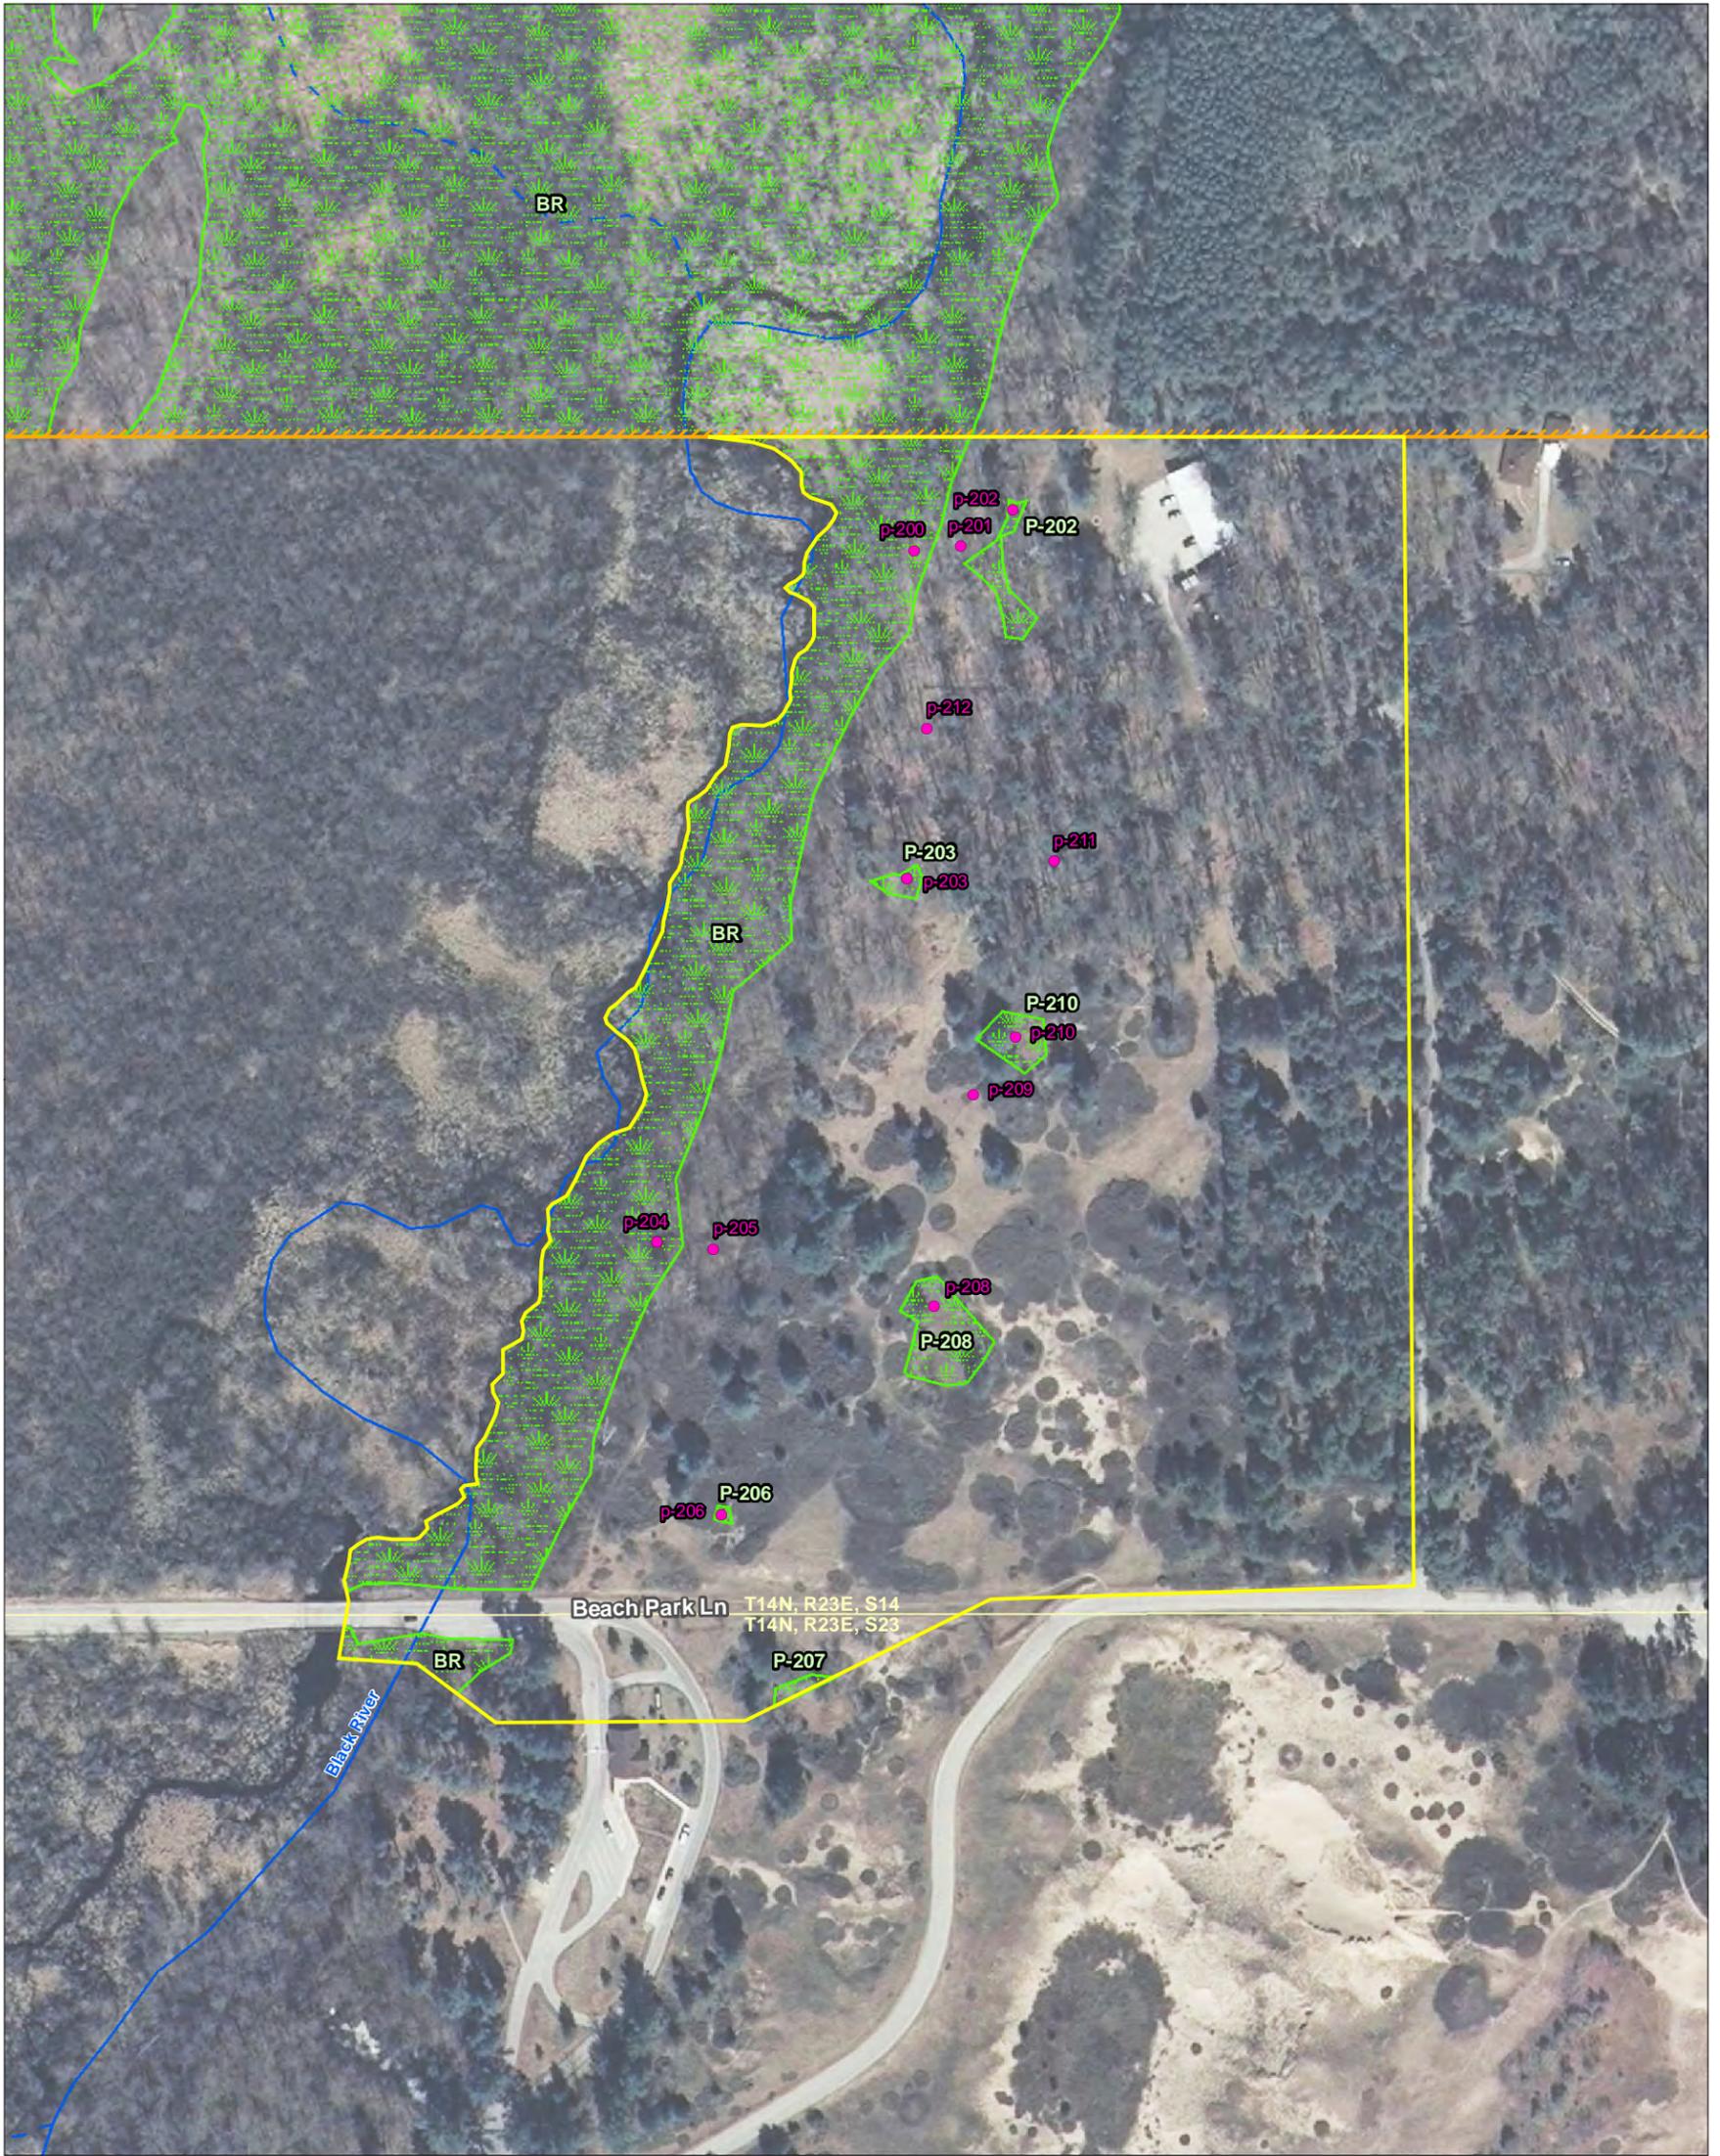
Figure No.
3

Seven wetlands were identified and delineated on State owned property within the additional survey area. The wetland determination data forms are included in Attachment A and describe the field conditions observed during the surveys. Photographs of the wetlands and adjacent uplands are included in Attachment B. The wetland boundary and sample point locations are shown on Figure 3. The wetlands are summarized in Table 2 and described in detail in the following section.

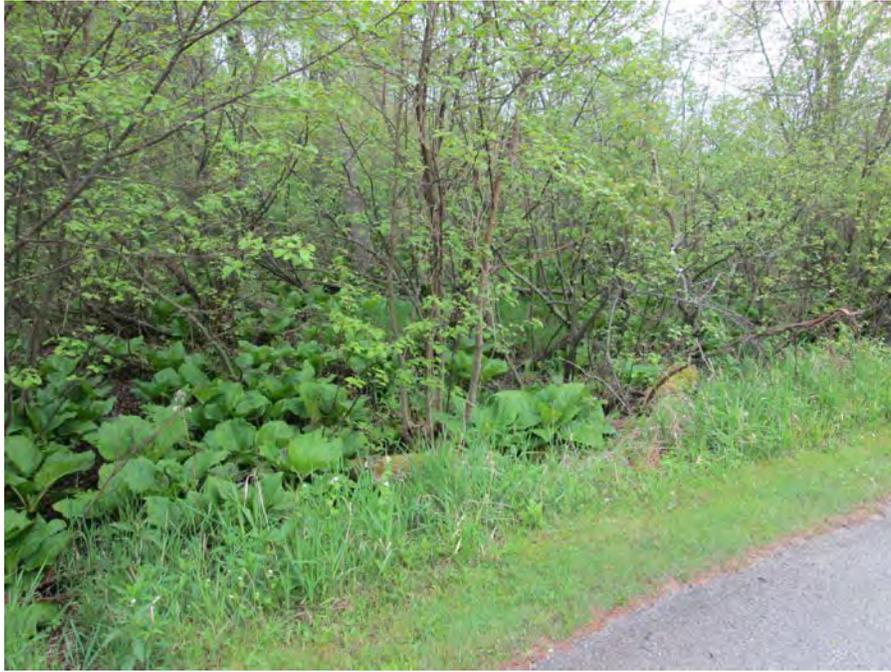
Wetland BR is a hardwood swamp located on the western edge of the additional survey area within the floodplain of the Black River. The community is characterized by a relatively open tree canopy with approximately 50 to 75% cover, dominated by green ash (*Fraxinus pennsylvanica*, FACW) and speckled alder (*Alnus incana*, FACW). The understory varies from brushy to relatively open. Speckled alder, Japanese barberry (*Berberis thunbergii*, FACU)(invasive species), and cockspur hawthorn (*Crataegus crus-galli*, FAC) are dominant in the shrub layer. Common

Photo 7. Representative photo of Wetland BR south of Beach Park Ln.

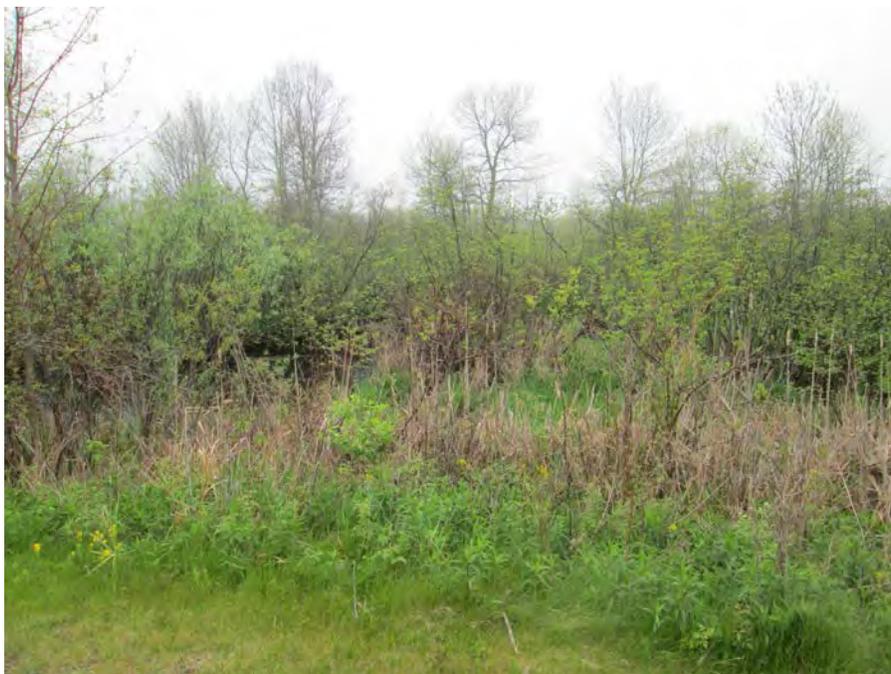
Photo 8. Representative photo of Wetland BR north of Beach Park Ln.

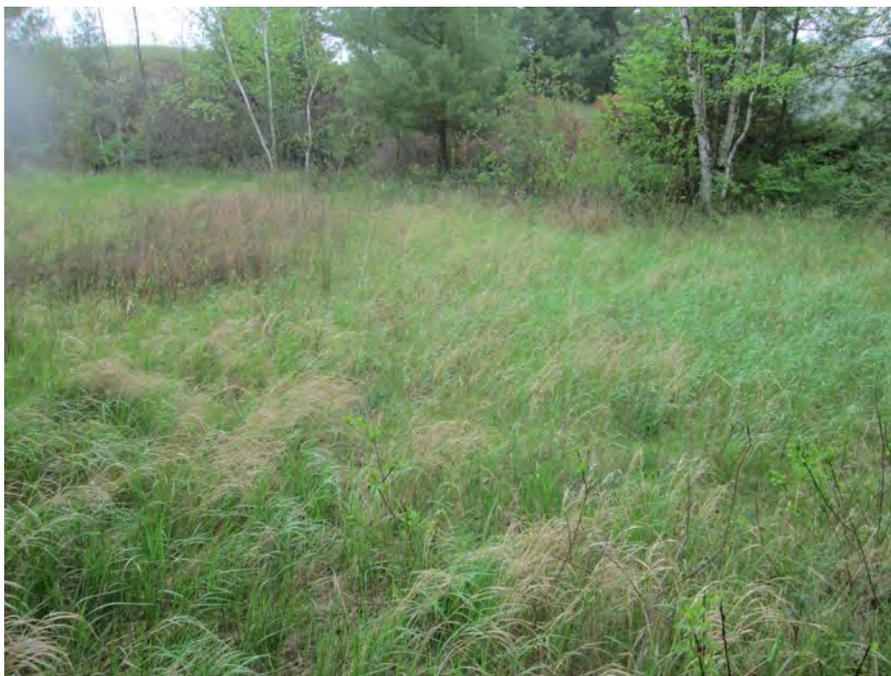
Wetlands P-202, P-203, P-206, P-207, P-208, and P-210 are seasonally flooded basins located in the central region of the additional survey area. These wetlands consist of small depressions comprised predominantly of wet meadow vegetation; with occasional components of alder thicket, forested wetland, and vernal pools. Tree canopy coverage within these wetlands is minimal, though occasional trees are present. The hydrologic regime consisted of seasonally inundated/seasonally saturated. Dominant vegetation includes blue-joint grass (*Calamagrostis canadensis*, OBL) and Baltic rush (*Juncus balticus*, OBL) in the herbaceous layer, Japanese barberry and shining willow (*Salix lucida*, FACW) in the shrub layer; and green ash in the tree layer. Field indicators of hydric soil were observed at wetland sample points within these wetlands. The transition from wetland to upland characteristics generally correlated with a well-defined topographic break.

Photo 10. Wetland P-207, view facing southeast.
