# 21<sup>st</sup> Road at North Branch Beaver Creek

# 21<sup>st</sup> Road at North Branch of Beaver Creek

# Site Description

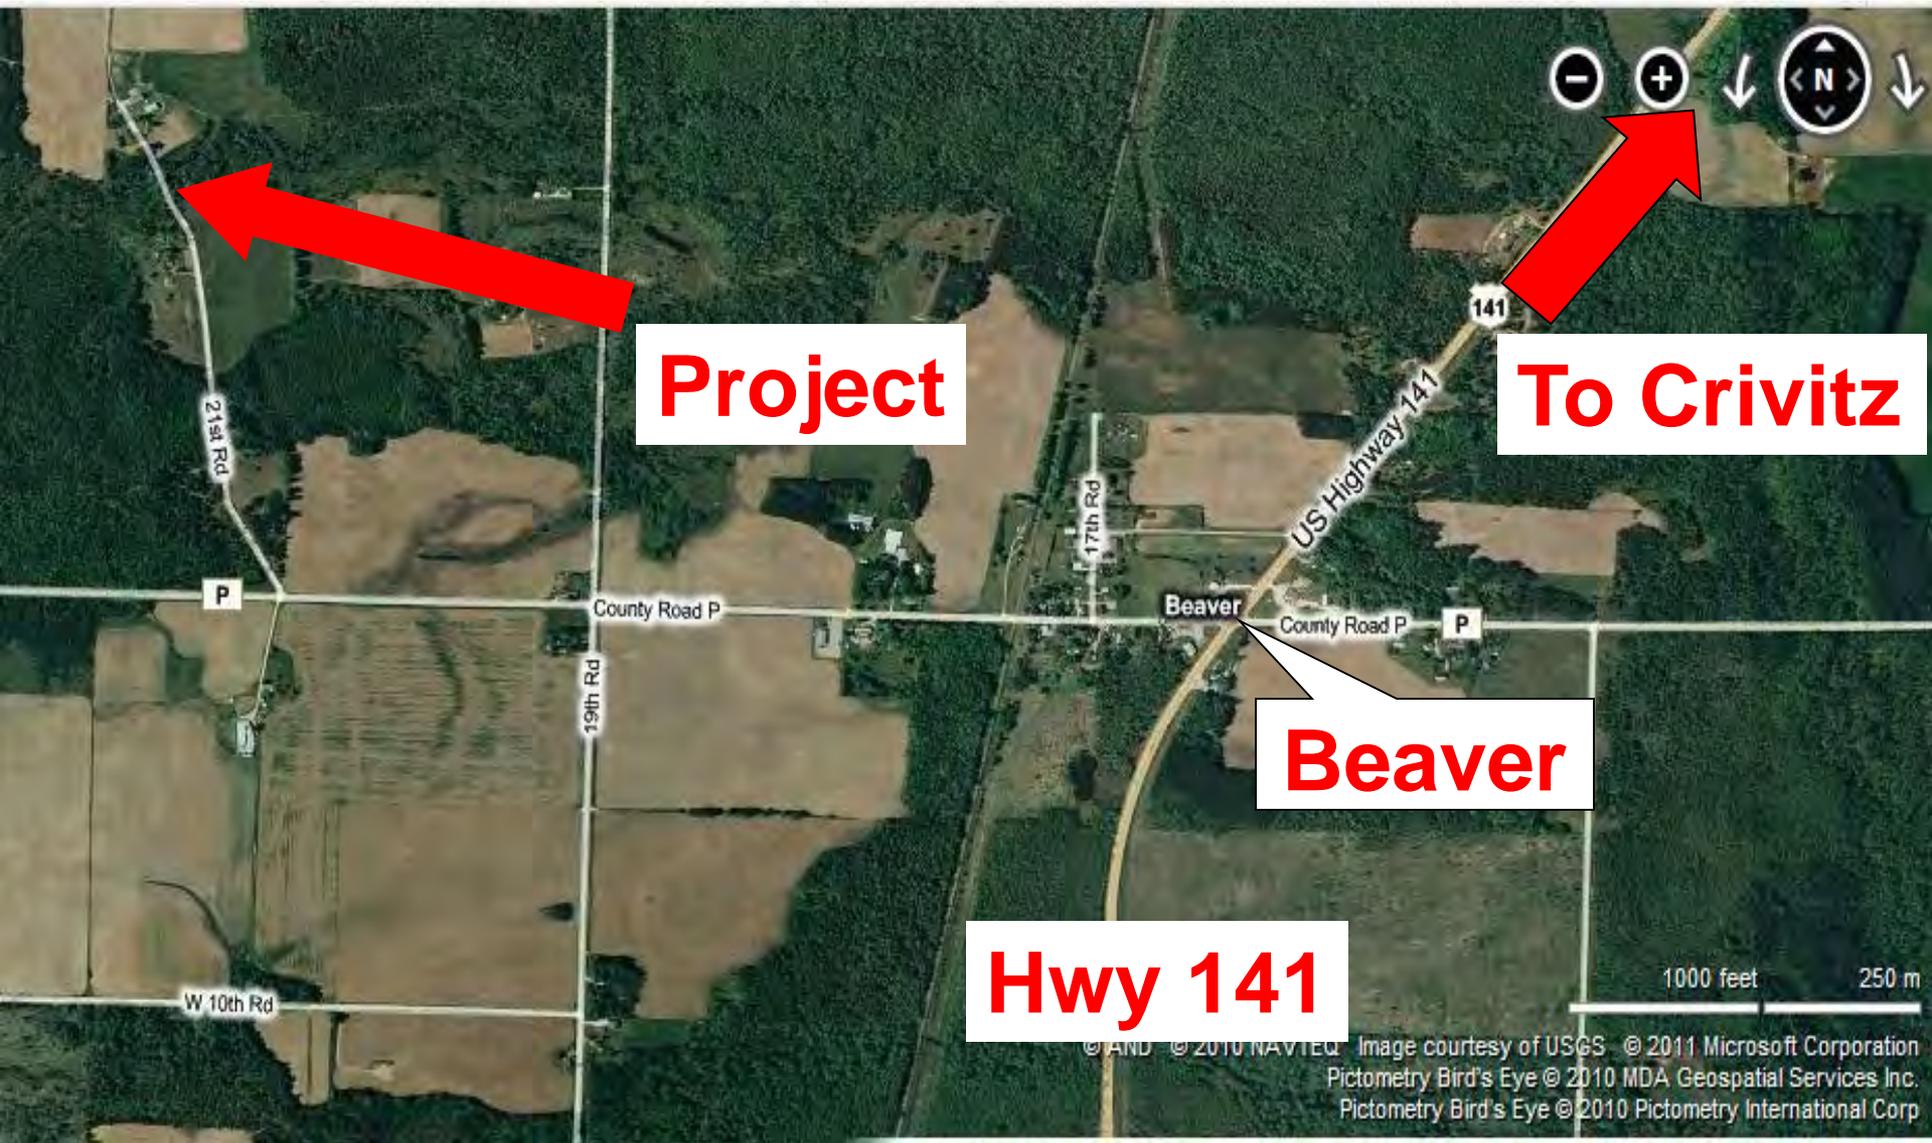
**Project**

**To Crivitz**

**Beaver**

**Hwy 141**

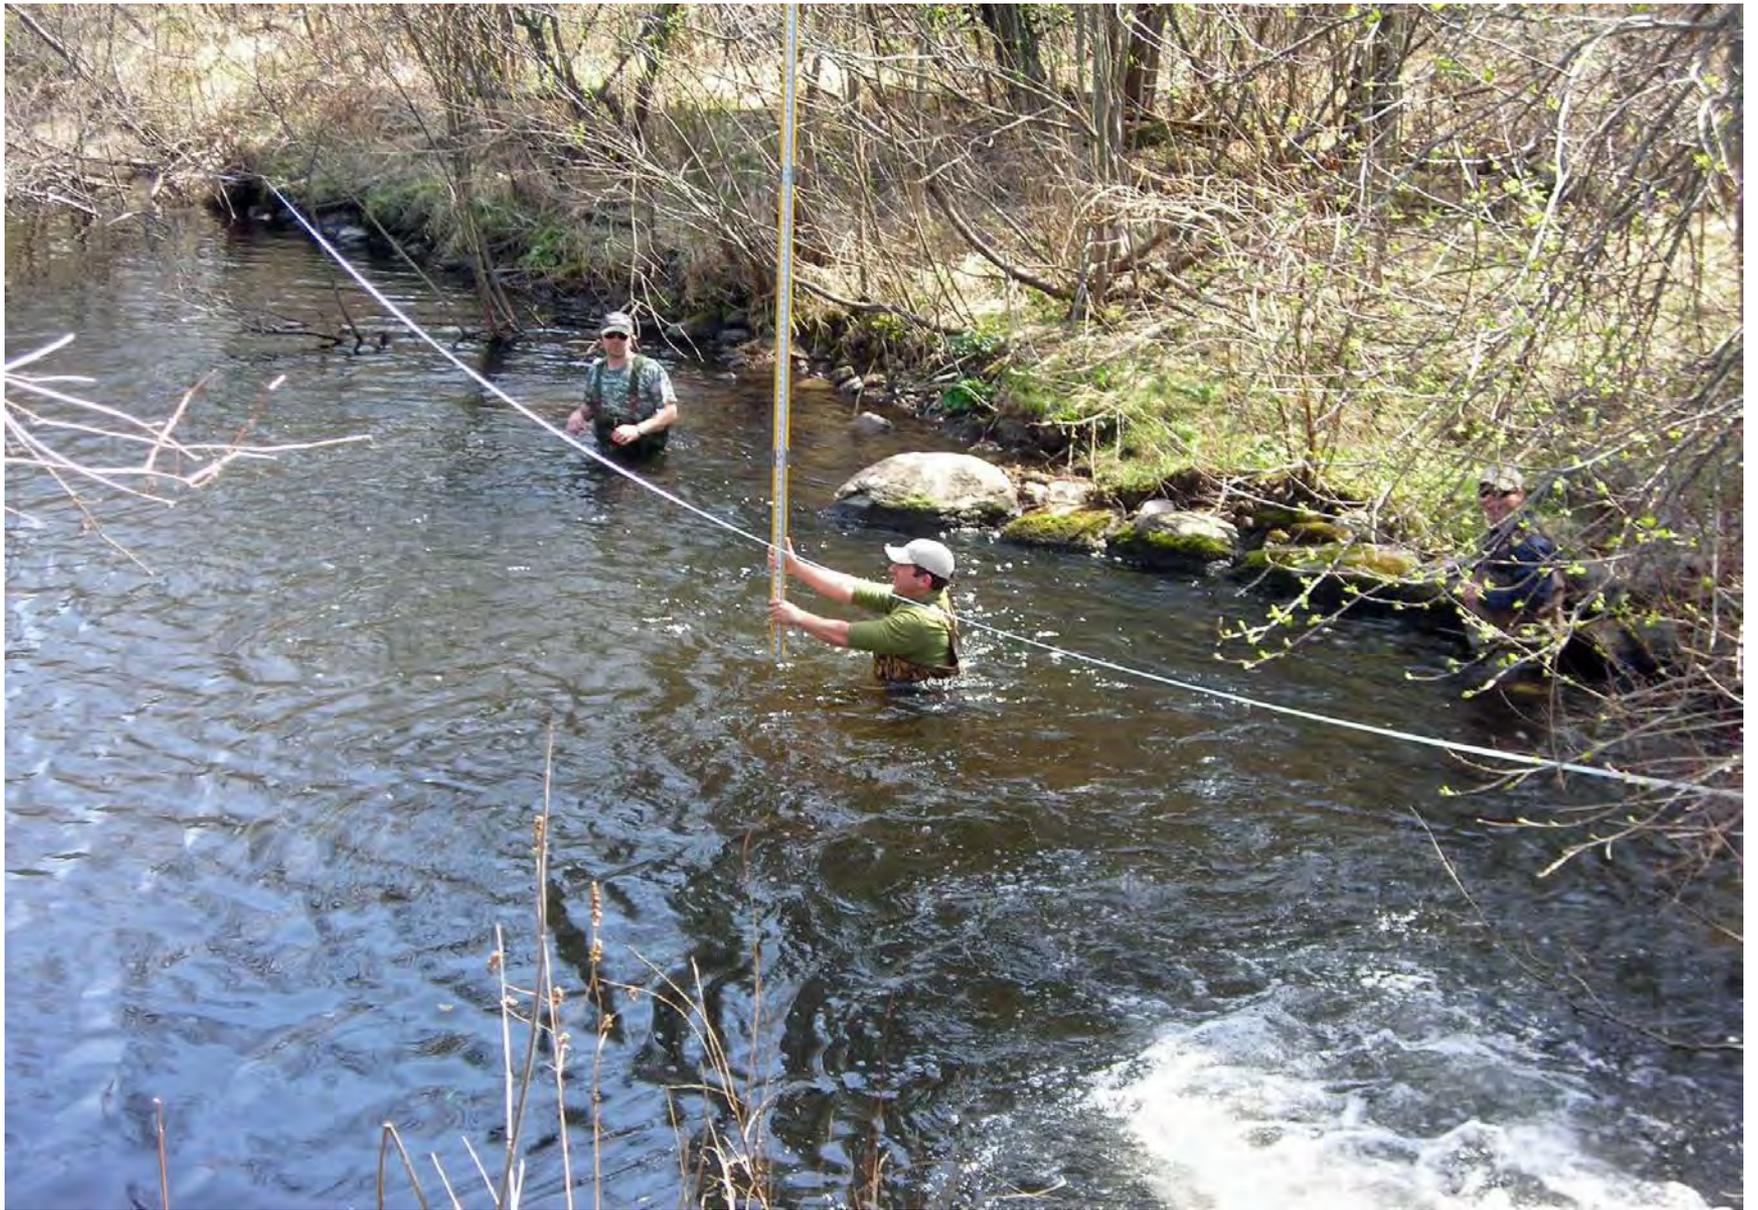
**Stream Profile Survey**

- The existing structure is perched and is an aquatic organism passage barrier—what replacement structure size and type is appropriate?
- Habitat Impacts—Removal of the structure will result in headcutting the stream upstream and sediment will fill in the plunge pool below. How will that impact the fish habitat?
- Constructability—How will the water be handled? How will the worksite be isolated? Where will the bypass channel be located? How/where will the dewatering basin be constructed/located?

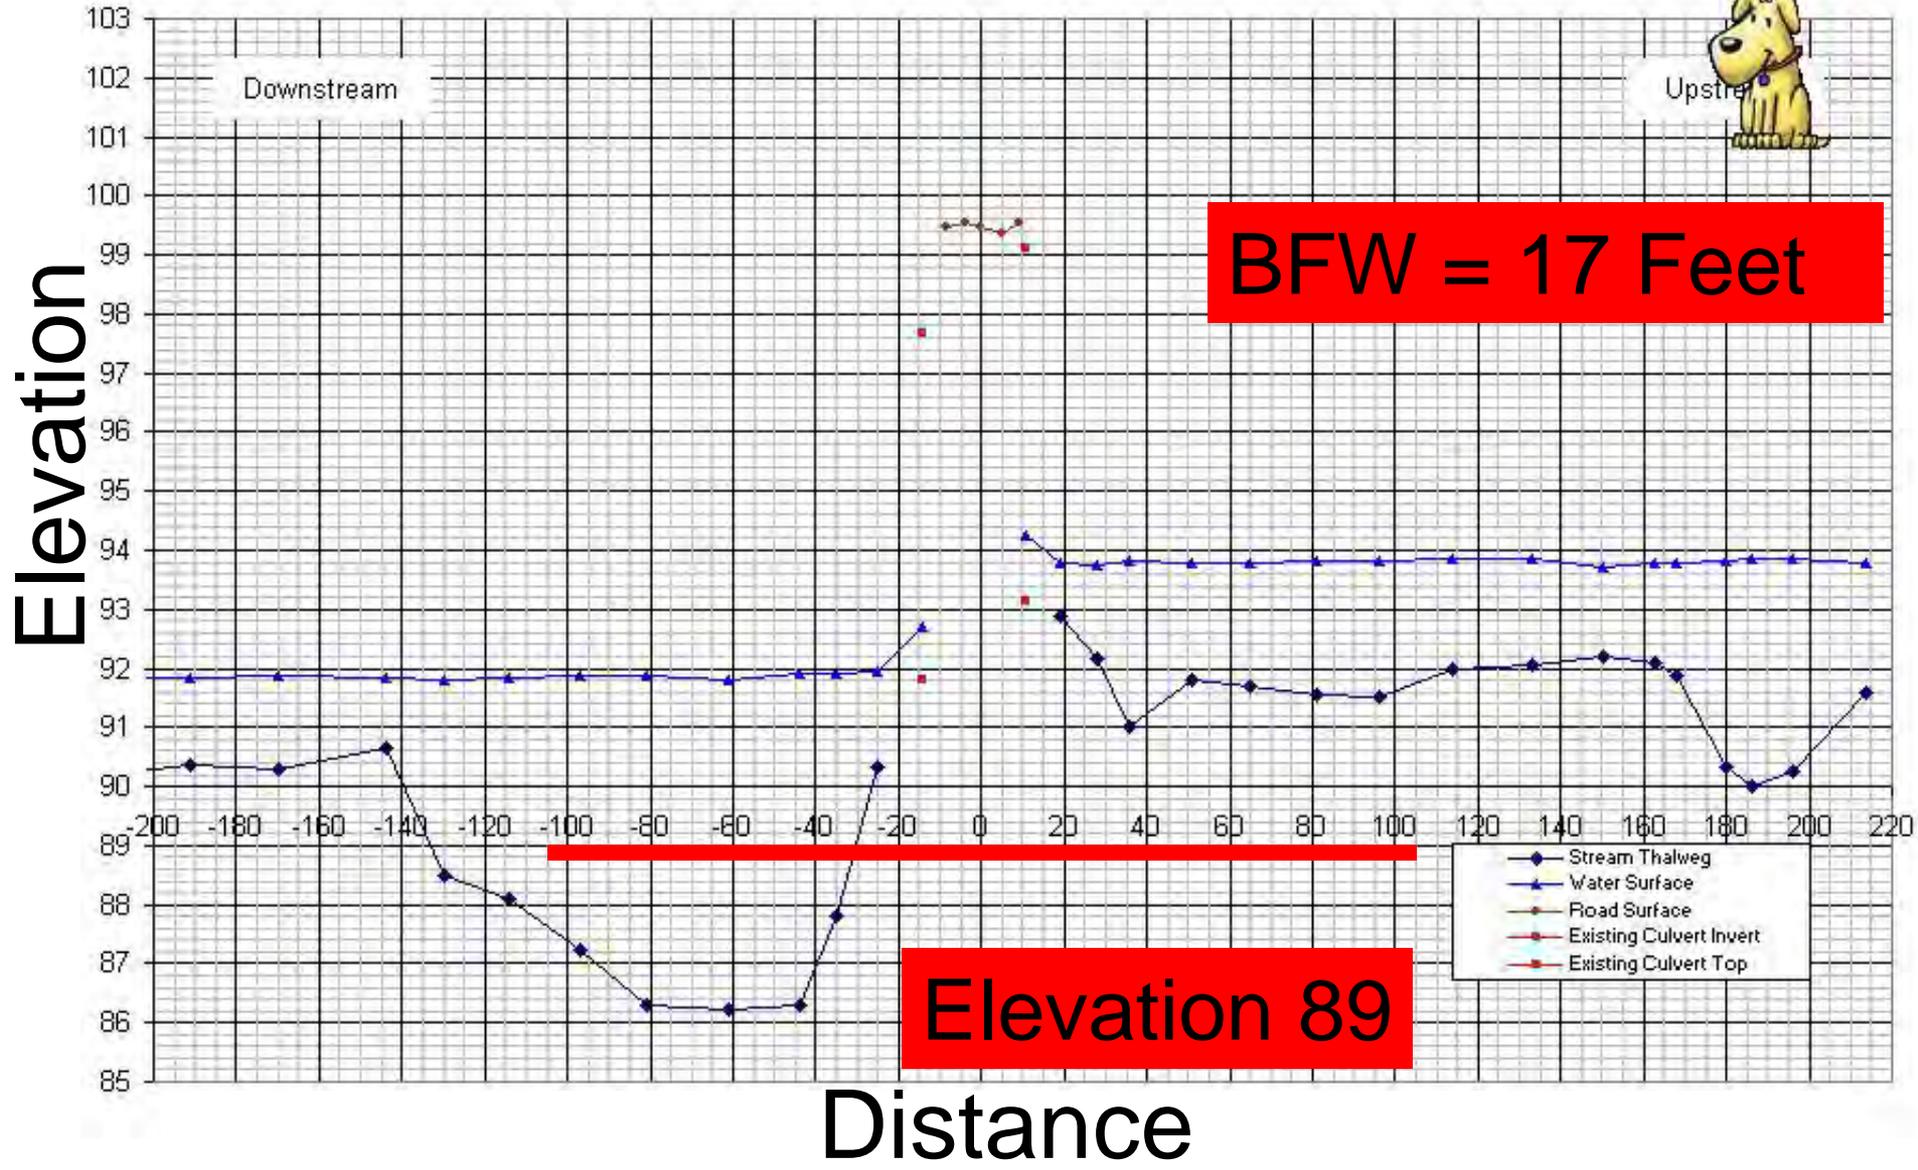
# Choosing a Structure

Beaver Creek @ 21st Road

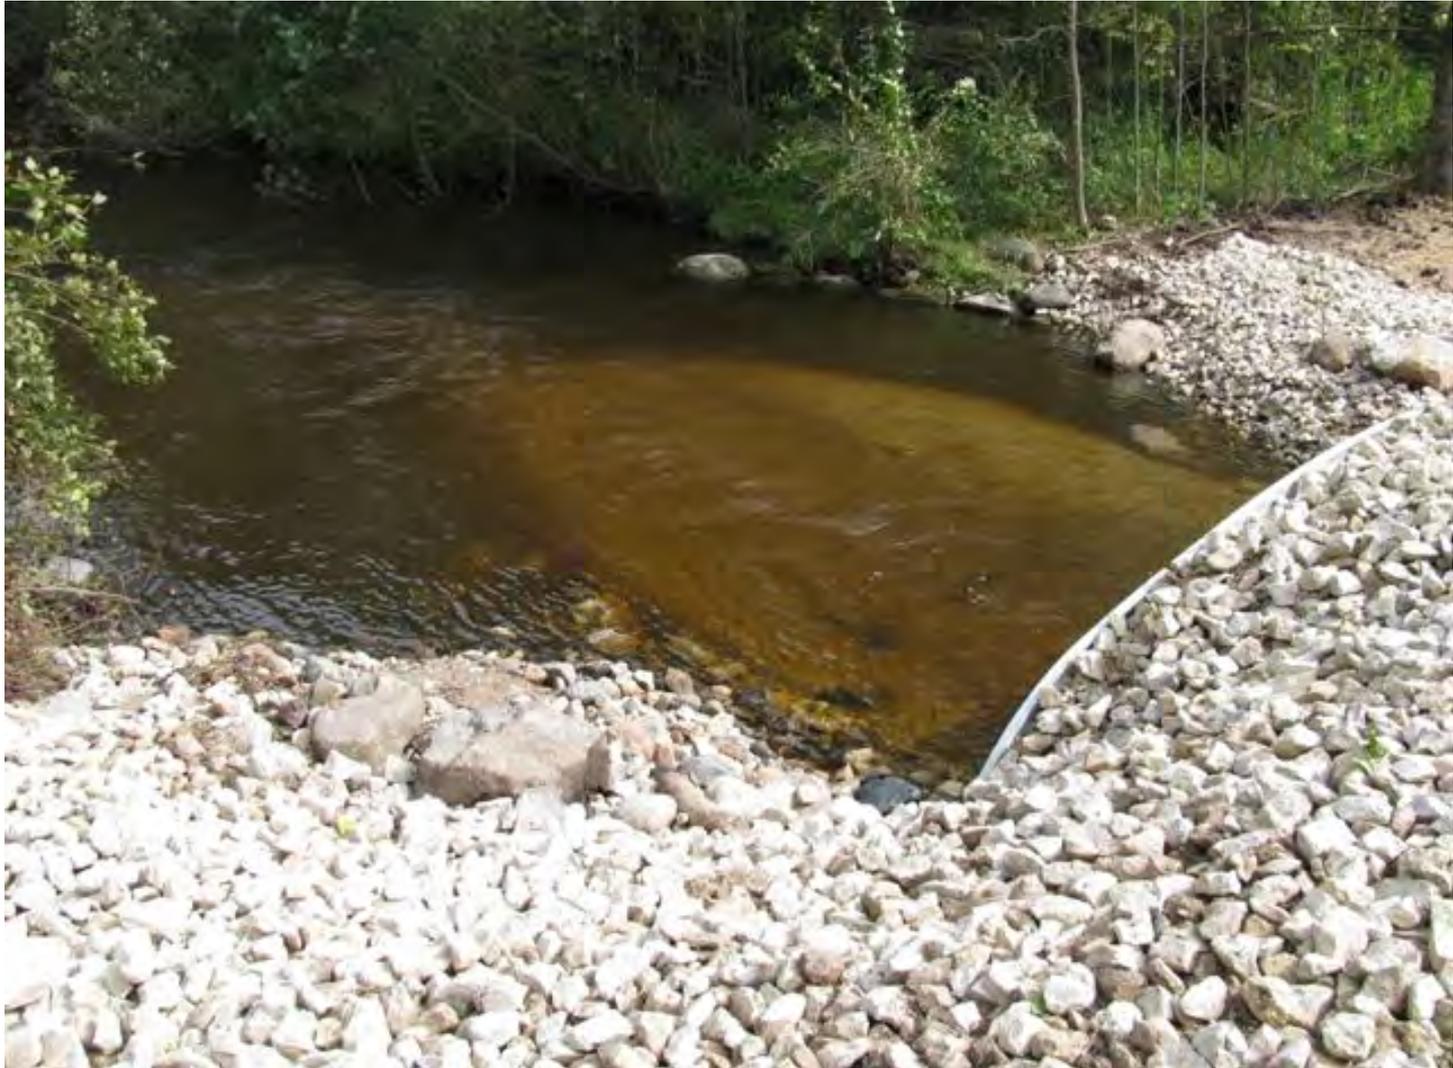
# Streambed Mobilization

Downstream Deposition into Plunge Pool

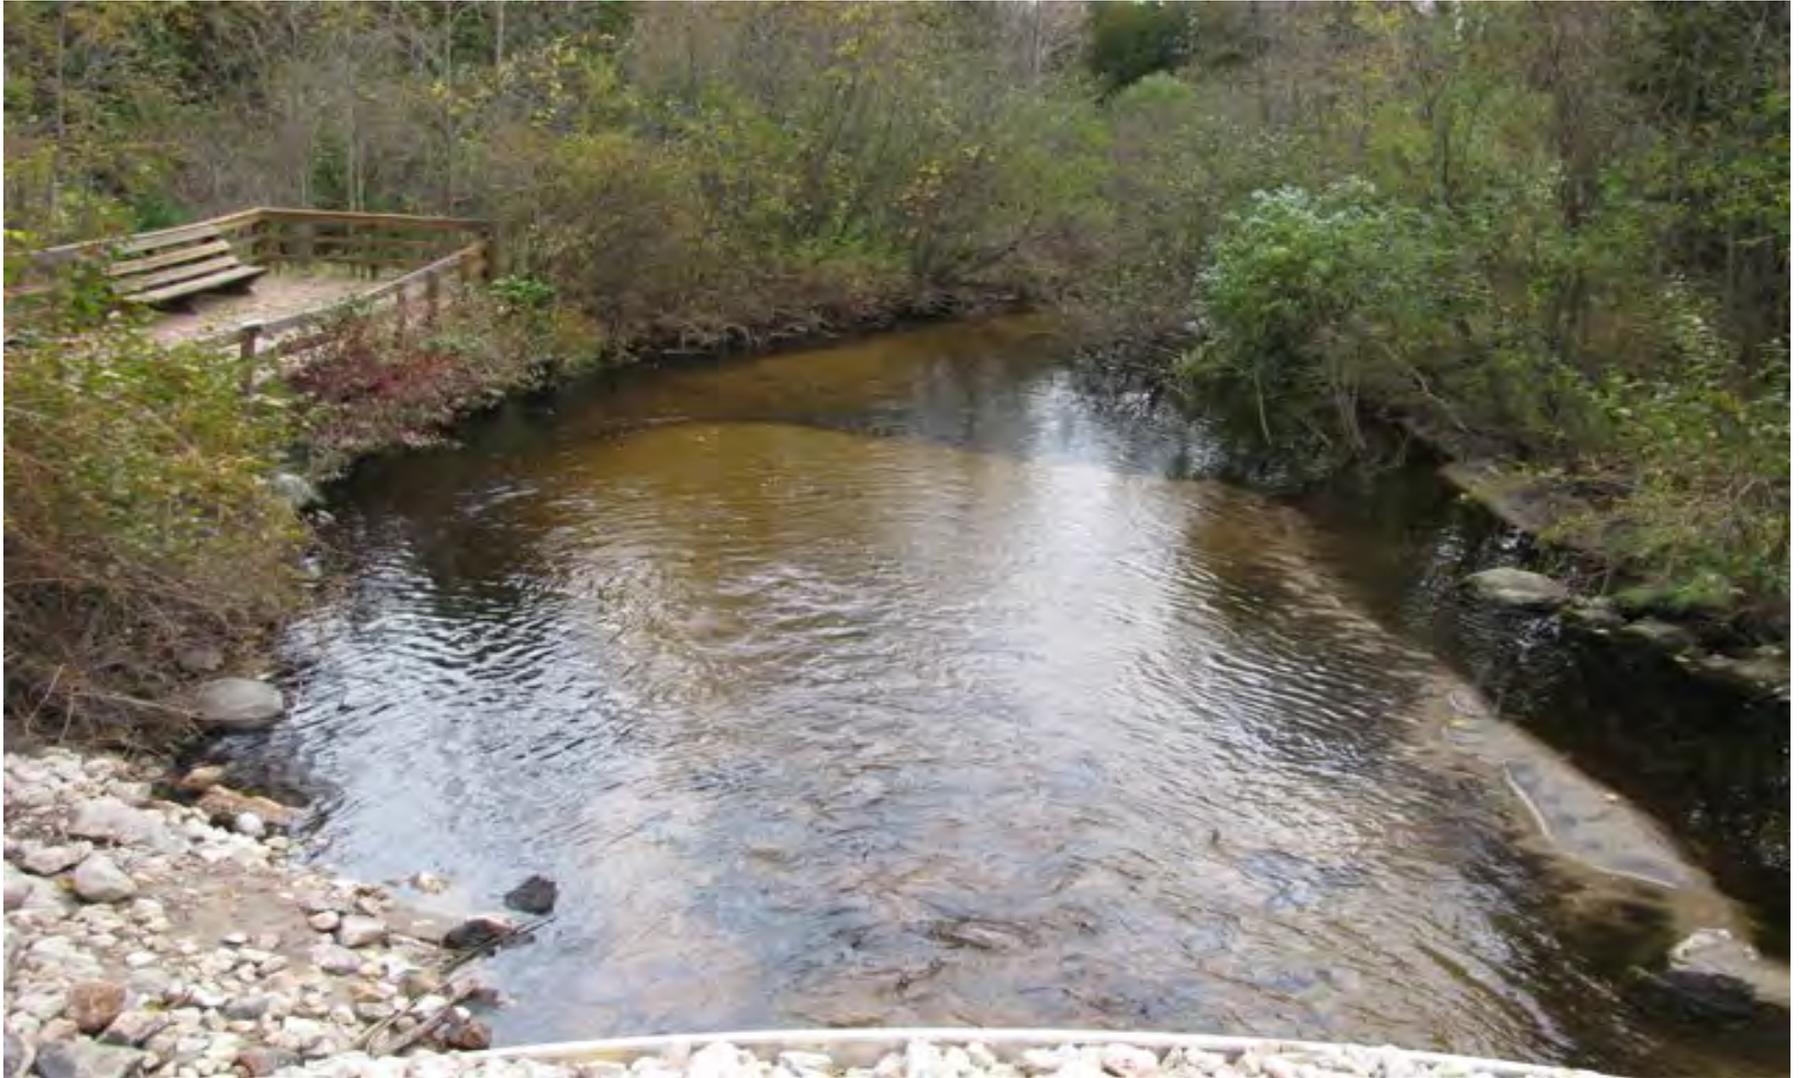
# Flooding Event after Construction

Mobilizing MORE Material into Plunge Pool

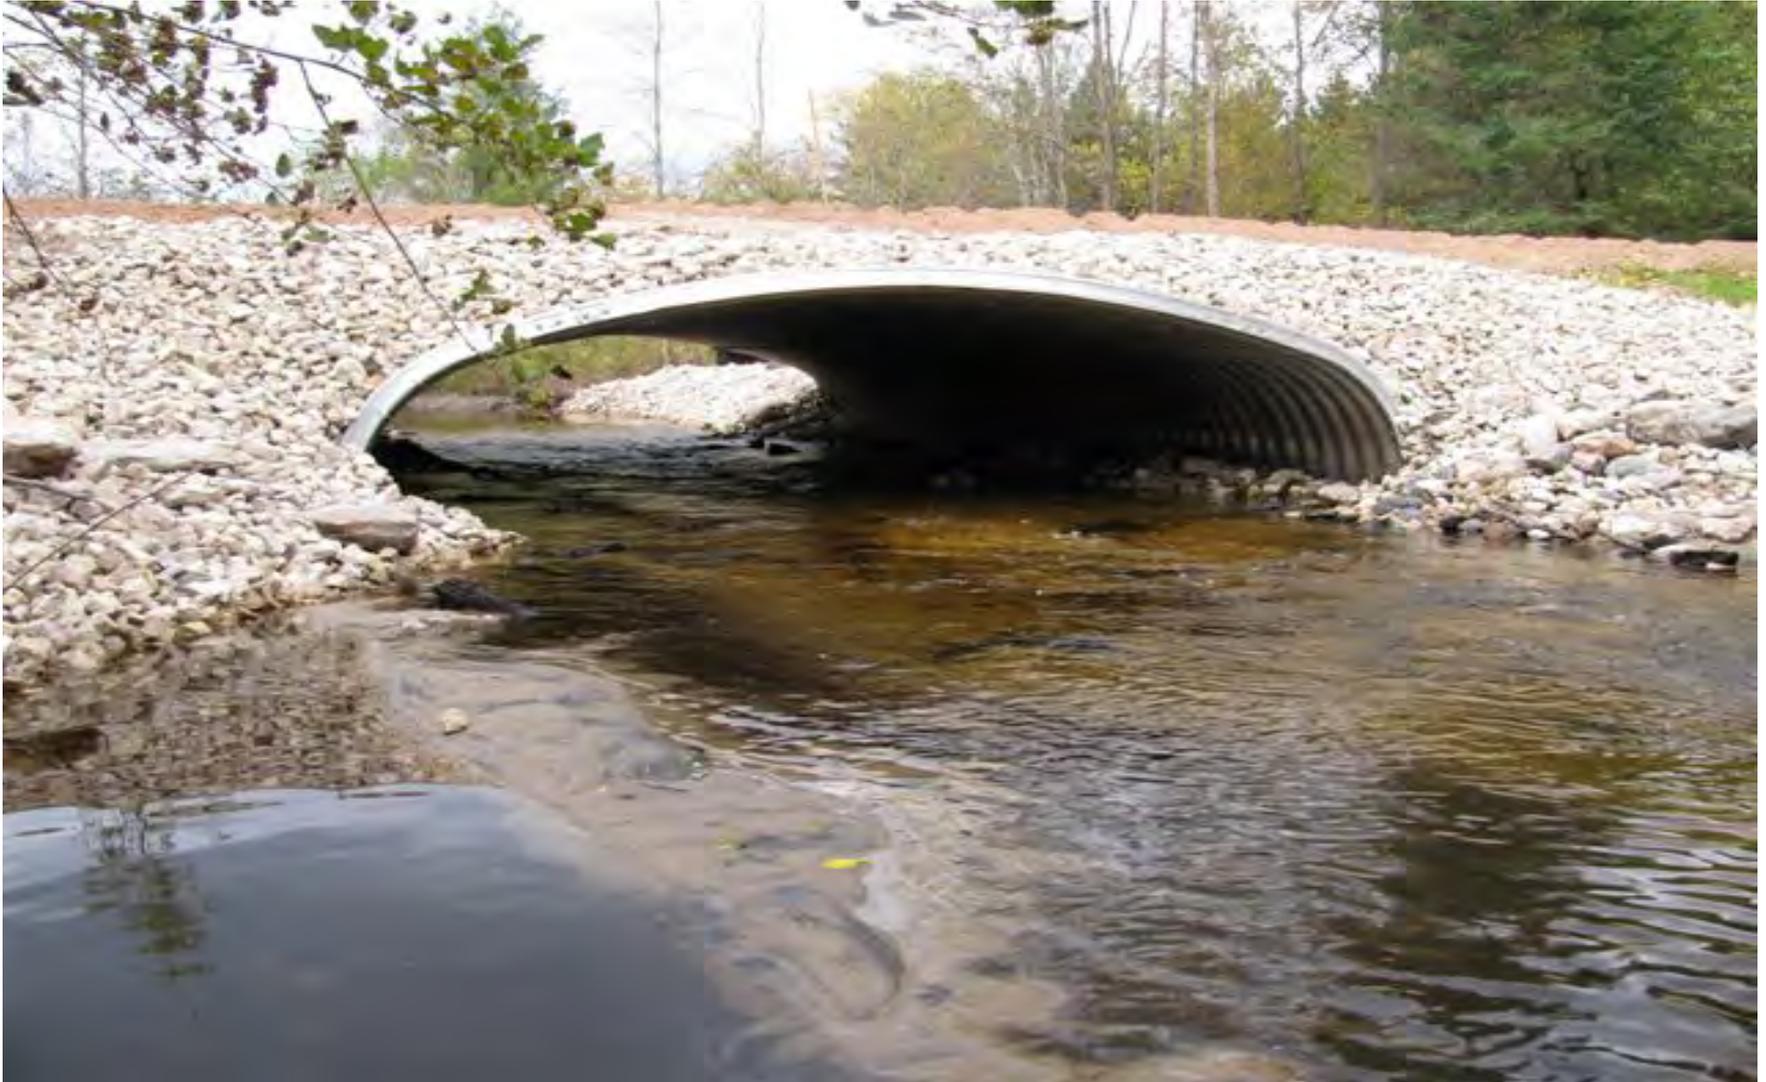
# Flooding Event after Construction

Mobilizing MORE Material into Plunge Pool

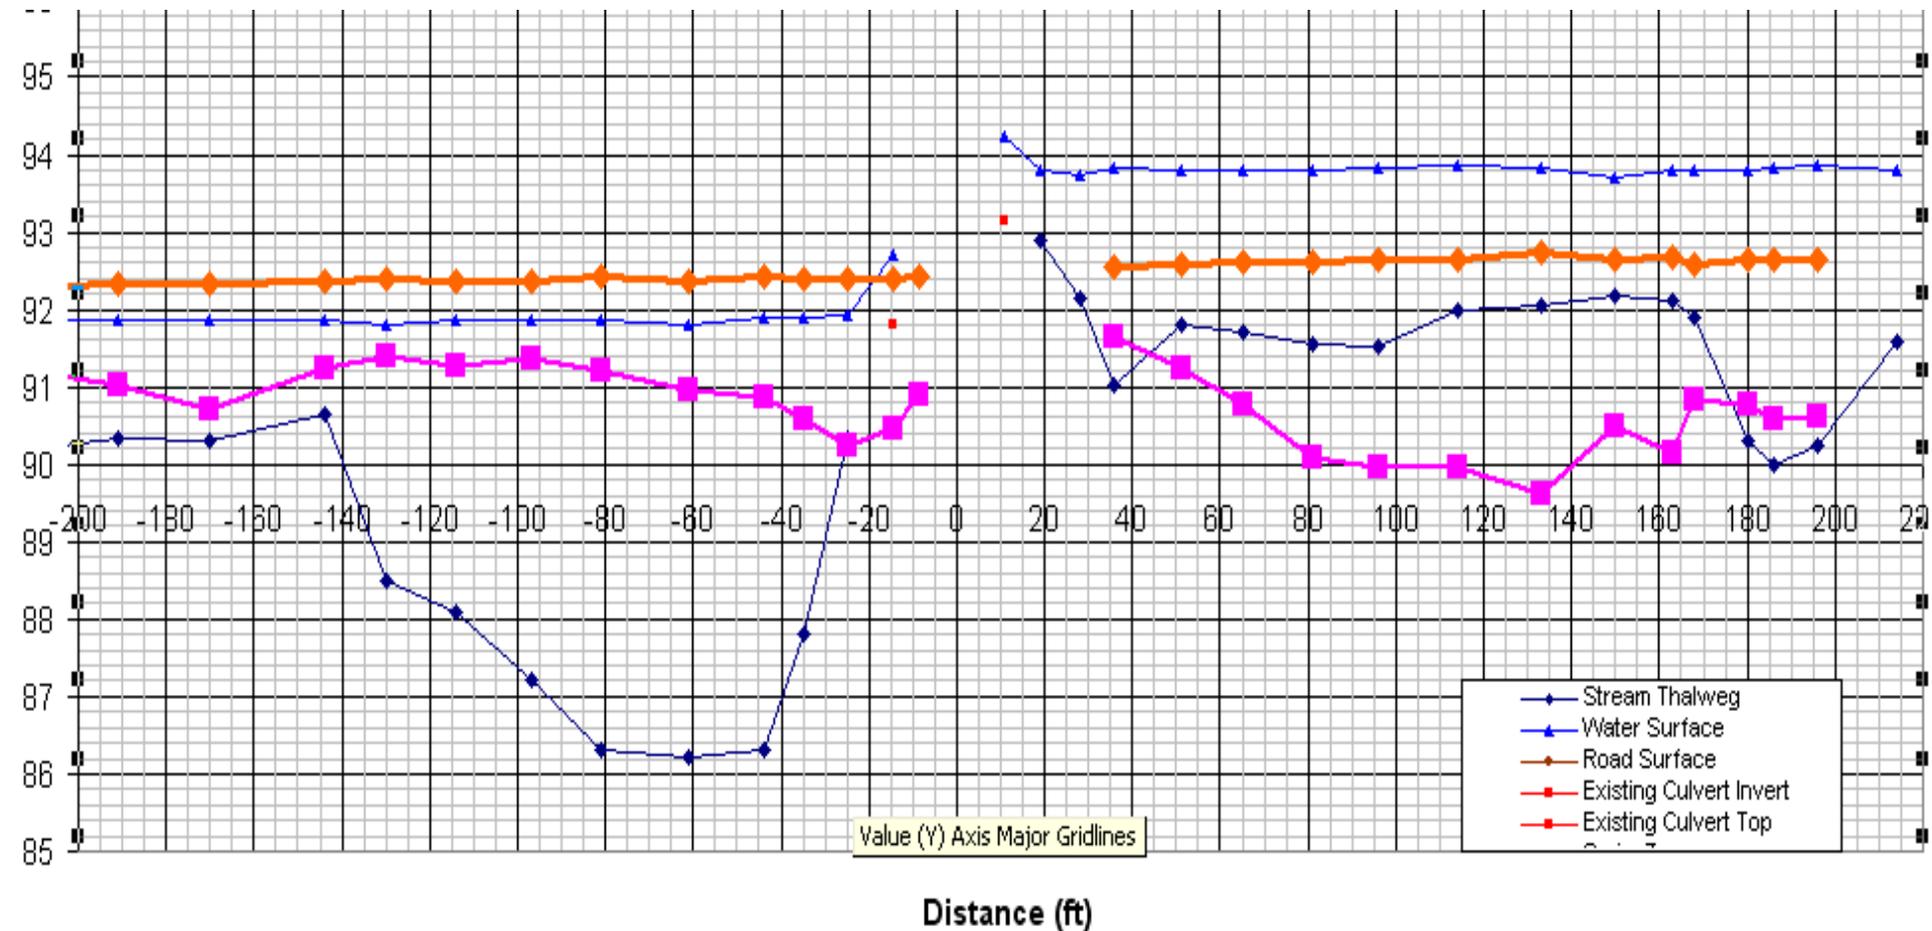
# Resurvey 2011

## 1 year after Construction

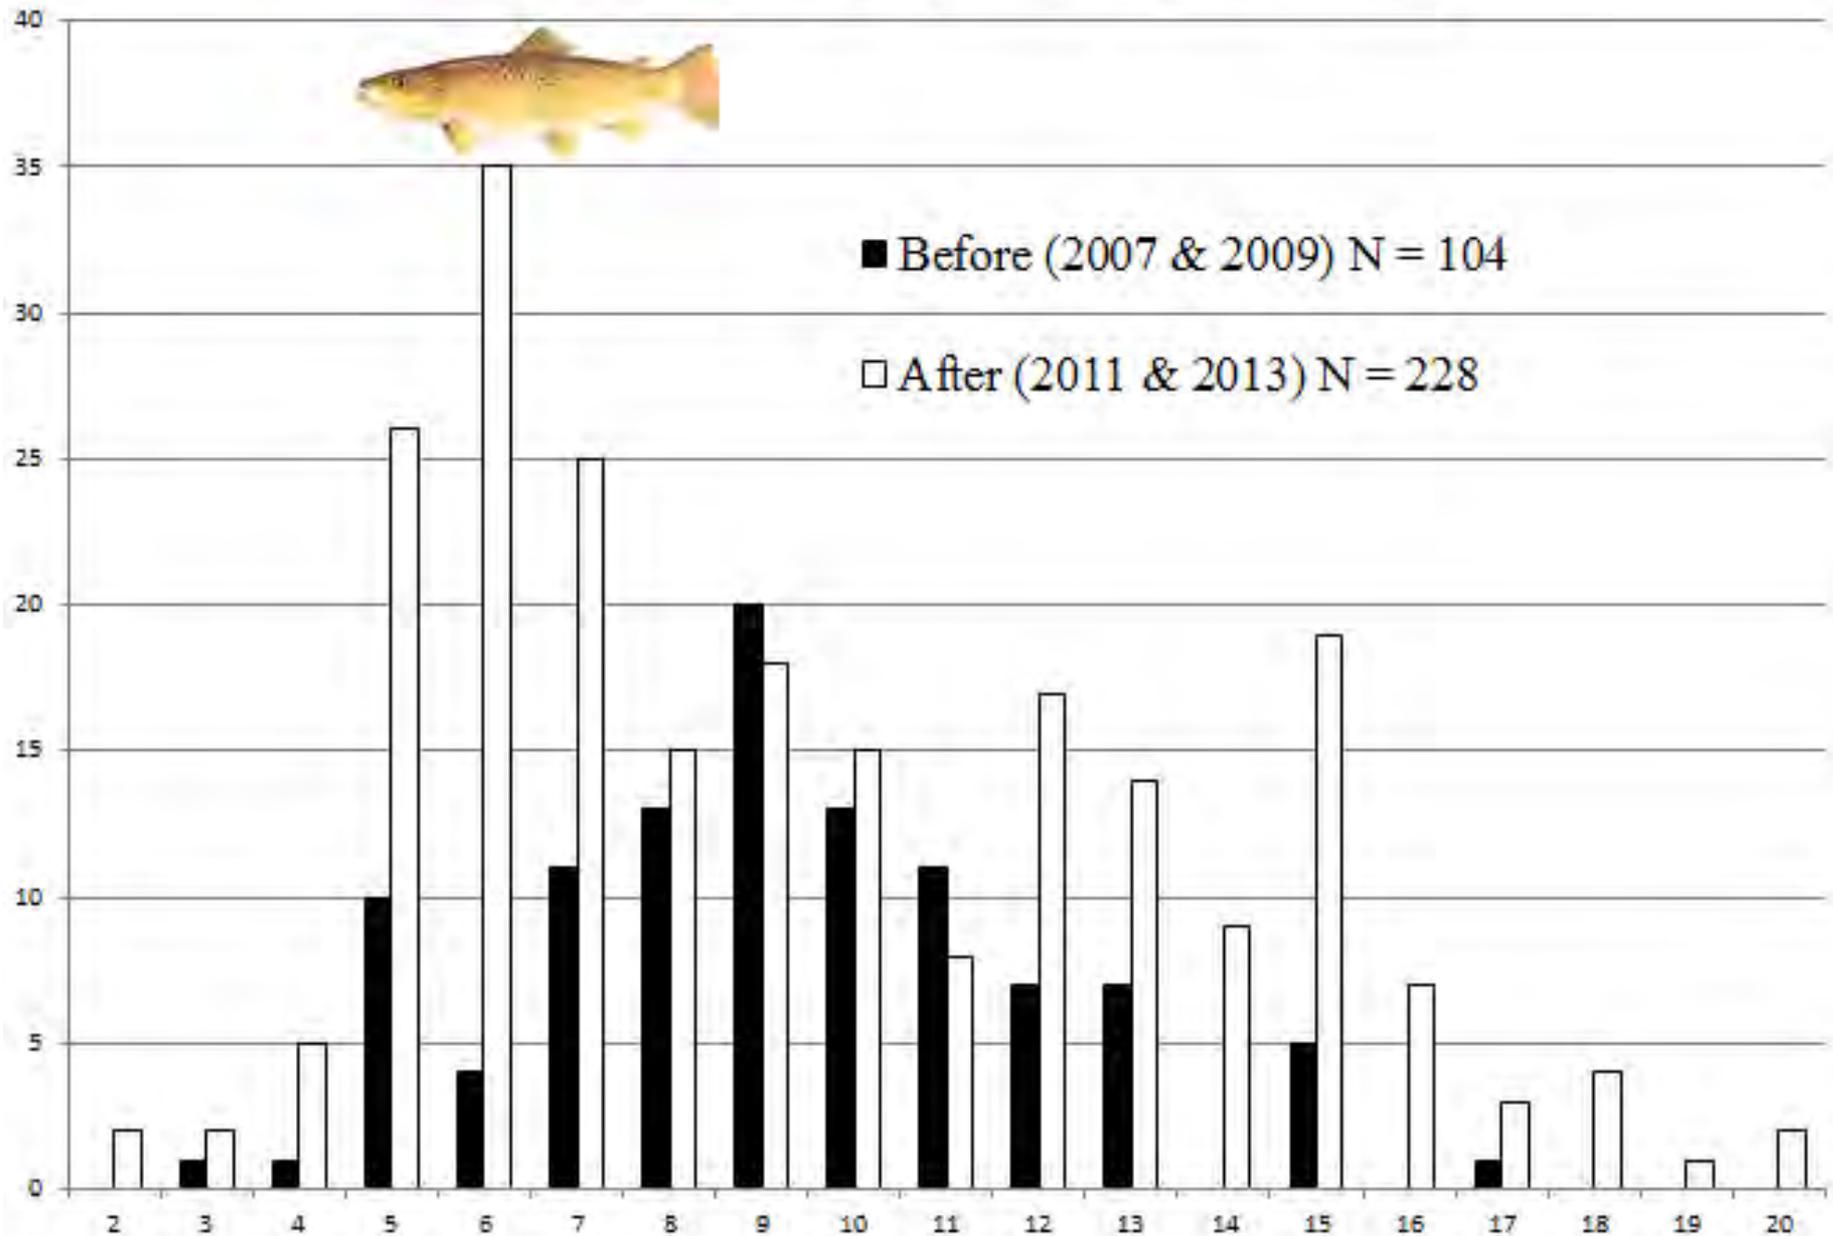
## Brown Trout - 21<sup>st</sup> Road (North Br Beaver Creek)

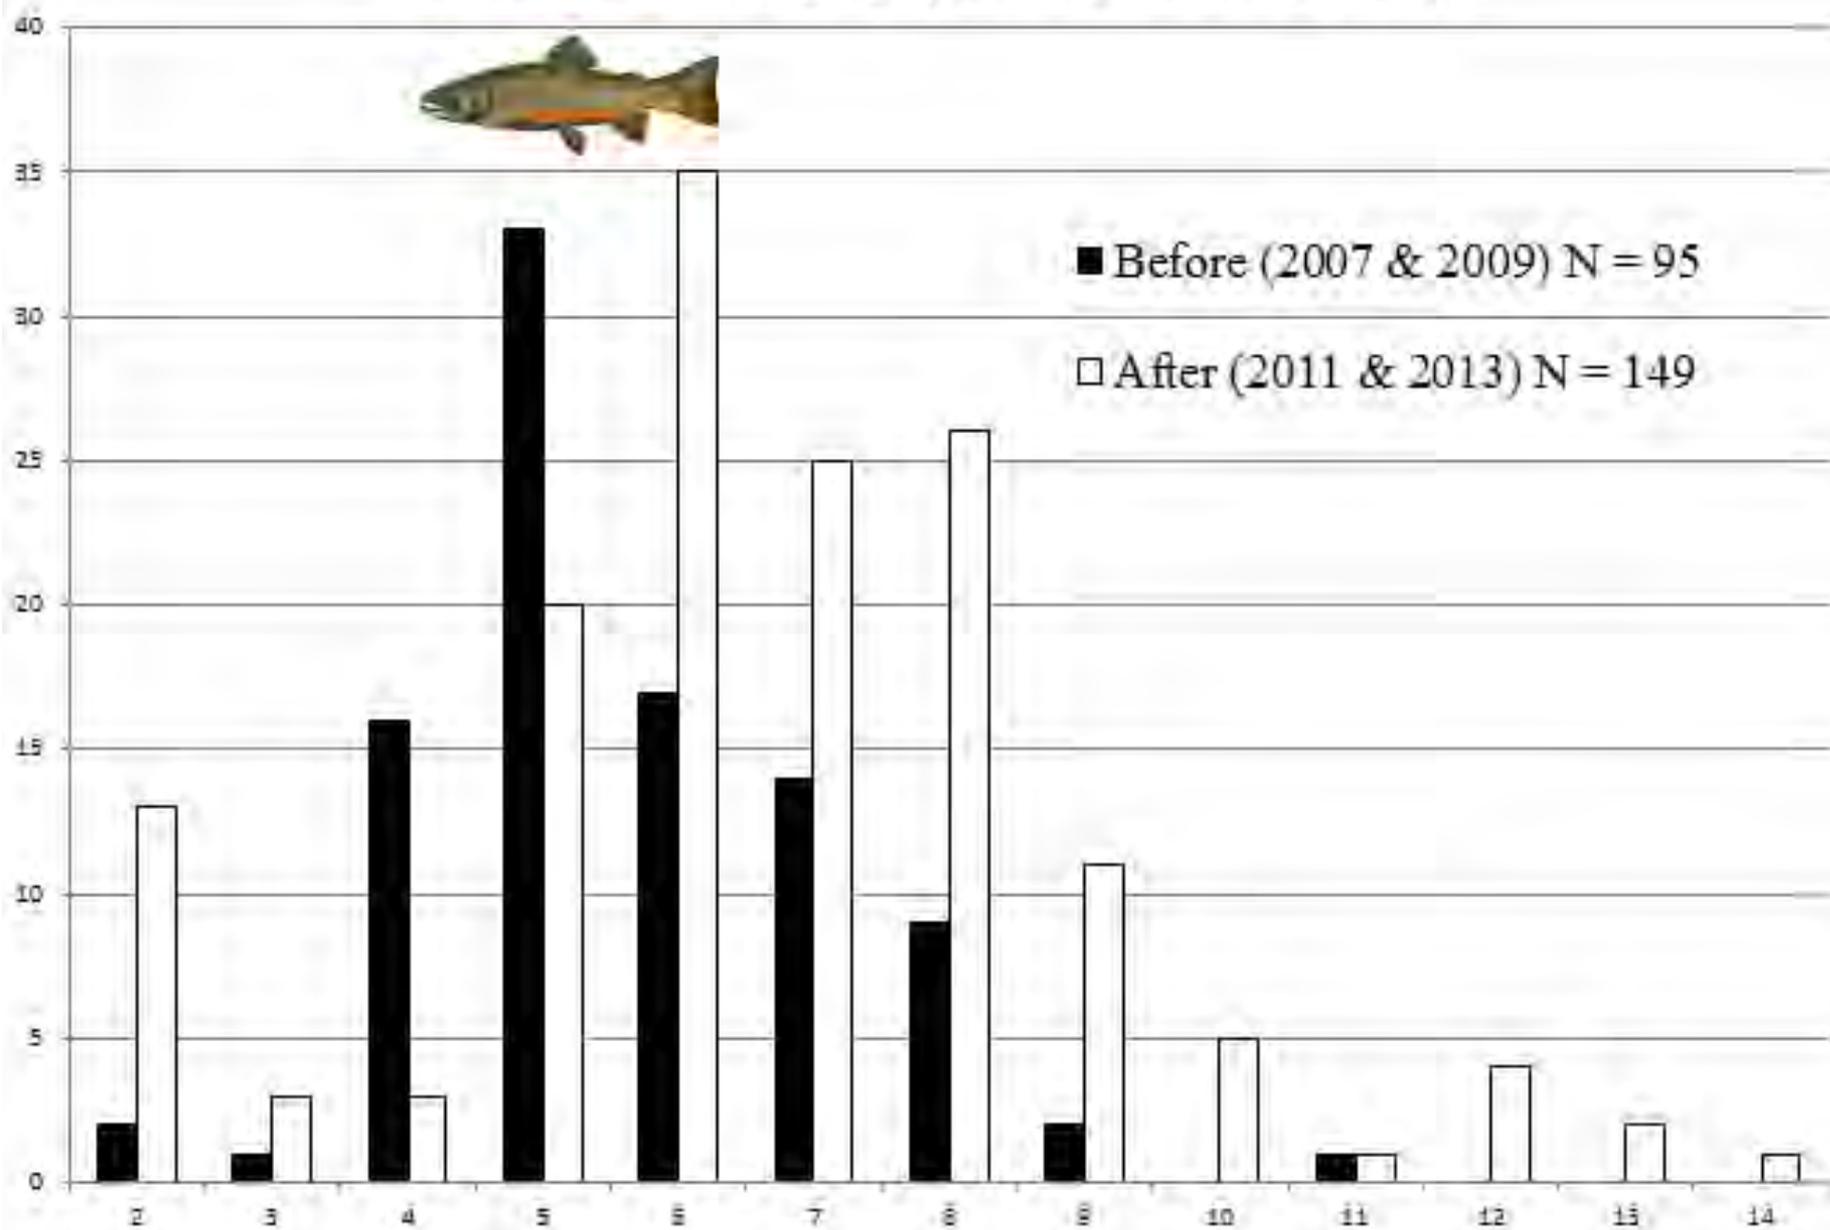
## Brook Trout - 21<sup>st</sup> Road (North Br Beaver Creek)
