CHAPTER 13. LEARNING FROM PAST EXPERIENCES: Case Studies from Wisconsin

Case Study #1: Ozaukee County

Case Study #2: Walker Site, Columbia County . . .

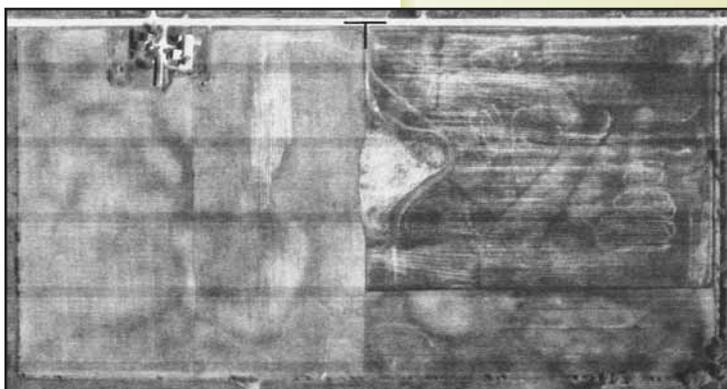
Top, aerial photo of "1989" restoration site prior to establishment.

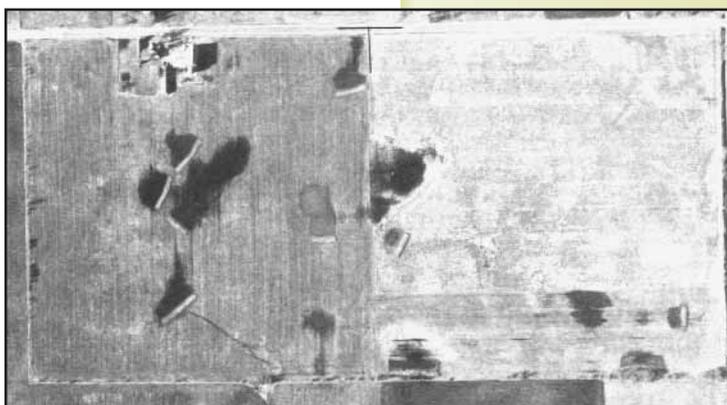
Middle, aerial photo of "1989" restoration site one year following restoration work. Note clusters of berm and scrape wetlands within farm field.

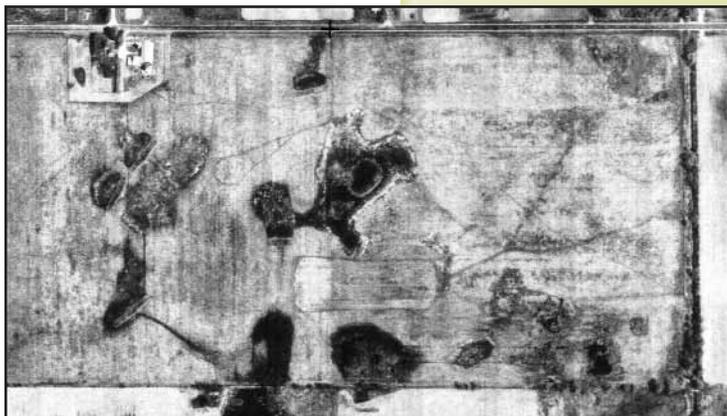
Bottom, aerial photo of "1989" restoration site five years after restoration.

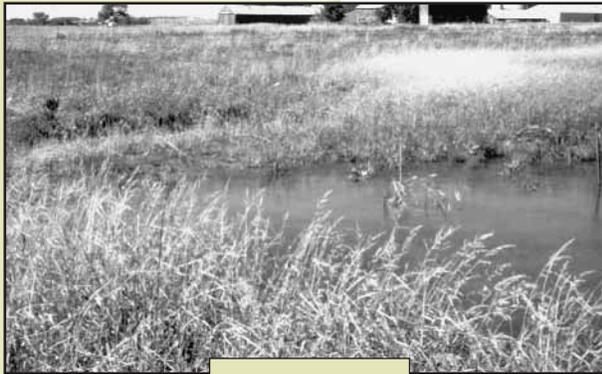
1989 SITE

Top left, "1989" restoration one year after restoration.

Viewing both wetlands 10 years after construction, the difference between these similarly constructed wetlands is remarkable. About half of the 1990 restoration area is open water with a diverse native and non-native plant community surrounding the open water. The shallow water edges are colonized by spike rushes (*Eleocharis* spp.) and coontail, a submerged aquatic. Very few cattails are present. In contrast, the 1989 site has a dense thicket of cattails with no open water, and by early summer no standing water. On the drier perimeter, the cattails give way to an equally dense willow fringe. After 10 years, all five of the seeded wetlands had higher diversity than the unseeded wetlands. These studies suggest that early seeding with native plants can “jump-start” the colonization of the site by natives and give the natives the establishment advantage. Cattail seed is light and wind blown and can quickly seed in from nearby wetlands. If cattail is the only plant in the wetland, it can rapidly spread. Once it is dominant it will exclude any other plants from gaining a foothold.

A closer comparison of the sites reveals some important distinctions between these two wetlands. The wetland constructed in 1989 appears to rely solely on surface water to supply the hydrology. This surface water drains agricultural land, with nearby cattle and sheep. As a result, the nutrient-rich animal waste drains directly to the wetland. In contrast, the wetland constructed in 1990 shows signs of groundwater input for its hydrology. Groundwater provides a stable, year-round water source that is lower in nutrients that favor invasive plants. Additionally, in the wetland constructed in 1990, the year-round supply of water made conditions favorable for a resident population of muskrats. The muskrats continually clip and chew wetland plants, including cattails. All of these differences illustrate the complexity in evaluating the results of wetland restoration.

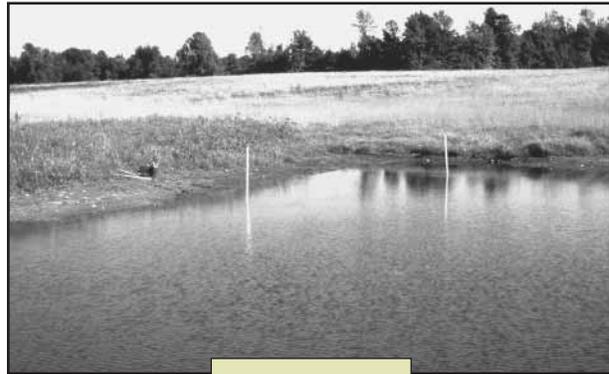
1990 SITE

Top right, "1990" site during first growing season.

Native wetland seed was not used in the wetland constructed in 1989. As part of a University of Wisconsin-Milwaukee project led by Dr. Reinartz, the site constructed in 1990 became one of five wetlands seeded with a mixture of 22 native wetland species. The seeds were collected locally on private land and stored outdoors in a metal can for winter stratification (to break dormancy). They were then hand scattered around the edge of the wetland in the spring of 1991, with half the seed cast in the shallow water at the wetland edge and half just above the water line. The development of vegetation and wildlife usage was monitored on these sites and 28 other

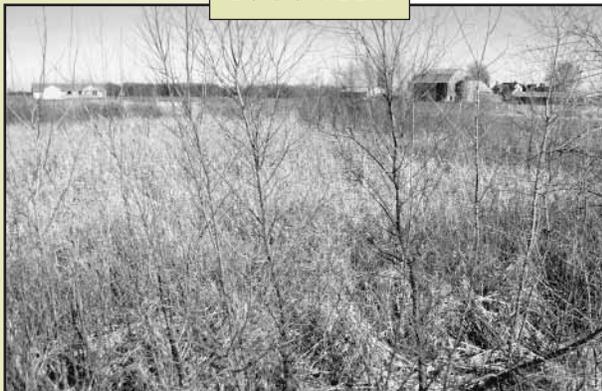
Bottom left, "1989" site ten years after restoration. Open water has been replaced by cattails in the basin and willows on the berm.

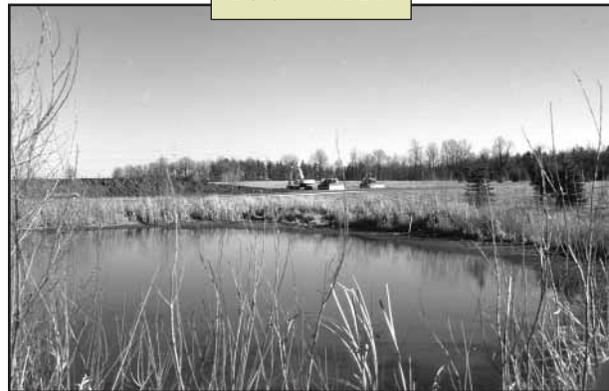
Bottom right, "1990" site nine years later. Open water and a diversity of native plants support wildlife use, including waterfowl and muskrats.

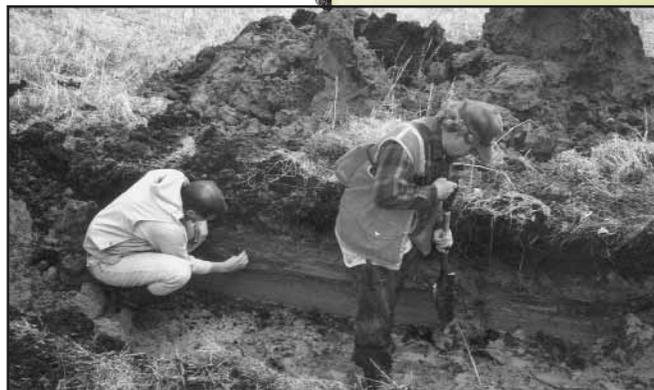
Determining the depth at which wetland (hydric) soils still occur is important in planning a wetland restoration.

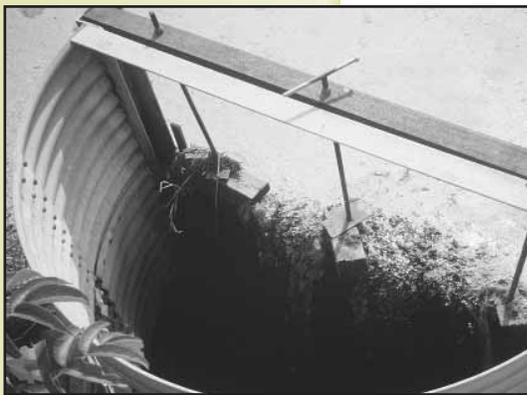
A water control structure is used to control water levels during restoration, creating a regime of high water and drawdown to stress reed canary grass.

In the summer of 1996, a temporary water control structure was installed at the drainage outlet to manage water levels during construction. A series of water level manipulations were planned, alternating with prescribed burns, to eradicate the reed canary grass. During the first summer, water levels were set

2 feet higher than the estimated historic levels in order to flood the reed canary grass. The water levels were then drawn down in winter. A prescribed burn in the spring preceded another water level elevation for the next summer. Four cycles of flooding/drawdown/burn resulted in eliminating about 80 percent of the reed canary grass in the basin. The reed canary that persisted occurred on the upper reaches of the site where it could not be flooded.

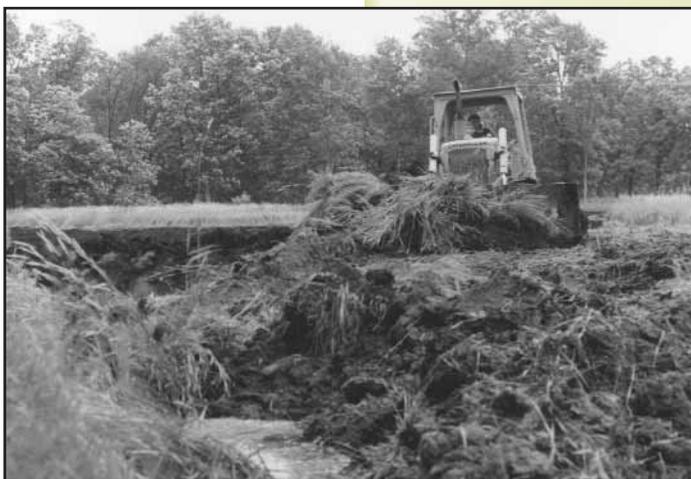
Reed canary grass is scraped from a restoration site and used to fill an existing ditch.

Beginning in 1996, the most critical portions of the ditches were filled over a four-year period. By the end of the first season, about a quarter of the ditches were filled. Water levels rose with the combination of ditch filling and the use of a water control structure. To fill the main ditch, a low pressure bulldozer skimmed 4 to 8 inches of remaining reed canary grass sod that was on a spoil pile and rolled it into the ditch. The remainder of the ditch was filled with spoils still intact from the original ditching. Ditched areas and slopes were graded to approximate the original elevations. Areas that had received erosional deposition from uplands were bulldozed to the original soil layer. In three successive years most of the ditches were filled, and the rising water levels affected more areas each year. The 60-acre upland area was planted with native prairie seed collected on nearby private land. The prairie was seeded over a three-year period, as seed became available.

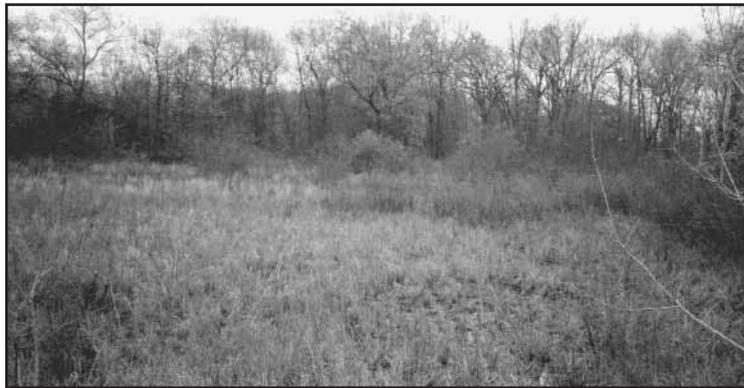
Wetland vegetation returns to the restored Walker site from the dormant seed bank.

The restored wetland now contains a diverse native community. Marsh areas are now covered with open water. Flooded trees and shrubs provide structure for waterfowl and other wetland animals. Beds of lake sedge (*Carex lacustris*) and tussock sedge (*Carex stricta*) have flourished in areas with saturated soils. A total of 140 plant species have been recorded at the site. However, continued management of reed canary grass, including prescribed burns, is necessary to protect the native vegetation.

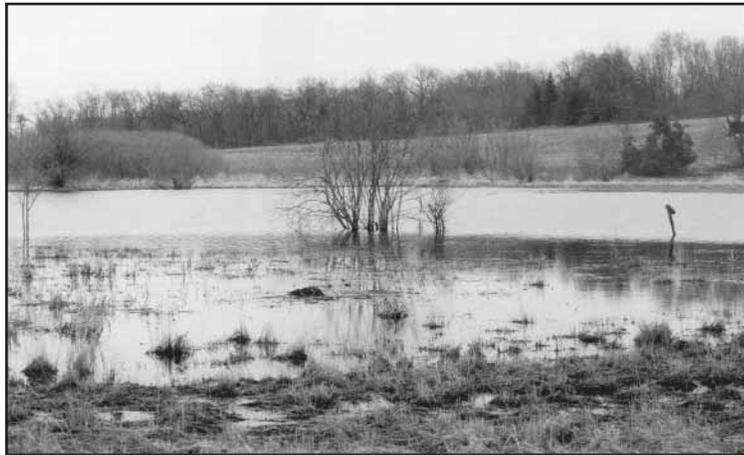
Wetland hydrology returns to the historic level at the Walker site following the filling of ditches that have a high water storage capacity.

Water levels began to stabilize three years after construction. By the fourth year, even areas considerably upslope from the basin had wetland vegetation. Water levels will be allowed to stabilize without manipulation, unless reed canary grass areas increase in size. Eventually the water control structure will be abandoned to create a self-sustaining natural system.

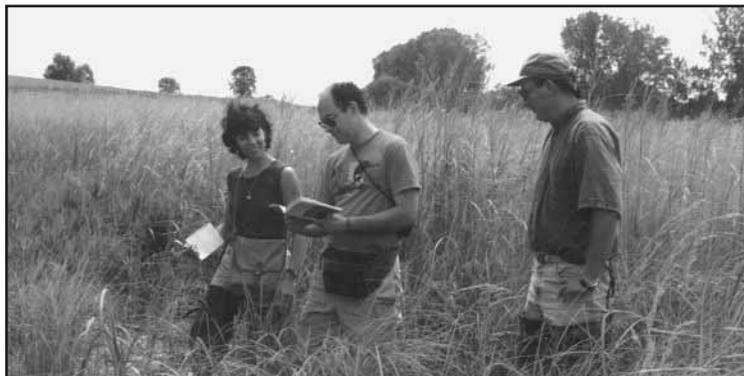
It is important to continue monitoring your wetland restoration for many years to determine what species become established and to detect any invasive plant problems.
