Bad Axe-LaCrosse River Basin, Wisconsin

DNR PUB WT-933

Bad Axe River Watershed

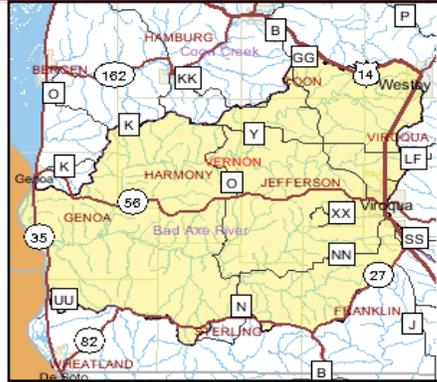
Map 1: Bad Axe River Watershed

The Bad Axe River Watershed, which lies entirely within Vernon County, encompasses approximately 200 square miles of steep forested hillsides, ridge top and valley farms.

The only farms with sizable tillable acreage in the basin are located on the upper plateau of the Bad Axe River watershed, west of Westby and Viroqua. The communities of Viroqua, Westby and Genoa are all found within this watershed.

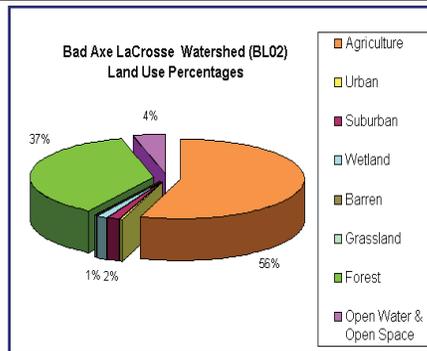
Figure 1: Watershed Land Use

The chart at right shows watershed land use data from the 2001 National Land Cover Inventory dataset, which illustrates the dominance of agriculture and forests in the watershed (Figure 1).

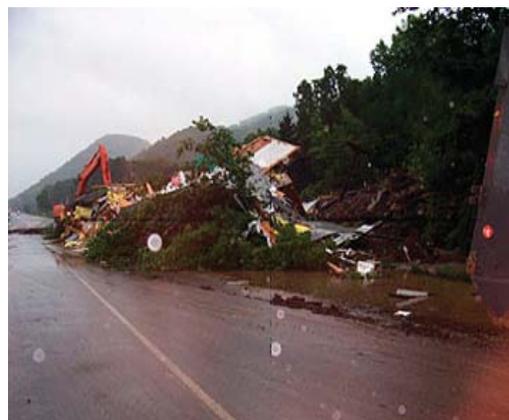
Mudslide that moved a house onto HWY 35 in Vernon County during August 18, 2007 flood. WDNR Photo

Steep hillsides became unstable with the excessive rain and many slumped or slid down to the lowest spot destroying some buildings and roads in the process (See photo upper right). Many stream miles and structures were unharmed due to the effectiveness of these flood control structures during both the 2007 and 2008 flood events.

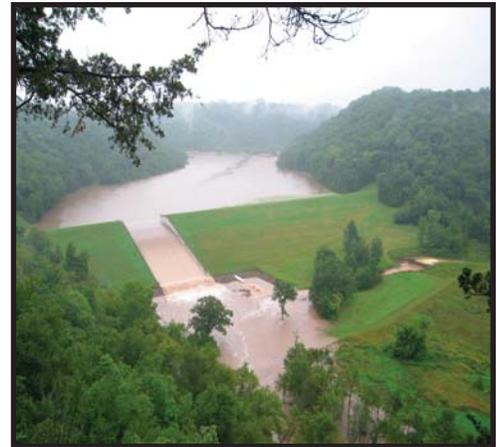
Floodwaters flowing over the emergency concrete spillway of the Springville Dam on the Springville Branch of the Bad Axe River. August 20, 2007.

damaged. Saturated soils on hillsides slumped and created mudslides; bridges and culverts were washed out; roads were flooded; and flood control structures were stressed to their limits. Emergency spillways were compromised at many dams in Vernon County. The waters behind the dam located on the Springville Branch of the Bad Axe River reached its concrete emergency spillway, which was an historic event.

Bad Axe River watershed resulting in overflow to their emergency spillways. Destructive scour by the excess water required extensive repair. The waters behind the Bad Axe 11 – Duck Egg dam (on the Springville Branch of the Bad Axe River) reached a height never before recorded.

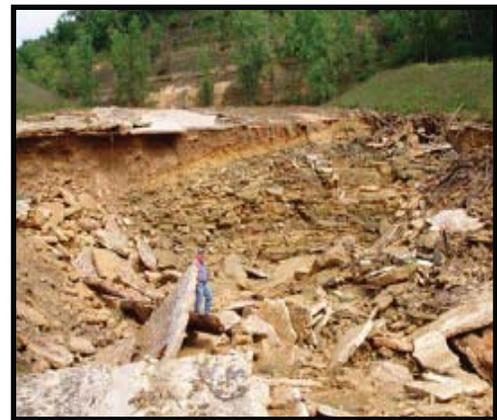
Aftermath of floodwater scour of the Runge Hollow Lake Dam emergency spillway on the North Fork of the Bad Axe River. August 23, 2007.

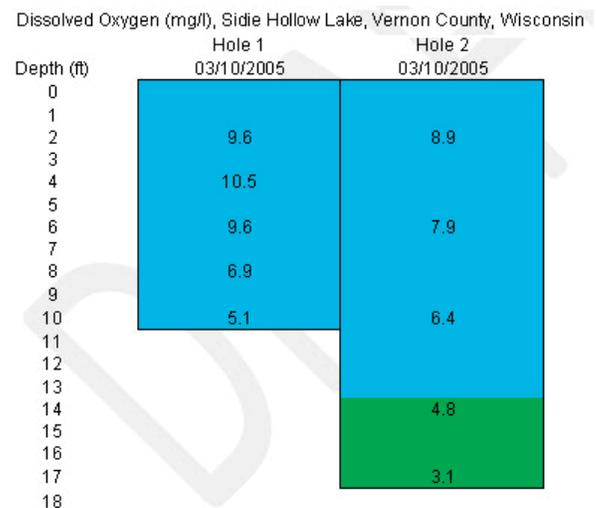
Figure 2. Sidie Hollow Lake Profile, 3/05

An early spring snowmelt event took place on March 8-9, 2005 in south western Wisconsin. Manure spreading of farm fields was prevalent during this unusually early warm spell. Runoff of snowmelt with recently applied manure caused a major fish kill of Jersey Valley Lake, an impoundment in a neighboring watershed. This event prompted monitoring of Sidie Hollow Lake. The lake did have an area of depressed dissolved oxygen (3.1 mg/l) at the deepest point, but no fish kill (Figure 2, previous page).

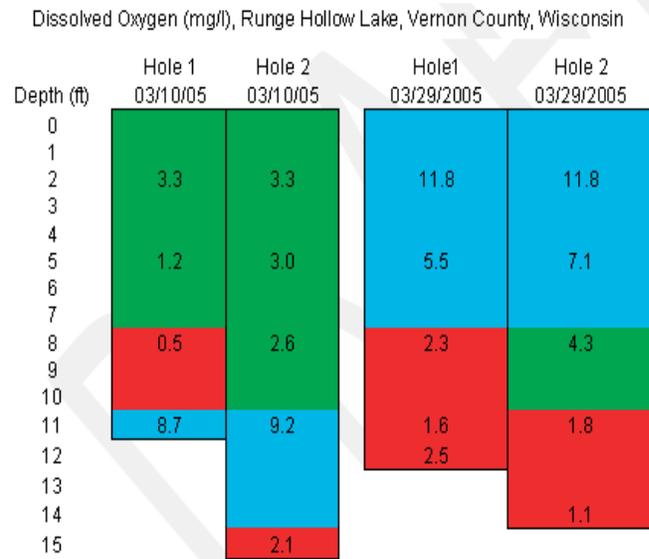
Figure 3. Runge Hollow Lake Profile, 3/05

An early spring snowmelt event took place on March 8-9, 2005 in south western Wisconsin. Manure spreading of farm fields was prevalent during this unusually early warm spell. Runoff of snowmelt with recently applied manure caused a major fish kill of Jersey Valley Lake, an impoundment in a neighboring watershed. This event prompted monitoring of Runge Hollow Lake. On March 10, 2005 Runge Hollow Lake did contain areas of very low dissolved oxygen, however there was a zone of refuge for fish containing between 8 and 9 mg/l of dissolved oxygen. A follow up survey on March 29, 2005 showed a larger area of low dissolved oxygen but also a larger total area of adequate levels. The watershed of Runge Hollow Lake is much larger than Sidie Hollow Lake and contains a larger percentage of farm fields that may have been spread with manure prior to the snowmelt. Runge Hollow Lake is certainly susceptible to winterkill due to manure laden snowmelt, but did not kill during this March 2005 event (see Figure 3).

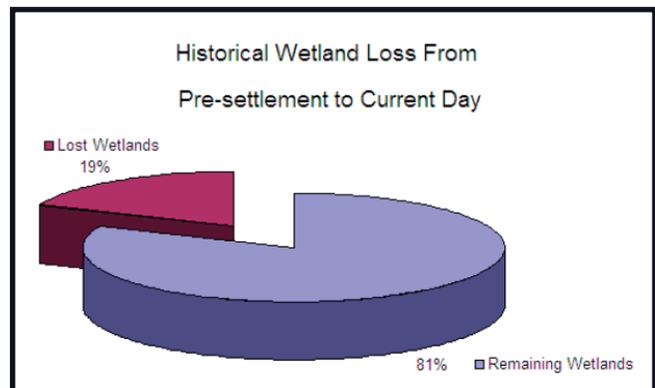
Figure 4: Historical Wetland Losses

The Bad Axe LaCrosse Basin, in the driftless area of the state, has few wetland resources. Only about 2% of the current land uses in the watershed are wetlands. However, 81% of original wetlands in the watershed are estimated to exist (Figure 4). Of these wetlands, the majority are forested wetlands (51%) and emergent wetlands (40.9%) which include marshes and wet meadows.

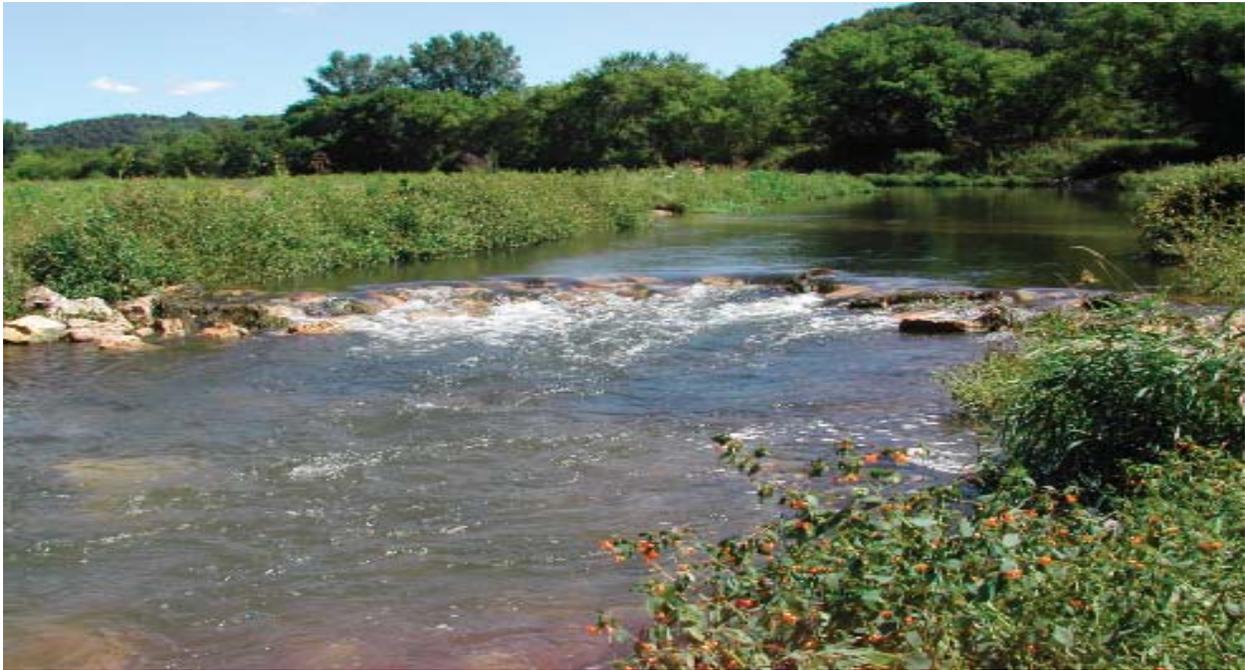
Stream Habitat Restoration, Bad Axe River. WDNR Photo, 2010.

Trout stamp funds have been used over the last 33 years to reshape many of these streambanks through movement of soil and planting of grasses, effectively giving the streams access to a new floodplain. After the floods of 2007 and 2008, those segments of streams where streambank work was done showed no catastrophic changes compared to those segments without reshaped and planted streambanks. Very little repair of the previous streambank work was necessary.
