2010 Water Quality Management Plan Update

Upper Rock River Basin, Wisconsin

August, 2010

Upper Rock Watershed

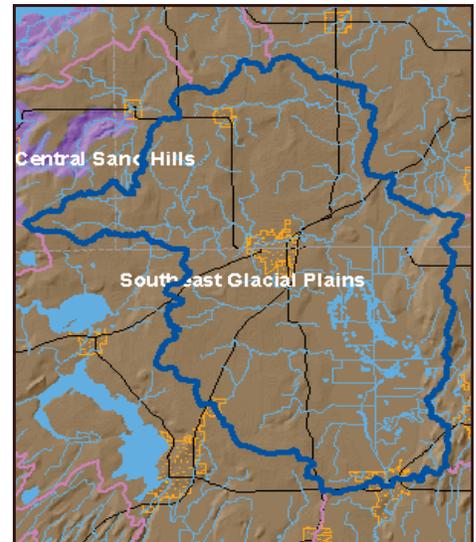
Map 2 Ecological Landscapes of the Upper Rock Watershed

The Southeast Glacial Plains Ecological Landscape makes up the bulk of the non-coastal land area in southeast Wisconsin. This Ecological Landscape is made up of glacial till plains and moraines. Most of this Ecological Landscape is composed of glacial materials deposited during the Wisconsin Ice Age, but the southwest portion consists of older, pre-Wisconsin till with a more dissected topography. Soils are lime-rich tills overlain in most areas by a silt-loam loess cap. Agricultural and residential interests throughout the landscape have significantly altered the historical vegetation. Most of the rare natural communities that remain are associated with large moraines or in areas where the Niagara Escarpment occurs close to the surface.

Historically, vegetation in the Southeast Glacial Plains consisted of a mix of prairie, oak forests and savanna, and maple-basswood forests. Wet-mesic prairies, southern sedge meadows, emergent marshes, and calcareous fens were found in lower portions of the Landscape. End moraines and drumlins supported savannas and forests. Agricultural and urban land use practices have drastically changed the land cover of the Southeast Glacial Plains since Euro-American settlement. The current vegetation is primarily agricultural cropland. Remaining forests occupy only about 10% of the land area and consist of maple-basswood, lowland hardwoods, and oak. No large mesic forests exist today except on the Kettle Interlobate Moraine which has topography too rugged for agriculture. Some existing forest patches that were formerly savannas have succeeded to hardwood forest due to fire suppression.

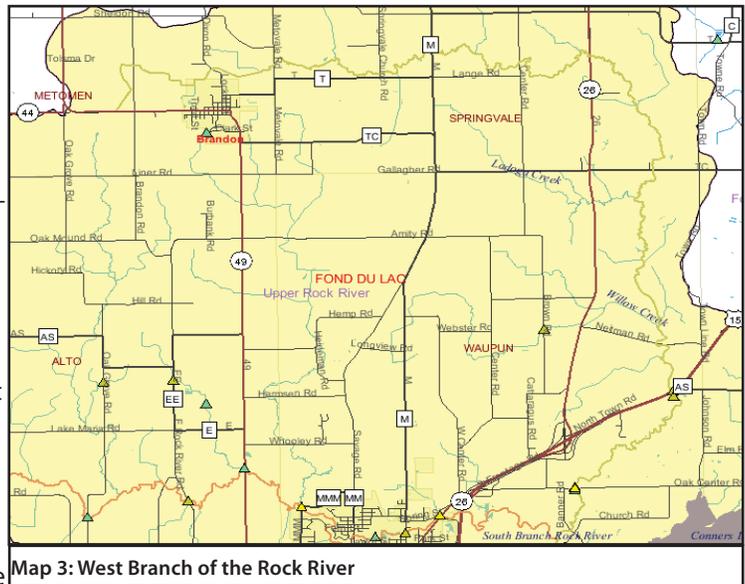
Map 3: West Branch of the Rock River

The West Branch of the Rock River (Map 3) has its headwaters east of the Village of Brandon. It flows east and then south through mainly agricultural land. This area contains many drained wetlands, so there is likely a relatively high input of groundwater from drain tile.

Willow and Ladoga Creeks flow into the river from the west as the river flows south. There are no Surface Water Integrated Monitoring System (SWIMS) monitoring stations in this stretch; therefore, there is no water quality data available until the river intersects Highway 151 in the Town of Waupun (T-14-N; R-15-E, Sect 24, SWIMS station # 143258). Data from this station is limited legacy data from the winter of 1975-76. The next SWIMS station is approximately 500 feet south on Guenther Road (SWIMS station # 203105). There is an extensive amount of water quality data for this station dating from late 1997-2000.

The next SWIMS station is approximately two miles downstream at Oak Center Road. SWIMS lists four stations for this crossing. Two of the stations (203126 and 100000) have no data available in SWIMS. Station # 203129 has very limited

water quality data but two Hilsenhoff Biotic Index (HBI) surveys have been conducted showing a HBI of 6.56 (fairly poor) in 2000 and 5.54 (fair) in 2008. In 2000, fish and habitat surveys were conducted at Oak Center Road (station 10008399) showing an Index of Biotic Integrity (IBI) of 15 (very poor) and a Qualitative Habitat Rating of 40 (fair). The next monitoring downstream is approximately 1 mile south of the junction with the South Branch Rock River. The entire west Branch Rock River has been listed as an impaired water due to sedimentation, habitat degradation and excessive nutrients. Although the river has never been formally classified, it is a default warm water sport fishery, which would likely be the correct classification.

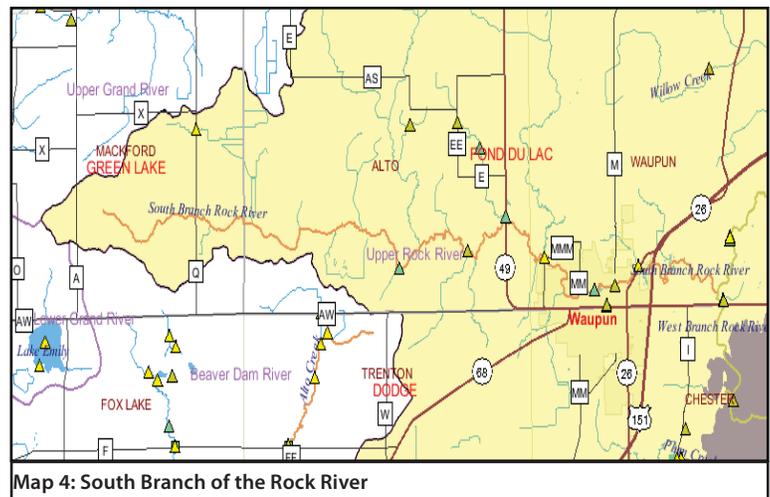
Map 4: South Branch of the Rock River

The South Branch of the Rock River (Map 4) is approximately 23 miles long, with its headwaters in the far eastern portion of Green Lake County. The river flows east through Dodge County and combines with the West Branch Rock River approximately two miles east of the City of Waupun. As the River flows through the City of Waupun, there is a small dam that creates a five-acre mill pond. The entire South Branch Rock River is also on the Impaired Waters list. It is listed as impaired for habitat and sediment, although there are also excessive nutrients as identified in recent monitoring. Although only the lower three miles of the river are formally classified as warm water sport fishery, there is potential in the upper reaches to also have a sport fishery.

There are 19 monitoring stations on the river and its tributaries, up to its confluence with the West Branch. There is one large point source discharger in the upper reaches above the City of Waupun. Saputo Dairy (formerly Alto Dairy) discharged excessive amounts of phosphorous into the system. With the adoption of Administrative Code NR 217, these levels have dropped significantly, however this is still a significant source of phosphorous. In addition, much of the watershed is agriculture allowing for excessive sedimentation. There are also a significant amount of drained wetlands, leading to inputs of groundwater from drain tile, which can be high in nitrogen. Available HBI data is highly variable ranging from good to poor.

There are several tributaries, such as Alto Creek, which do flow into the river. Alto Creek (WBIC 870500) is listed as an unnamed creek in the watershed. These tributaries show extensive ditching and straightening. In addition to increased sedimentation and high nitrogen levels, the City of Waupun discharges wastewater effluent into the river adding more phosphorous to the system.

Just east of Waupun, the South Branch and West Branch combine. There are two SWIMS stations listed just north of Highway 49 (SWIMS #203131 and #143263). Most of the data collected, from several studies, have been reported under #203131. Although the data is not in SWIMS, there was a USGS monitoring station at this site from October 1997 – 1999 as was mentioned before. The study showed excessive levels of phosphorous and suspended solids. There was more macroinvertebrate collection done in 2002 and in 2008. The 2002 study showed an HBI of 5.2 (good). The 2008 study showed a decrease in quality with an index of 5.9 (fair). Data from station #143263 was acquired from a macroinvertebrate study conducted in 1998, resulting in a HBI of 5.423 (good).
