AQUATIC PLANT MANAGEMENT PLAN

**BOOT LAKE
VIALS COUNTY, WISCONSIN**

October 17, 2007
Revised September 28, 2009

Northern Environmental Technologies, Incorporated
1203 Storbeck Drive
Waupun, Wisconsin 53963

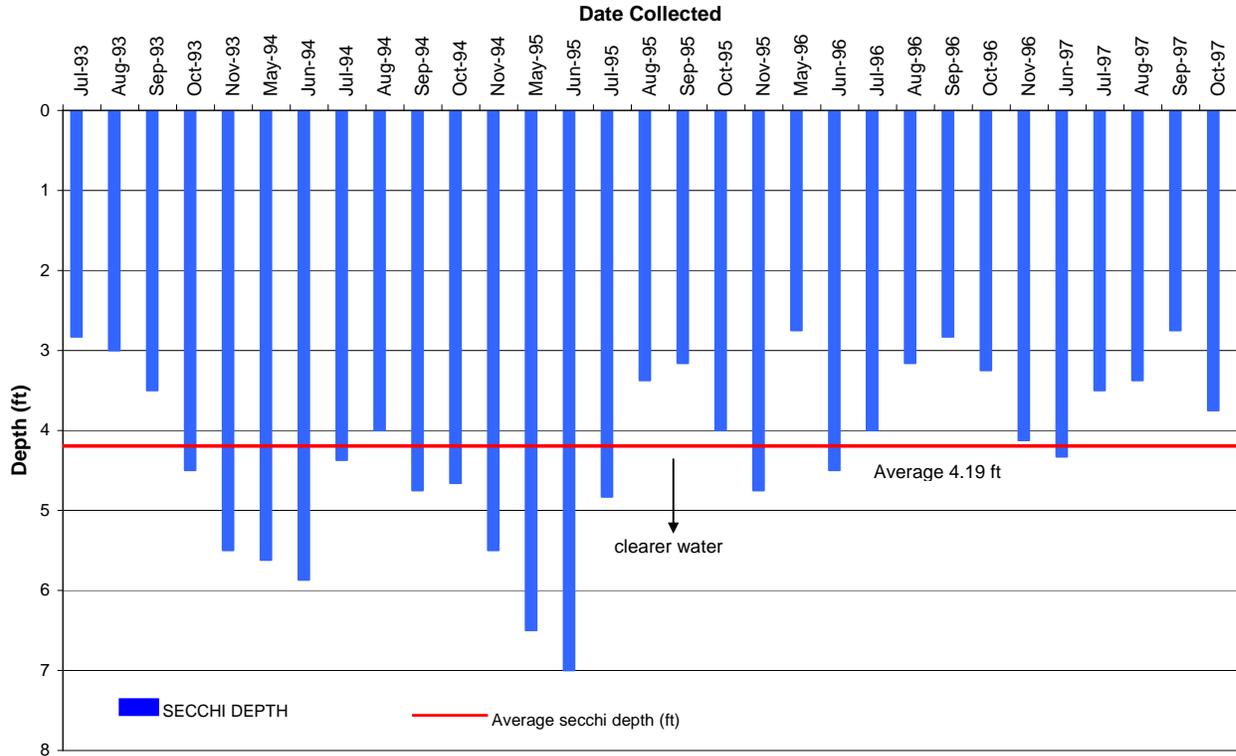
Boot Lake Secchi Readings

The historical water clarity average based on Secchi Disk readings is 4.19 feet (1.28 meters) and ranges from 2.75 to 7 feet. The Wisconsin average Secchi Disk reading in 2005 was 10 feet (Larry Bresina, The Secchi Disk and Our Eyes - Working Together To Measure Clarity of Our Lakes; internet document). The following graph illustrates the historical water clarity measurements on Boot Lake.

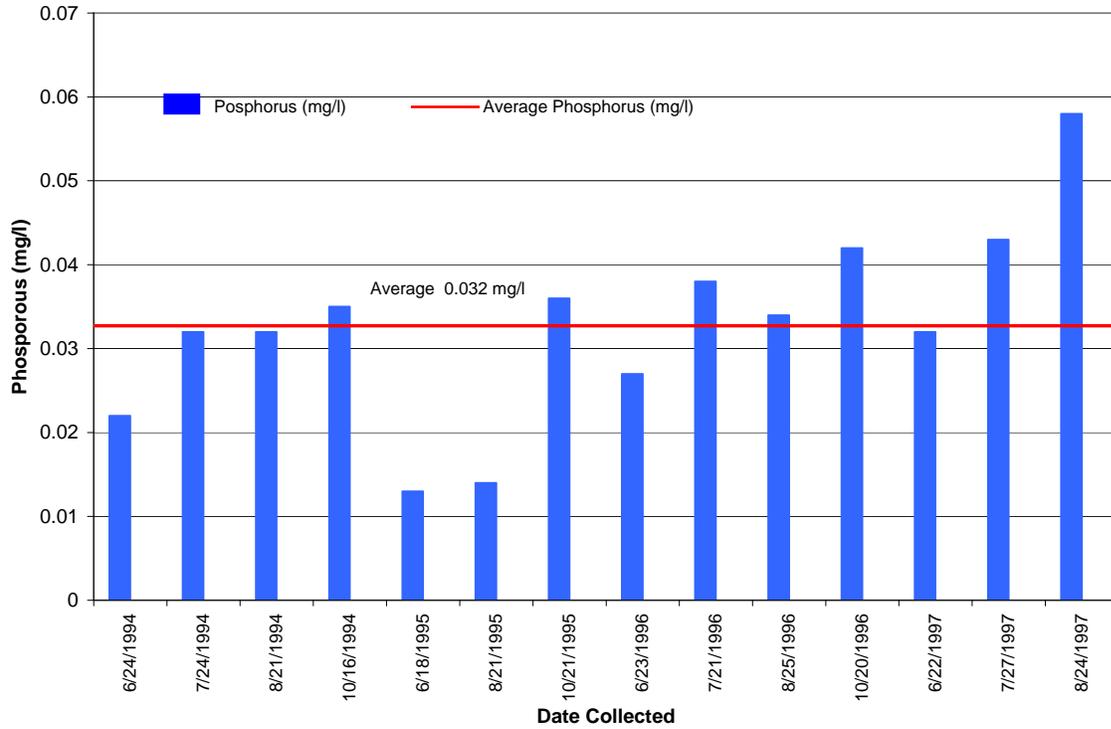
Boot Lake Phosphorus Readings

Historically, Boot Lake has an average phosphorus reading of 0.032 milligrams per liter (mg/L - parts per million). The total phosphorus has varied from 0.013 mg/L to 0.058 mg/L. Chlorophyll *a* data has an average of 16.64 micrograms per liter (ug/L - parts per billion). Data ranged from 8.0 ug/L to 30.0 ug/L. The following graphs illustrate phosphorus and chlorophyll *a*, respectively.

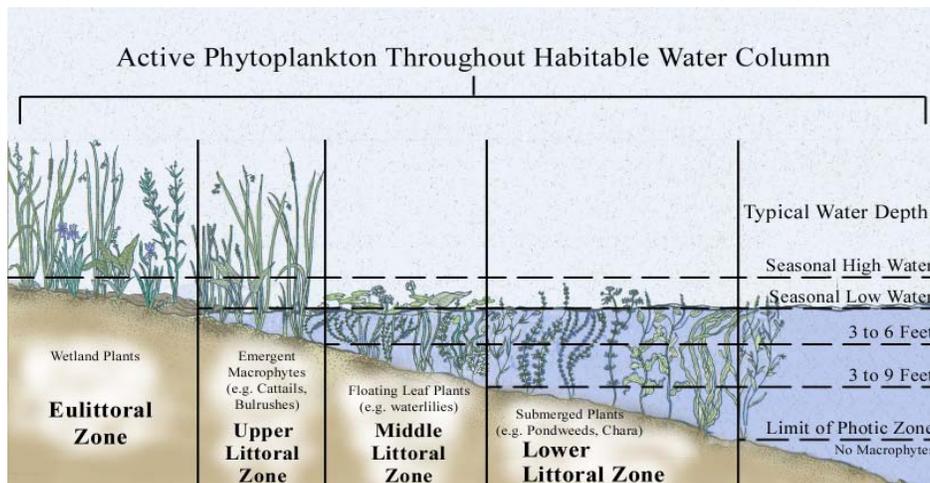
Aquatic Plant Communities Schematic

- Eulittoral Zone:** Includes the area between the highest and lowest seasonal water levels, and often contains many wetland plants.
- Upper Littoral Zone:** Dominated by emergent macrophytes and extends from the shoreline edge to water depths between 3 and 6 feet.
- Middle Littoral Zone:** Occupies water depths of 3 to 9 feet, extending deeper from the upper littoral zone. The middle littoral zone is often dominated by floating-leaf plants.
- Lower Littoral Zone:** Extends to a depth equivalent to the limit of the photic zone, which is the maximum depth that sufficient light can support photosynthesis. This area is dominated by submergent aquatic plant types.

The following illustration depicts these particular zones and aquatic plant communities.
