Floating booms to prevent blue-green algal scums and other floating debris from fouling Madison area swimming beaches: a pilot test

Richard C. Lathrop, Wis. Dept. Natural Resources

John R. Reimer, Madison Engineering Dept.

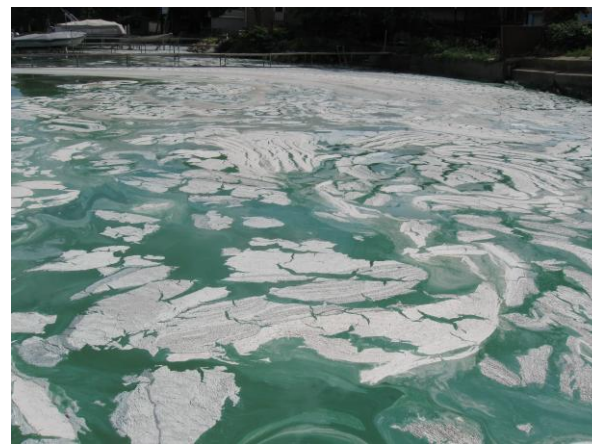
Fig. 1. Blue-green algal scum on the Yahara lakes. (Lake Kegonsa, June 2012; Photo credit: Dane County Land and Water Resources Dept.)

Excessive growths or “blooms” of blue-green algae (a.k.a. cyanobacteria) commonly occur during the summer months in the nutrient-rich Yahara lakes (Fig. 1). Such blooms are a serious health concern to humans and wildlife because certain species of blue-green algae can produce neurotoxins, skin toxins, and/or heptatotoxins leading to symptoms such as: liver and kidney lesions; and gastrointestinal, muscular, and respiratory symptoms including seizures and respiratory arrest.

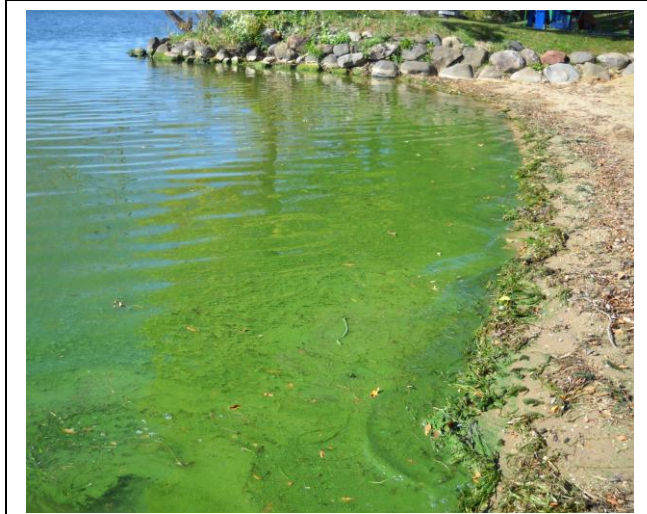
Fig. 2. Algae pile-up in the protected shoreline cutout at B.B. Clarke Beach, Oct. 5, 2010. (Photo: G. Steinhorst, City of Madison Engineering Dept.)

Besides scums and other floating debris piling up on the downwind shorelines of the Yahara lakes, the noxious material can also accumulate along other shorelines in protected backwater areas due to eddy formation from “long-shore” water currents moving laterally to the shoreline. Public beaches on the Yahara lakes are particularly susceptible to eddy formation and trapping material because many of the local beaches are constructed as tapered sand bottom cutouts into rip-rapped shorelines (Fig. 2).

deployment of the deflector boom system. Another algal bloom was present at B.B. Clarke Beach on October 5-6, 2010 after the boom system was removed (Fig. 2). Microcystin toxin concentrations found in this algal bloom were greater than the highest measureable concentration ($>125 \mu\text{g/L}$) for a sample taken of the scum itself, and $8 \mu\text{g/L}$ for a sample taken below the scum layer. (For reference, $20 \mu\text{g/L}$ is the threshold limit established by the World Health Organization for microcystin health advisories in recreational waters.)

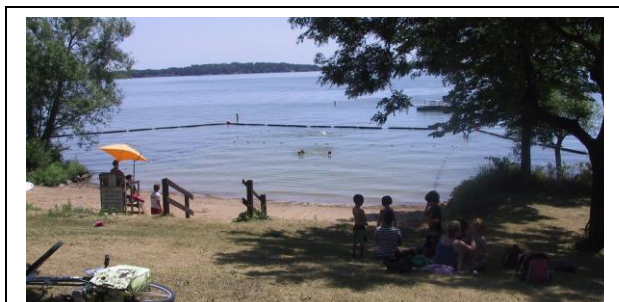
Fig. 3. Three-sided, trapezoid-shaped deflector boom system deployed at B.B. Clarke Beach during June-August 2010-2012. (Photo: R. Lathrop, WDNR)

Boom system design. Each boom system consisted of three individual boom walls connected to form three sides of a trapezoid surrounding a beach’s swimming area (designated by floating ropes) with the much wider “base” of the trapezoid being the park shoreline extending beyond each side of the sand beach (Fig. 3). Thus, the shorter endwall boom of the trapezoid was deployed parallel to shore just beyond the roped swimming area. The two longer sidewall booms were designed to ideally attach at the park shoreline with an approximate 120-degree angle on the outside

corner of the trapezoid. This design allowed the obtuse-angled sidewall boom when subjected to long-shore currents to “deflect” floating material away from the beaches and out into the lake. During other times, floating material would be temporarily trapped outside the boom near shore.

B.B. Clarke Beach. The 3-sided deflector boom system worked well at B.B. Clarke Beach (Figs. 3, 6) during all three summers of boom deployment in 2010-2012 because this beach is often exposed to long-shore water currents (Fig. 7). Beach users and lifeguards during informal interviews felt the beach was much cleaner with high public acceptance of the boom system. However, in 2010 the popular diving platform was not installed in deeper water beyond the boom endwall due to concerns that lifeguards could not easily traverse the boom wall if an emergency occurred. Experience showed that the boom wall was not a barrier (even acting as a safety float) such that diving platform was installed in subsequent summers.

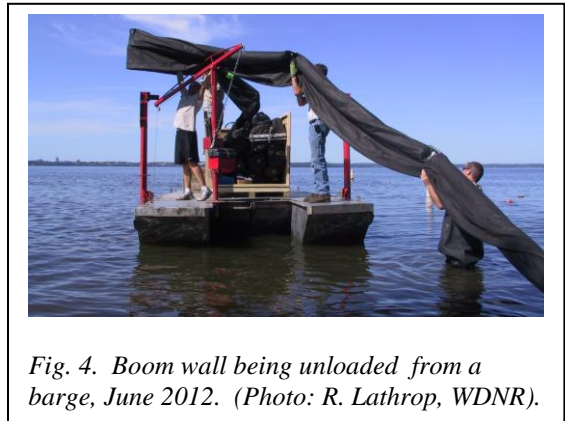
Fig. 4. Boom wall being unloaded from a barge, June 2012. (Photo: R. Lathrop, WDNR).

Each boom wall was constructed of 8 oz. Polypropylene Geotextile fabric. The boom wall’s flotation collar consisted of a series of 10-foot long styrofoam tubes (6-inch diameter) covered by a double layer of fabric for extra durability (Fig. 4). A hanging fabric curtain weighted with a ballast chain extended one foot below the flotation collar to ensure good interception of floating debris in the lake while allowing water to circulate freely underneath the boom. This design prevented water from stagnating within the swimming area. During windy periods with strong waves and water currents, the curtain would “billow” sideways thereby reducing pressure on the boom wall. A stainless steel tension cable in the curtain directly underneath the flotation collar allowed each boom wall to be tightly stretched in a straight line between two anchoring points on the shoreline and/or in the water.

Boom installation. Deploying each boom system required a barge and a boat plus crew from Dane County (Fig. 4). After unfurling a boom wall from the barge, the shore end of each sidewall boom was attached by chain to a large tree, rip-rap boulder, or installed iron tie-down rod on shore. In the lake, the two sidewall booms were connected to the endwall boom by bolting the respective fabric curtain edges together to form a tight seal at each corner. Then the two boom tension cables on the outside of each boom corner were attached to a large floatation barrel. Ropes attached to each corner barrel allowed the barge and boat to stretch the 3-sided boom system to its full size. Heavy concrete block anchors were then placed in deeper water some distance away from the corners in the general direction of a perpendicular bisector of each corner angle to equalize the tension on the two boom walls. Finally, the anchors were attached by a long chain to each floatation barrel with full tension put on the boom system to ensure all three boom walls were straight while the floatation barrel prevented the boom corner from being pulled underwater. For safety, navigation hazard buoys were attached to each anchor chain.

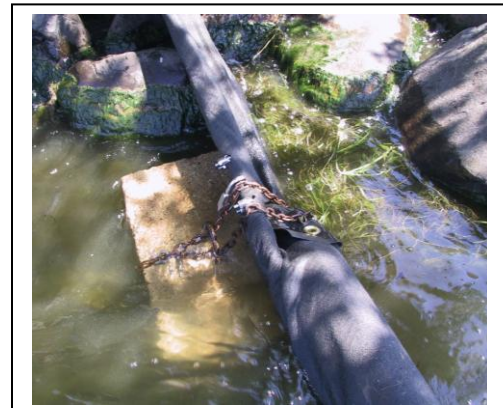
Fig. 5. Concrete block and chain used to prevent boom wall from being lifted out of lake at shoreline. (Photo: R. Lathrop, WDNR)

Because the shoreline attachment point was usually well above the waterline, the boom wall tended to lift out of the lake near shore. That problem was rectified by placing a heavy block at the water’s edge and chaining the boom’s tension cable downward to the block at a point right next to the edge of the first floatation tube (Fig. 5). A 5-ft piece of geotextile curtain fabricated on each sidewall boom’s shore end helped ensure a tight seal at the shoreline to prevent floating debris from leaking into the swimming area.

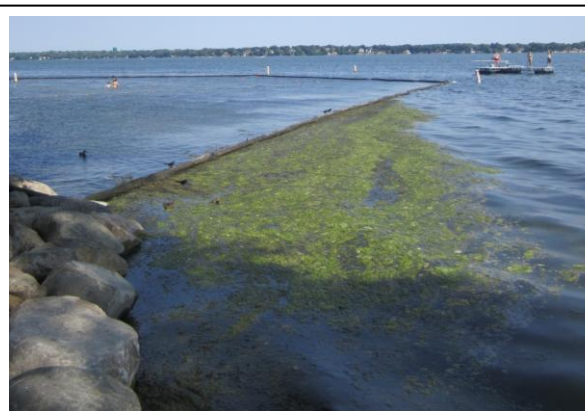
Fig. 6. Photo showing the deflector boom system preventing algae scums and other floating debris from entering the enclosed swimming area at B.B. Clarke Beach, June 2012. (Photo: C. Betz)

In addition to these results, a graphic photo taken in June 2012 showcased how the western sidewall boom prevented algal scums and other floating debris from entering the swimming area (Fig. 6). The floating material was trapped in the southwest corner of the boom at shore. No health advisory was posted at the beach during this period and the trapped debris later left the area. Time-elapsed photos taken every 5 minutes for a period of 90 minutes during mid-July 2010 also showed how floating debris interacted with the same boom subjected to long-shore currents. In the sequence of photos, a mass of floating aquatic plants was filmed moving along the deflector sidewall boom to its end where the plant mass was released into deeper water.

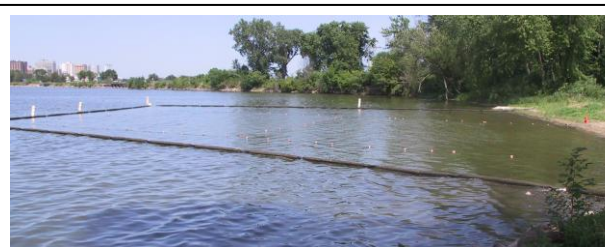
Fig. 8. Deflector boom system deployed at Bernie's Beach, June-August 2010-2011. (Photo: R. Lathrop, WDNR)

Bernie's Beach. The deflector boom system deployed at Bernie's Beach (Fig. 8) during the summers of 2010-2011 maintained the swimming area relatively free of algal scums and other floating debris. Because of the more sheltered and restricted location of the beach area in the corner of Monona Bay, the two sidewall booms were attached to shore with outside wall angles only slightly greater than 90 degrees. Floating material was often observed trapped outside the corner of the west sidewall boom (Fig. 9).

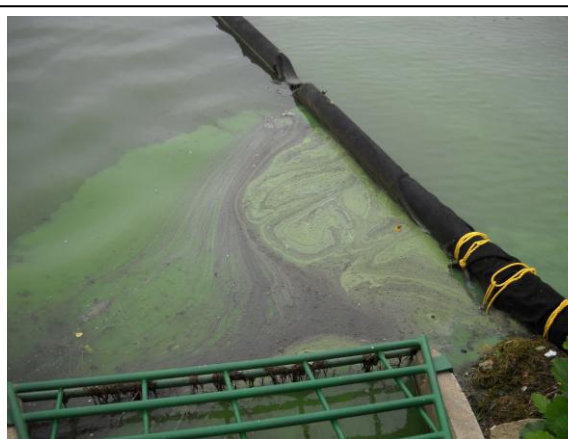
Fig. 9. Algae scum and other floating debris trapped outside the sidewall boom at Bernie's Beach, July 2010. (Photo: G. Steinhorst, City of Madison Engineering Dept.)

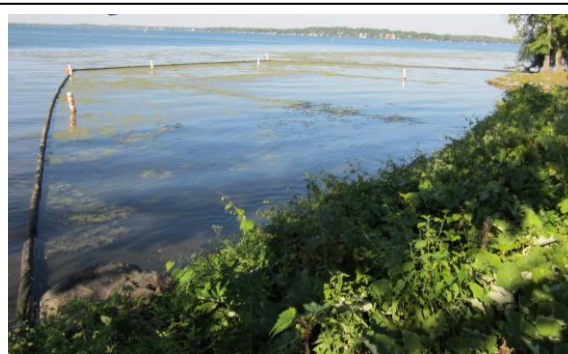
Fig. 10. Deflector boom system deployed at Olin Beach in 2012 showing aquatic plants and filamentous algae growing inside and outside the boom system. (Photo: R. Lathrop, WDNR)

Olin Beach. The deflector boom system tested at Olin Beach on Monona's southern shoreline in 2012 did not work particularly well even though the boom system itself was a good fit for the beach (Fig. 10). The main problem was the swimming area inside the boom system was very shallow with a significant amount of aquatic plants and filamentous algae growing from the lake bottom. Some effort was made to clear out this area with a weed harvester prior to installing the boom, but the filamentous algae quickly grew back into thick masses that created unappealing swimming conditions at the beach. This southwest beach shoreline often was on the upwind end of the lake where water currents could not remove the floating material trapped outside of the boom walls.

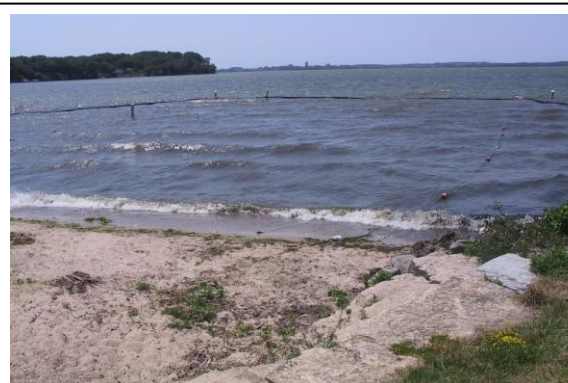
Fig. 11. Deflector boom system deployed at Warner Beach in 2012. (Photo: R. Lathrop, WDNR)

Warner Beach. A new deflector boom system was tested at Warner Beach in 2012 (Fig. 11) as the location presented some challenges that were different from the other beaches tested during the previous two years. First, during prevailing southwesterly winds, Warner Beach on Mendota's northeast end had a very long fetch (the longest distance that waves travel unobstructed) and hence subjected to high waves and strong water currents. Modeling of water currents in Warner Bay indicated large opposing gyres of water currents (i.e., one circulating clockwise and one circulating counterclockwise) occur in the bay near the beach shoreline (Fig. 12). Thus, floating debris potentially could be intercepted by either or both sidewalls of the boom system prior to the surface water currents leaving the bay. These water circulation patterns helped explain why floating material sometimes accumulates in large amounts at Warner Beach (Fig. 13).

The deflector boom system with the modified "shovel" anchors deployed at Warner Beach in 2012 did not appreciably shift due to strong wave action and water currents, although one corner anchor chain had to be readjusted after the anchors had "settled in." The boom system did appear to absorb some of the wave energy, calming the water in the shallow swimming area.

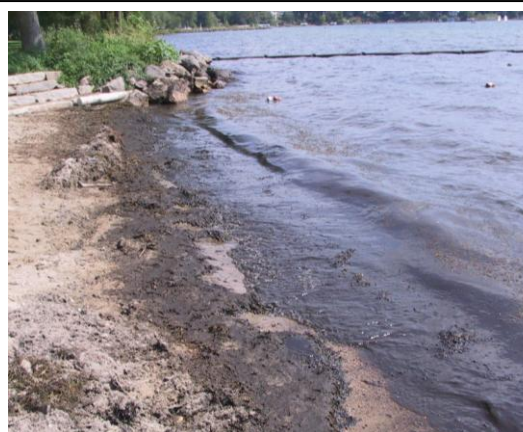
Fig. 13. Suspended debris in the water and on shore inside the deflector boom system at Warner Beach in late July 2012. (Photo: R. Lathrop, WDNR)

While blue-green algal scums were not a problem in Lake Mendota in summer 2012, decaying filamentous algae material originating from shallow areas all over the lake was particularly dense along the Warner Bay shoreline. This unaesthetic detrital material had entered the boom system and become trapped as a thick dark brown mass of suspended rotting sludge in a zone extending a few feet from the beach shoreline (Fig. 13). The park shoreline farther to the east also had this same sludge for a number of weeks, but the boom system likely would prevent the suspended material from leaving the beach when exposed to high winds.

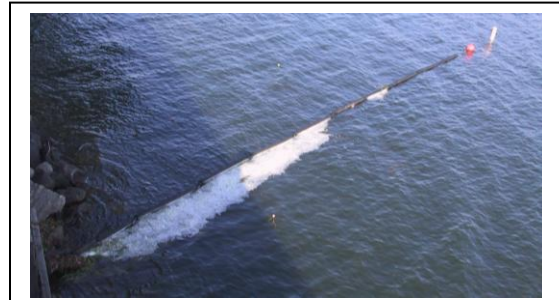
Fig. 14. Floating material trapped on the single boom deployed at UW Center for Limnology in 2010. (Photo: R. Lathrop,

Single boom test (UW-Madison shoreline). The single boom tested at the UW Center for Limnology shoreline in 2010 (Fig. 14) was deployed with a 60 degree angle on the west side of the boom to trap material coming from that direction. However, floating material occasionally became trapped for short periods on the obtuse-angled side of the boom wall; material was rarely trapped on the boom side facing University Bay. While large scums did not occur in Lake Mendota during 2010, this test demonstrated that a single boom could intercept and temporarily trap floating material especially along shorelines subjected to long-shore currents.
