# Pike Lake Chain of Lakes Report PRICE AND VILAS COUNTIES, WISCONSIN Summary of the Lake Management Study

Prepared by Blue Water Science, St. Paul, MN, May 2012

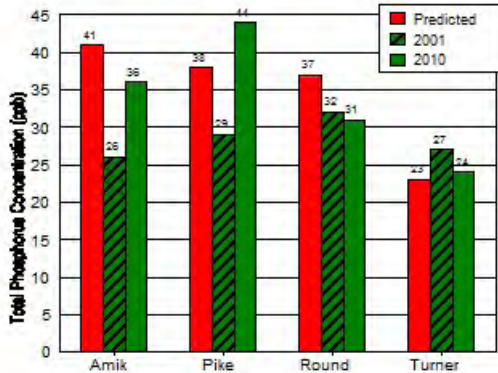
### Total Phosphorus

Total phosphorus is somewhat high, but close to what would be predicted, based on stream phosphorus concentrations.

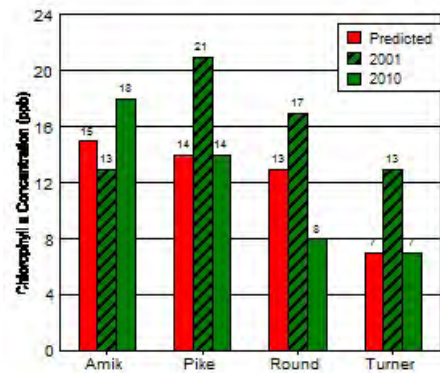
### Algae (Chlorophyll)

The algae concentration was close to predicted or slightly higher than expected in 2001.
