**Eurasian water milfoil (*Myriophyllum spicatum*)
Pre/Post Herbicide and Fall Bed Mapping Surveys
Sand Lake - WBIC: 2661100
Barron County, Wisconsin**

June 14, August 11, and October 13, 2013

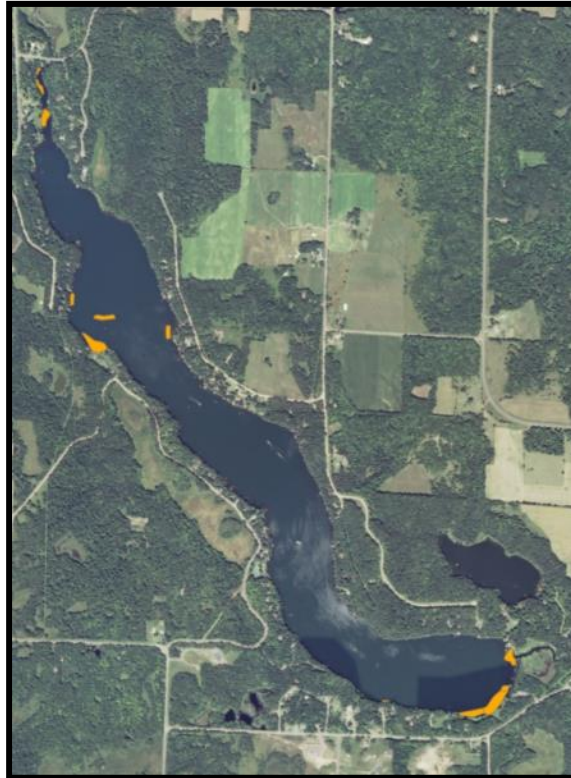
Figure 1: 2013 Spring EWM Treatment Areas

Eurasian water milfoil (*Myriophyllum spicatum*) (EWM) was discovered in the lake in 2002, and the Sand Lake Management District (SLMD) is engaged in active management to control this invasive exotic species. Following the 2012 fall EWM bed mapping survey that found EWM plants scattered throughout the lake, the SLMD, under the direction of Short Elliott Hendrickson Inc (SEH), decided to chemically treat 12 areas in 2013. Collectively, they totaled 7.02 acres or 2.2% of the lake's surface area (Figure 1).
