## MEMORANDUM

**TO: Wheeler Lake Association**

**SUBJECT: Results of the October 13, 2014 Eurasian watermilfoil survey on Wheeler Lake**

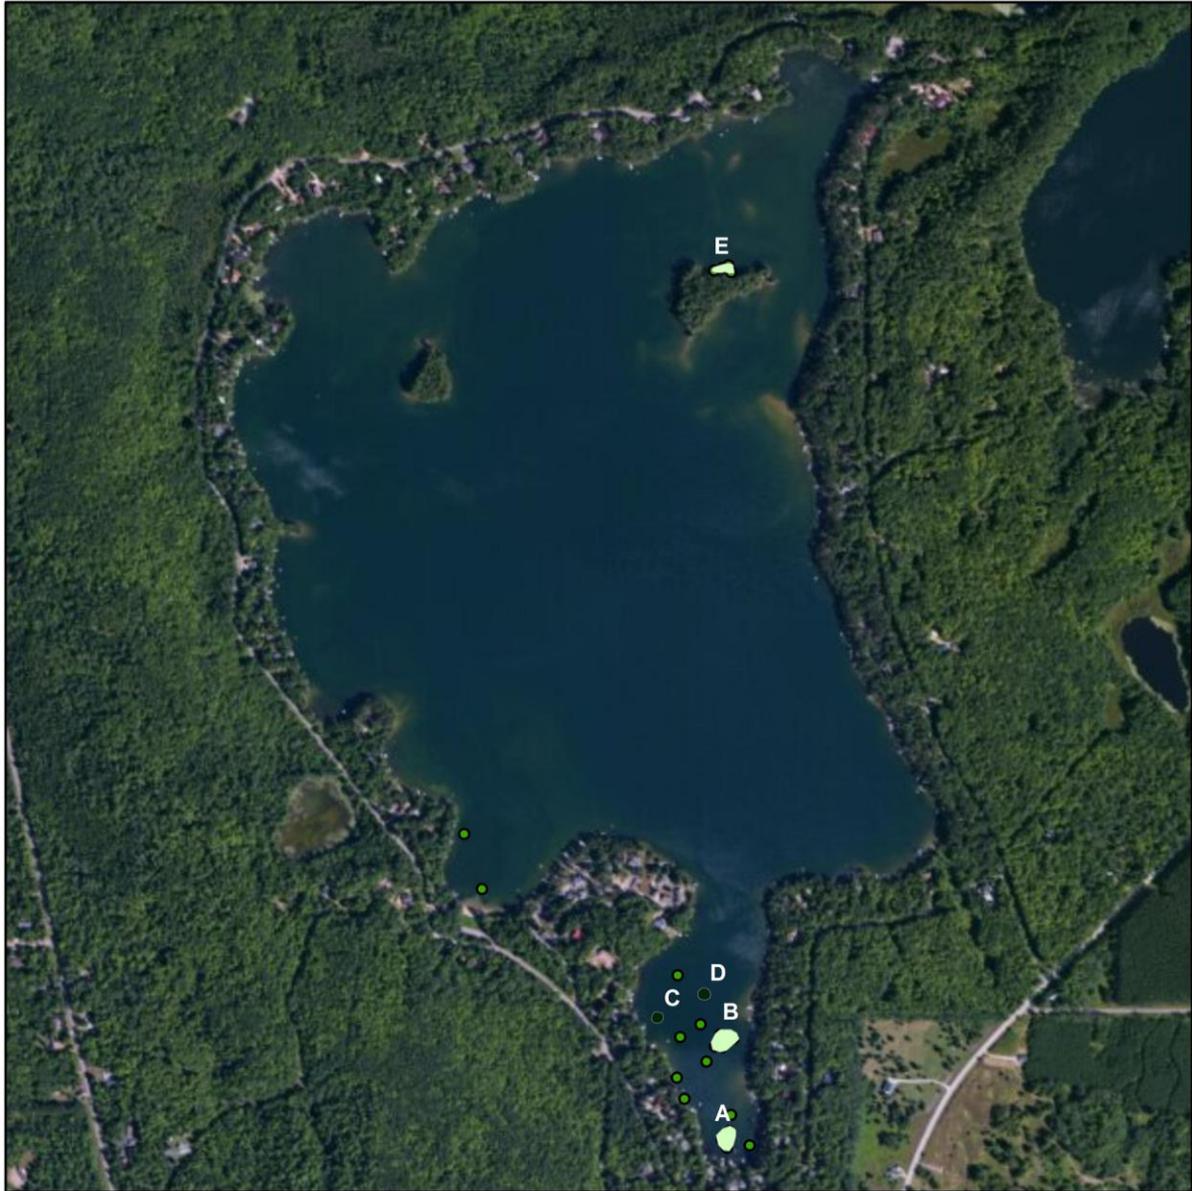
The October 2014 survey found five beds of EWM that covered a total area of 0.9 acre (**Figure 1**). Three of the beds were highly scattered and two were dense. In addition,

there were ten locations that had individual plants or small groups of plants. The majority of the EWM was found in the southern bay, a location where EWM has been most problematic in the past. There was one 0.1 acre bed of highly scattered EWM found along the north shore of the largest island (Bed E). During the survey it was also noted that northern watermilfoil was more abundant than EWM in most areas.

**Figure 1. Distribution of Eurasian watermilfoil in Wheeler Lake, Oconto County, WI during the October 13, 2014 survey.**

Traditionally, annual chemical treatments have been the tool of choice for managing EWM in Wheeler Lake. In the spring of 2015, a chemical treatment could again be utilized. The five discreet EWM beds could again be targeted using Navigate<sup>®</sup>. The application rate for EWM ranges from 2.0 to 4.0 ppm. For small, isolated beds, the maximum labeled rate of 4.0 ppm (56.8 lbs/acre-ft) is recommended. The higher concentration requires less contact time to be effective.

Chemical treatments can provide seasonal relief from EWM, but may not provide long-term control at these small scales. Often these beds are found in the same locations from year to year. These treatments also serve to prevent or slow the further spread of EWM throughout the lake. While this approach rarely leads to eradication, these treatments can serve as a means to prevent wide-spread expansion of EWM. **Table 1** provides a breakdown of estimated treatment costs for 2015.
