INTRODUCTION

2014 EWM PEAK-BIOMASS SURVEY RESULTS

Map 1
Kentuck Lake
Forest & Vilas Counties, Wisconsin
2013 EWM Locations & 2013 Treatment Areas

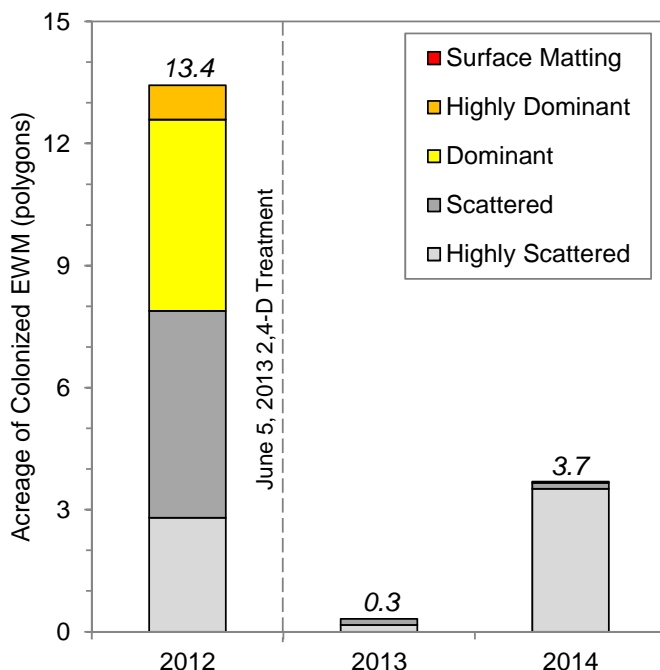
In total, approximately 3.7 acres of colonized EWM were located in Kentuck Lake in 2014 (Figure 1). This represents a slight increase from 2013 where approximately 0.3 acres of EWM were located; however, the 2014 acreage is still significantly lower than the 13.4 acres located in

2012 prior to the 2013 spring herbicide treatment. The majority of the colonized EWM located in Kentuck Lake in 2014 was comprised of the lowest density rating *highly scattered*.

Figure 1. Acreage of mapped EWM colonies on Kentuck Lake from 2012-2014.

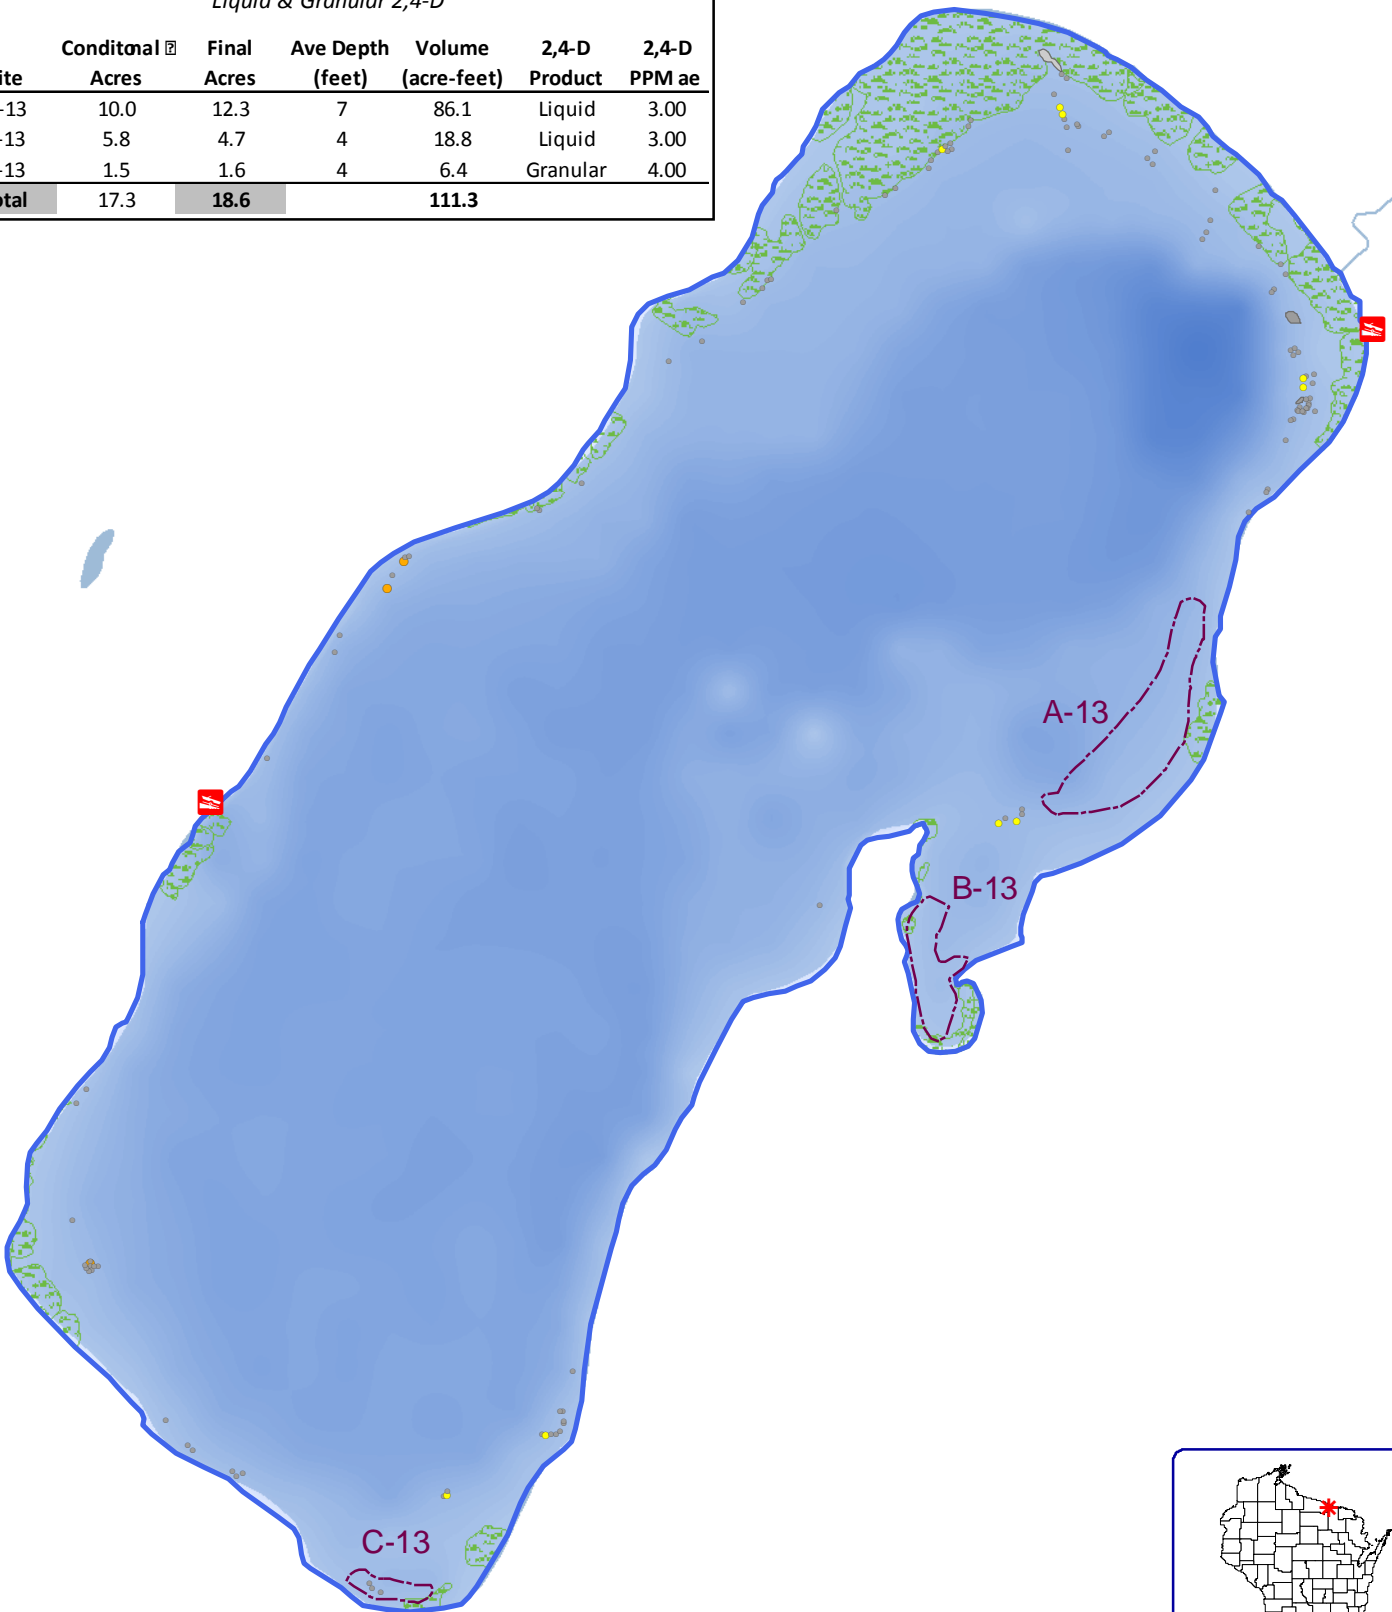
In 2011, Eurasian water milfoil (EWM; *Myriophyllum spicatum*) was discovered in Kentuck Lake. During the summer of 2012, Onterra was contracted by the Kentuck Lake Protection and Rehabilitation District (KLPRD) to conduct EWM mapping surveys on the lake later that summer. GPS coordinates relating to suspected EWM locations were provided to Onterra to aid in the August 2012 AIS survey. Unfortunately, Onterra field crews located more EWM on Kentuck Lake than was likely believed to exist by the-district. In February 2013, with Onterra's guidance, the KLPRD received a Wisconsin Department of Natural Resources (WDNR) Aquatic Invasive Species (AIS) Early Detection and Response (EDR) Grant to cover the costs of a two-year monitoring and herbicide control project on Kentuck Lake. As a result of the EWM findings in 2012, an herbicide treatment strategy targeting 18.6 acres of colonized EWM with liquid or granular 2,4-D at 3.0-4.0 ppm ae was conducted in the spring of 2013. Post treatment surveys conducted in the summer of 2013 indicated the spring treatment was successful in reducing EWM at all targeted locations (Map 1).

2013 Final EWM Treatment Strategy

Site	Conditonal ² Acres	Final Acres	Ave Depth (feet)	Volume (acre-feet)	2,4-D Product	2,4-D PPM ae
A-13	10.0	12.3	7	86.1	Liquid	3.00
B-13	5.8	4.7	4	18.8	Liquid	3.00
C-13	1.5	1.6	4	6.4	Granular	4.00
Total	17.3	18.6		111.3

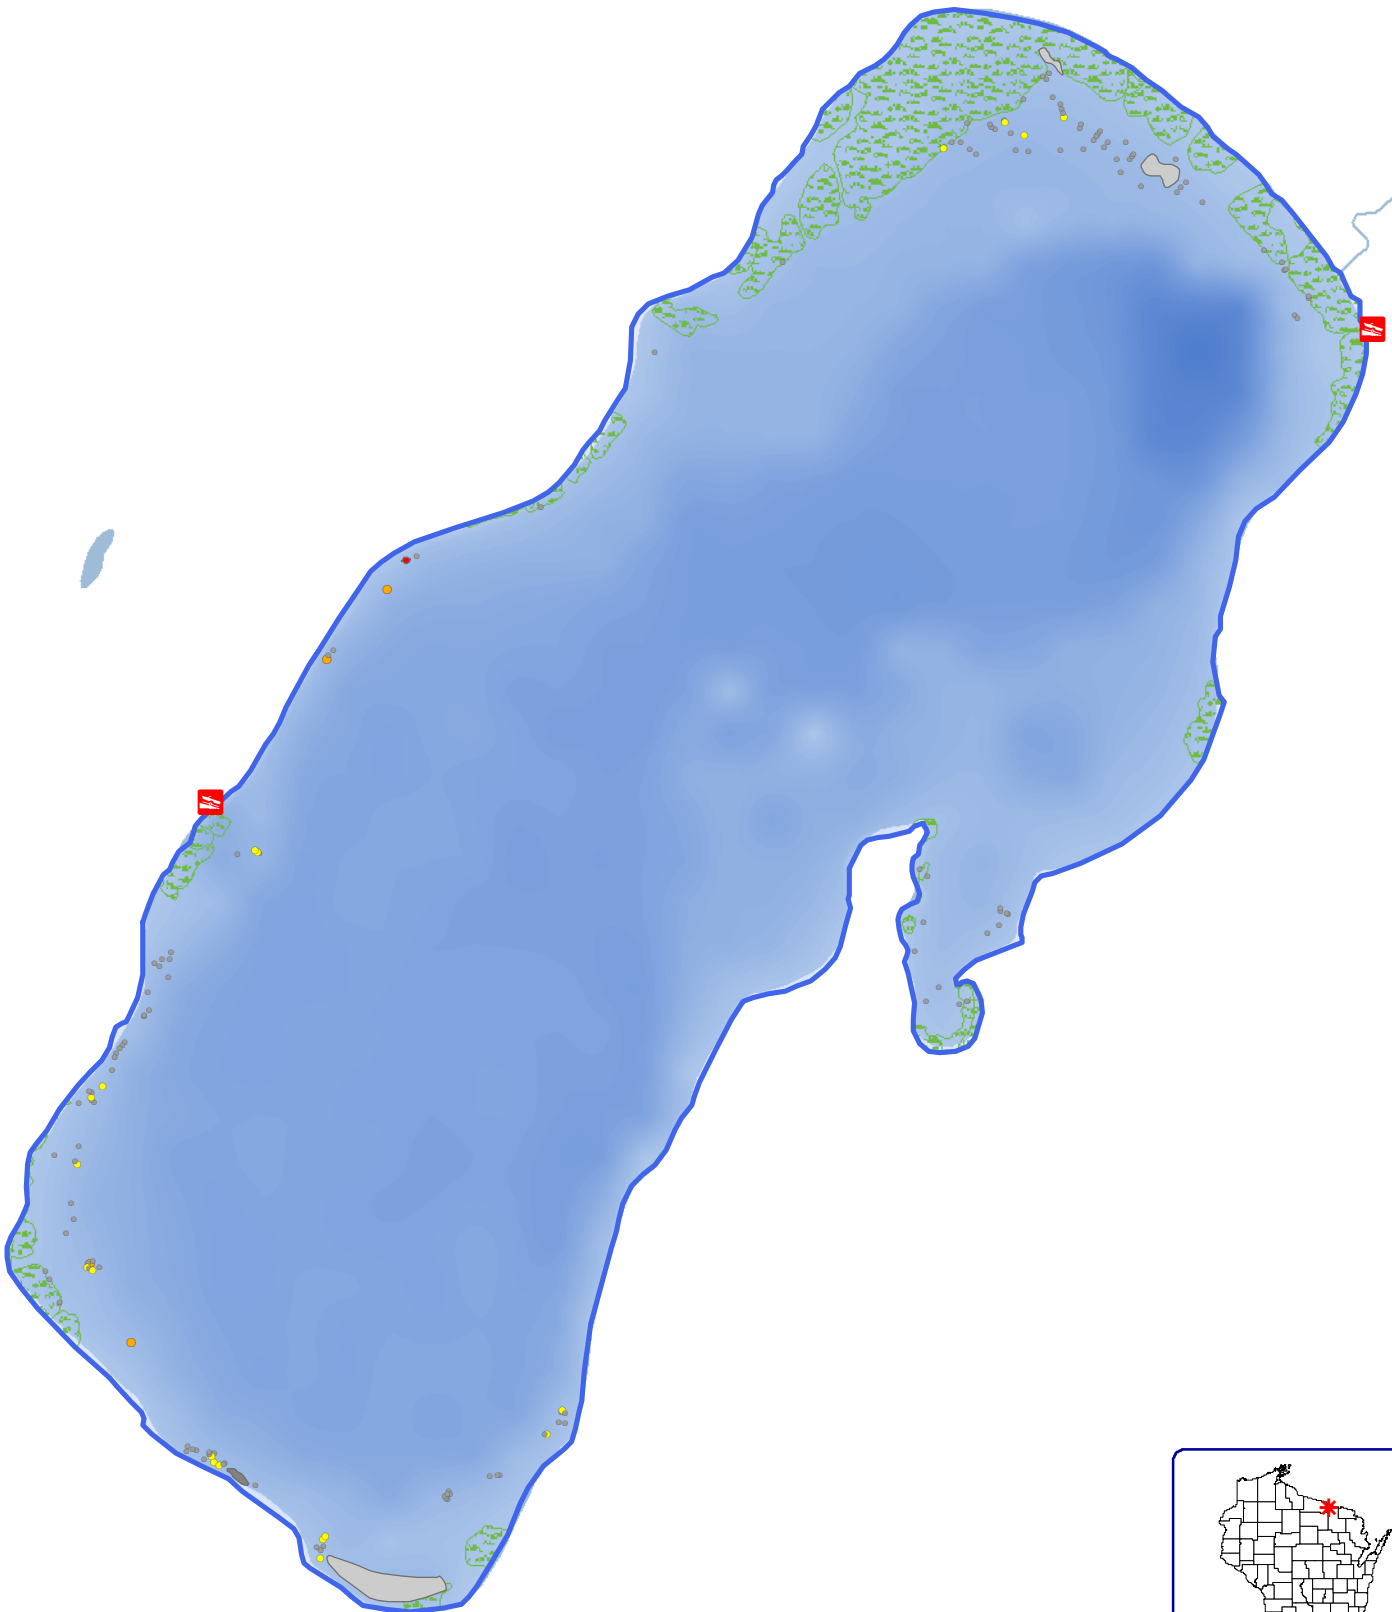
Map 2
Kentuck Lake
 Forest & Vilas Counties, Wisconsin
2014 EWM Locations

On August 26, 2014, Onterra ecologists visited Kentuck Lake to complete the Late-Summer EWM Peak-Biomass Survey and to assess any EWM rebound within the 2013 herbicide treatment areas. This meander-based survey of the lake's littoral zone indicated that the EWM population had expanded somewhat since 2013. Colonies consisting of *highly scattered*, *scattered*, and *surface matted* EWM were found in 2014 along with numerous additional point-based occurrences consisting of *single or few plants*, *clumps of plants*, and *small plant colonies* (Map 2).

From the results of the 2014 survey, it is not believed that Kentuck Lake’s EWM population is at a level which is significantly impacting the lake’s ecology or recreation. While the EWM mapping data indicate that EWM has increased since 2013, it is still at a very low level within the lake with only 3.7 acres containing colonized EWM, the majority of which is *highly scattered*. Because of this, no herbicide control strategy targeting EWM is proposed to occur in Kentuck Lake in 2015. Within a the first draft of Kentuck Lake’s Implementation Plan that was submitted to the WDNR in November 2014, the Implementation Plan outlined an EWM control and monitoring strategy that was developed by Onterra ecologists and KLPRD Planning Committee members. While the management plan has not yet been approved by the WDNR, the plan developed “triggers” or thresholds that once met or exceeded would initiate a potential

EWM control strategy utilizing herbicides. The trigger level would be areas of colonized EWM and encompassing approximately 3.0 acres or greater with the majority of that areas being at a density level of *dominant* or greater. No areas of EWM met or exceeded this threshold in 2014, and thus, no treatment is proposed to occur in 2015.

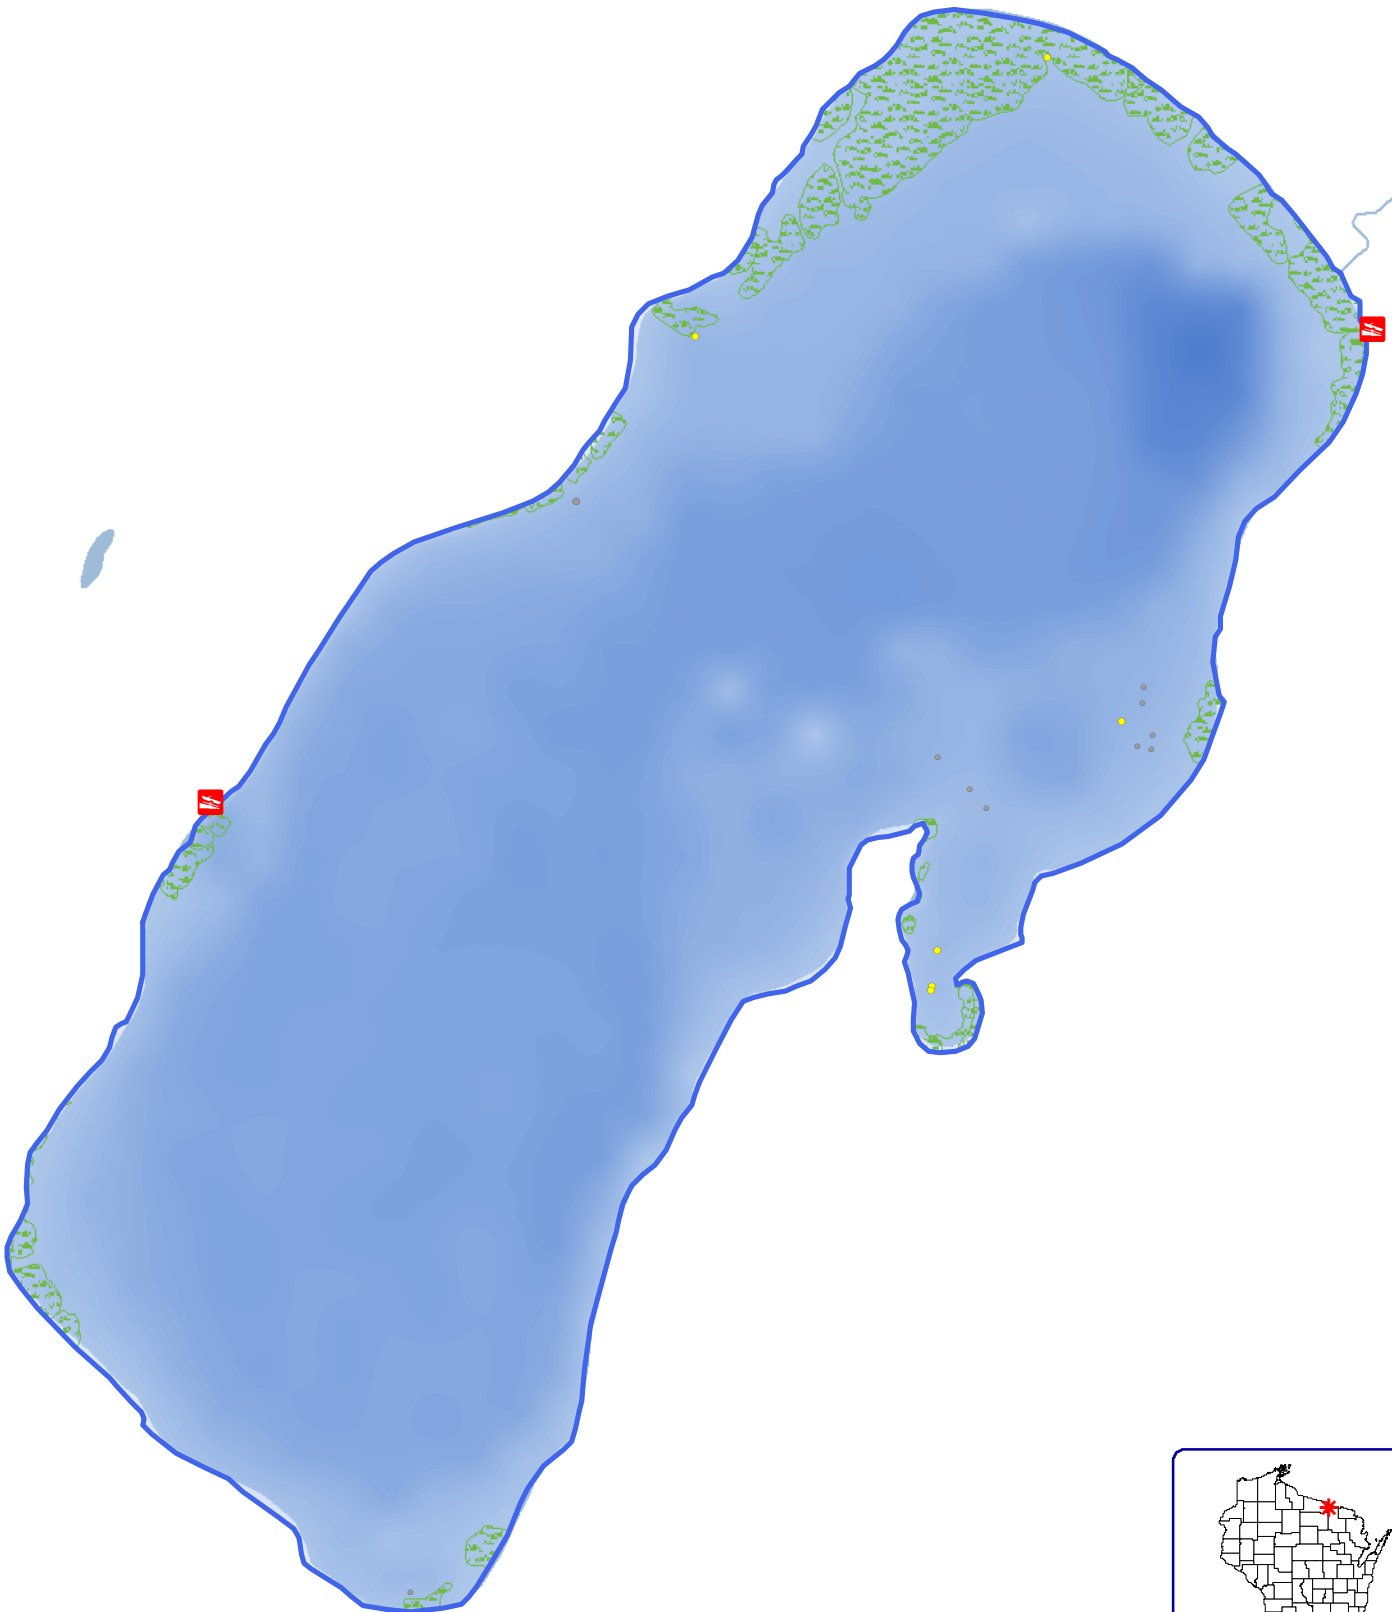
Map 3
Kentuck Lake
 Forest & Vilas Counties, Wisconsin
2013 CLP Locations

An Early-Season AIS Survey was conducted by Onterra ecologists in 2013 with an objective to map the CLP population at its peak growth in Kentuck Lake. A small number of CLP *Single or Few Plants* and *Clumps of Plants* were observed during this survey (Map 3). Particularly in northern Wisconsin, not all established CLP populations become problematic to the lake ecosystem. While the CLP may not be currently causing significant impacts to Kentuck Lake, that may not hold true for other nearby lakes that may inherit CLP that originated in Kentuck Lake from hitch-hiking on transient watercraft. Within Kentuck Lake’s current management planning project, it will be important to develop strategies to continually monitor the CLP population within Kentuck Lake as well as implement strategies to limit its spread to other area waterbodies. The CLP population was not assessed as a part of the 2014 monitoring on Kentuck Lake, but as will be discussed in the next section, a combination of professional- and volunteer-based surveys focused on the CLP population are proposed to occur in 2015 and 2016.
