# Management of Eurasian Watermilfoil (*Myriophyllum spicatum*) using Diver Assisted Suction Harvesting

Anvil Lake, Vilas County, WI

2015 Final Reporting

Many Waters, LLC  
2527 Lake Ottawa Road  
Iron River, MI 49935

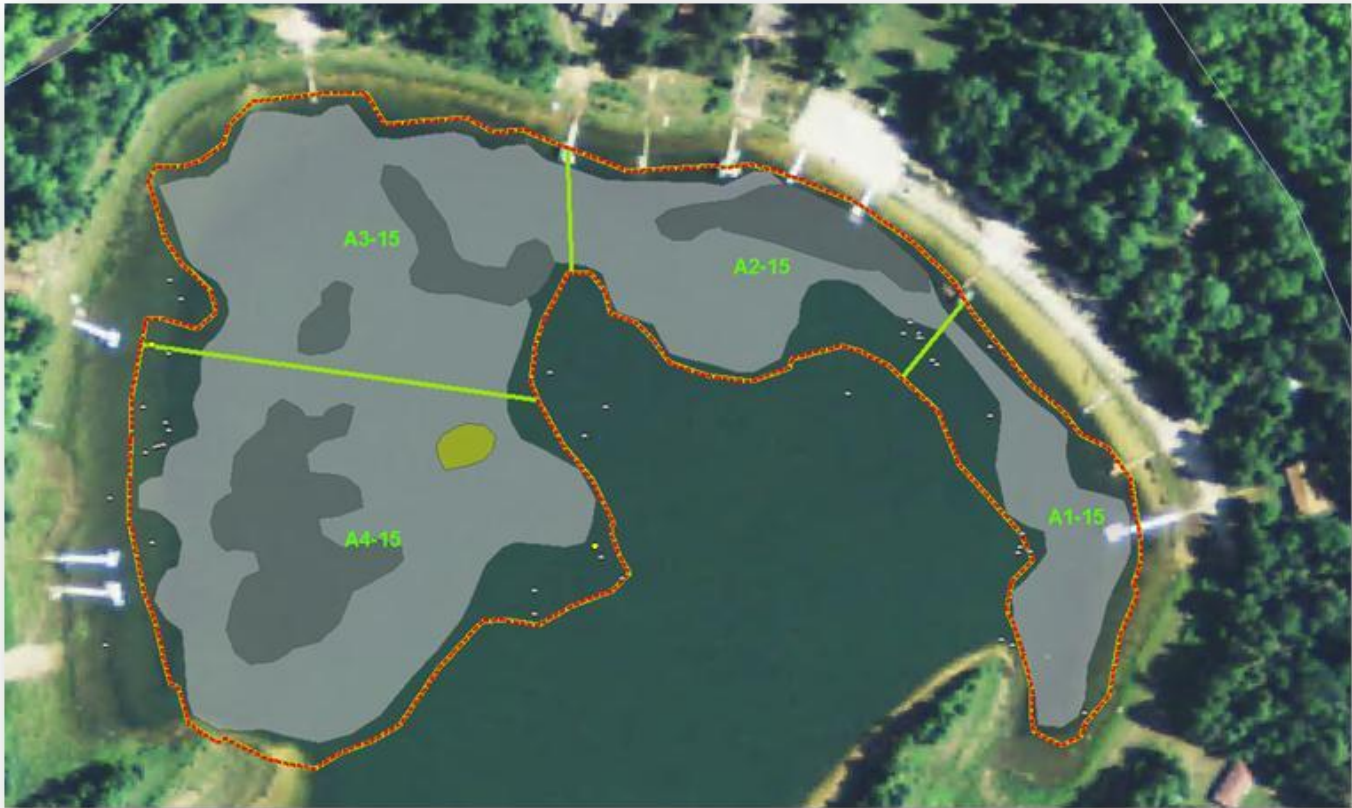
**Figure 2: Overview of Quadrants (Onterra, LLC – 2015)**

Given the extent of total DASH area, the strategy as discussed with Onterra, LLC was to work keep track of efforts per quadrants setup across the north bay. All work was completed in the A4-15 quadrant.
