# Aquatic Plant Management LLC

## Upper Kaubashine Lake EWM Removal Report Summer 2015

# Upper Kaubashine Lake EWM Removal Summary 2015

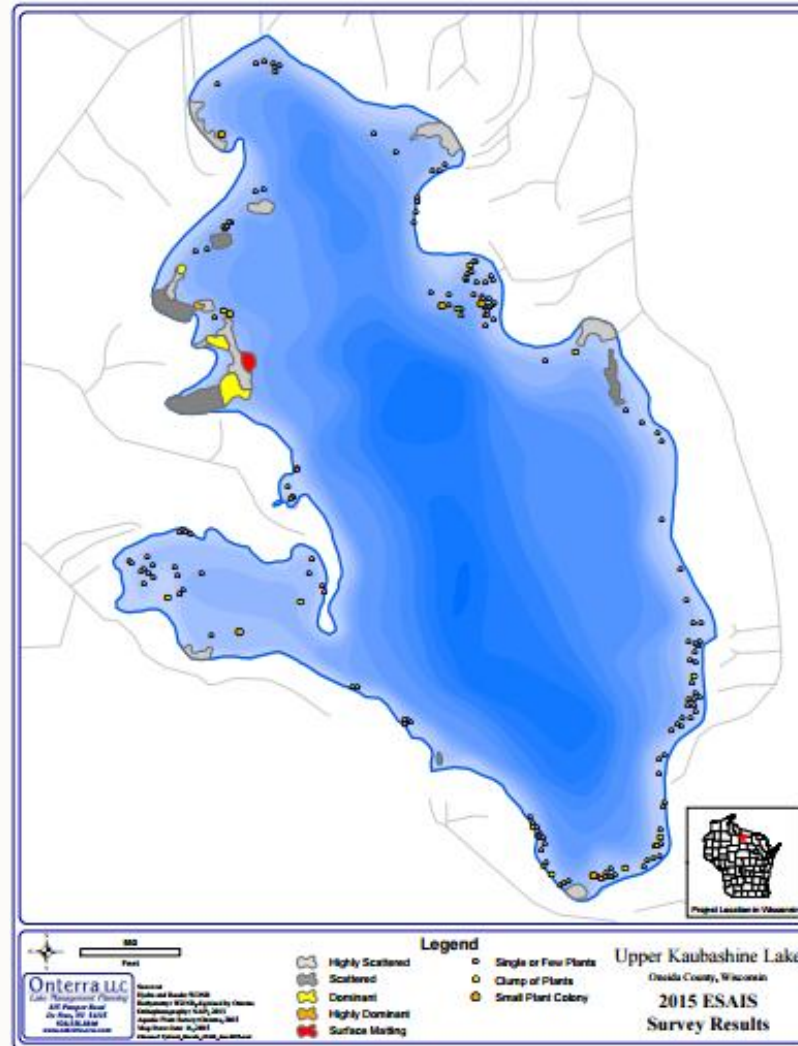
# Map Created by Onterra LLC

**Dive Conditions:** Conditions on 6/27/15 were excellent, with little cloud cover, light winds and abundant sunshine. Conditions on 6/28/15 were less than desirable with overcast sky, mild winds, and the occasional rain shower. Incoming T-storms forced our crew off the water after about three hours of diving. Conditions on 7/30/15, 8/4/15, and 8/12/15 were all excellent, with clear skies, light to mild winds and abundant sunshine. Water clarity on Upper Kaubashine is extremely high, with underwater visibility of 25+ feet. The substrate on U. Kaubashine typically varied from sandy/organic to sandy/rocky. In some of the rockier areas, complete removal of the root ball was hampered by the dense substrate, but the majority was able to be removed. For the first three days of hand-harvesting activities, the EWM was in healthy condition, with stems at their peak tensile strength. However, on 8/4/15 and 8/12/15 the plants were noticeably more brittle and prone to fragmentation. Of the areas marked by Onterra as SCATTERED, site A-15 and F-15 had the densest growth of individual plants. The majority of the larger EWM clumps and colonies encountered were found from the North side of A-15 to the North side of D-15.

**Recommendations:** During the summer of 2016, we will be implementing new diving strategies that will allow us to target some of the deeper plants found on the lake that are near the limits of a diver using a snorkel. By our standards, the EWM infestation on Upper Kaubashine is still manageable, and with continued monitoring and an annual hand-harvesting effort, can be kept in check.
