**Draft 2015 Purple Loosestrife & Eurasian Watermilfoil Inventory
For the
Oconto Falls Upper Hydroelectric Project
Oconto County, Wisconsin
FERC Project #2523 License Article 407**

**Prepared For
Northeast Wisconsin Hydro, LLC**

September 1, 2015

**Prepared By
Eagle Creek Renewable Energy
116 State Street
Neshkoro, Wisconsin 54960**

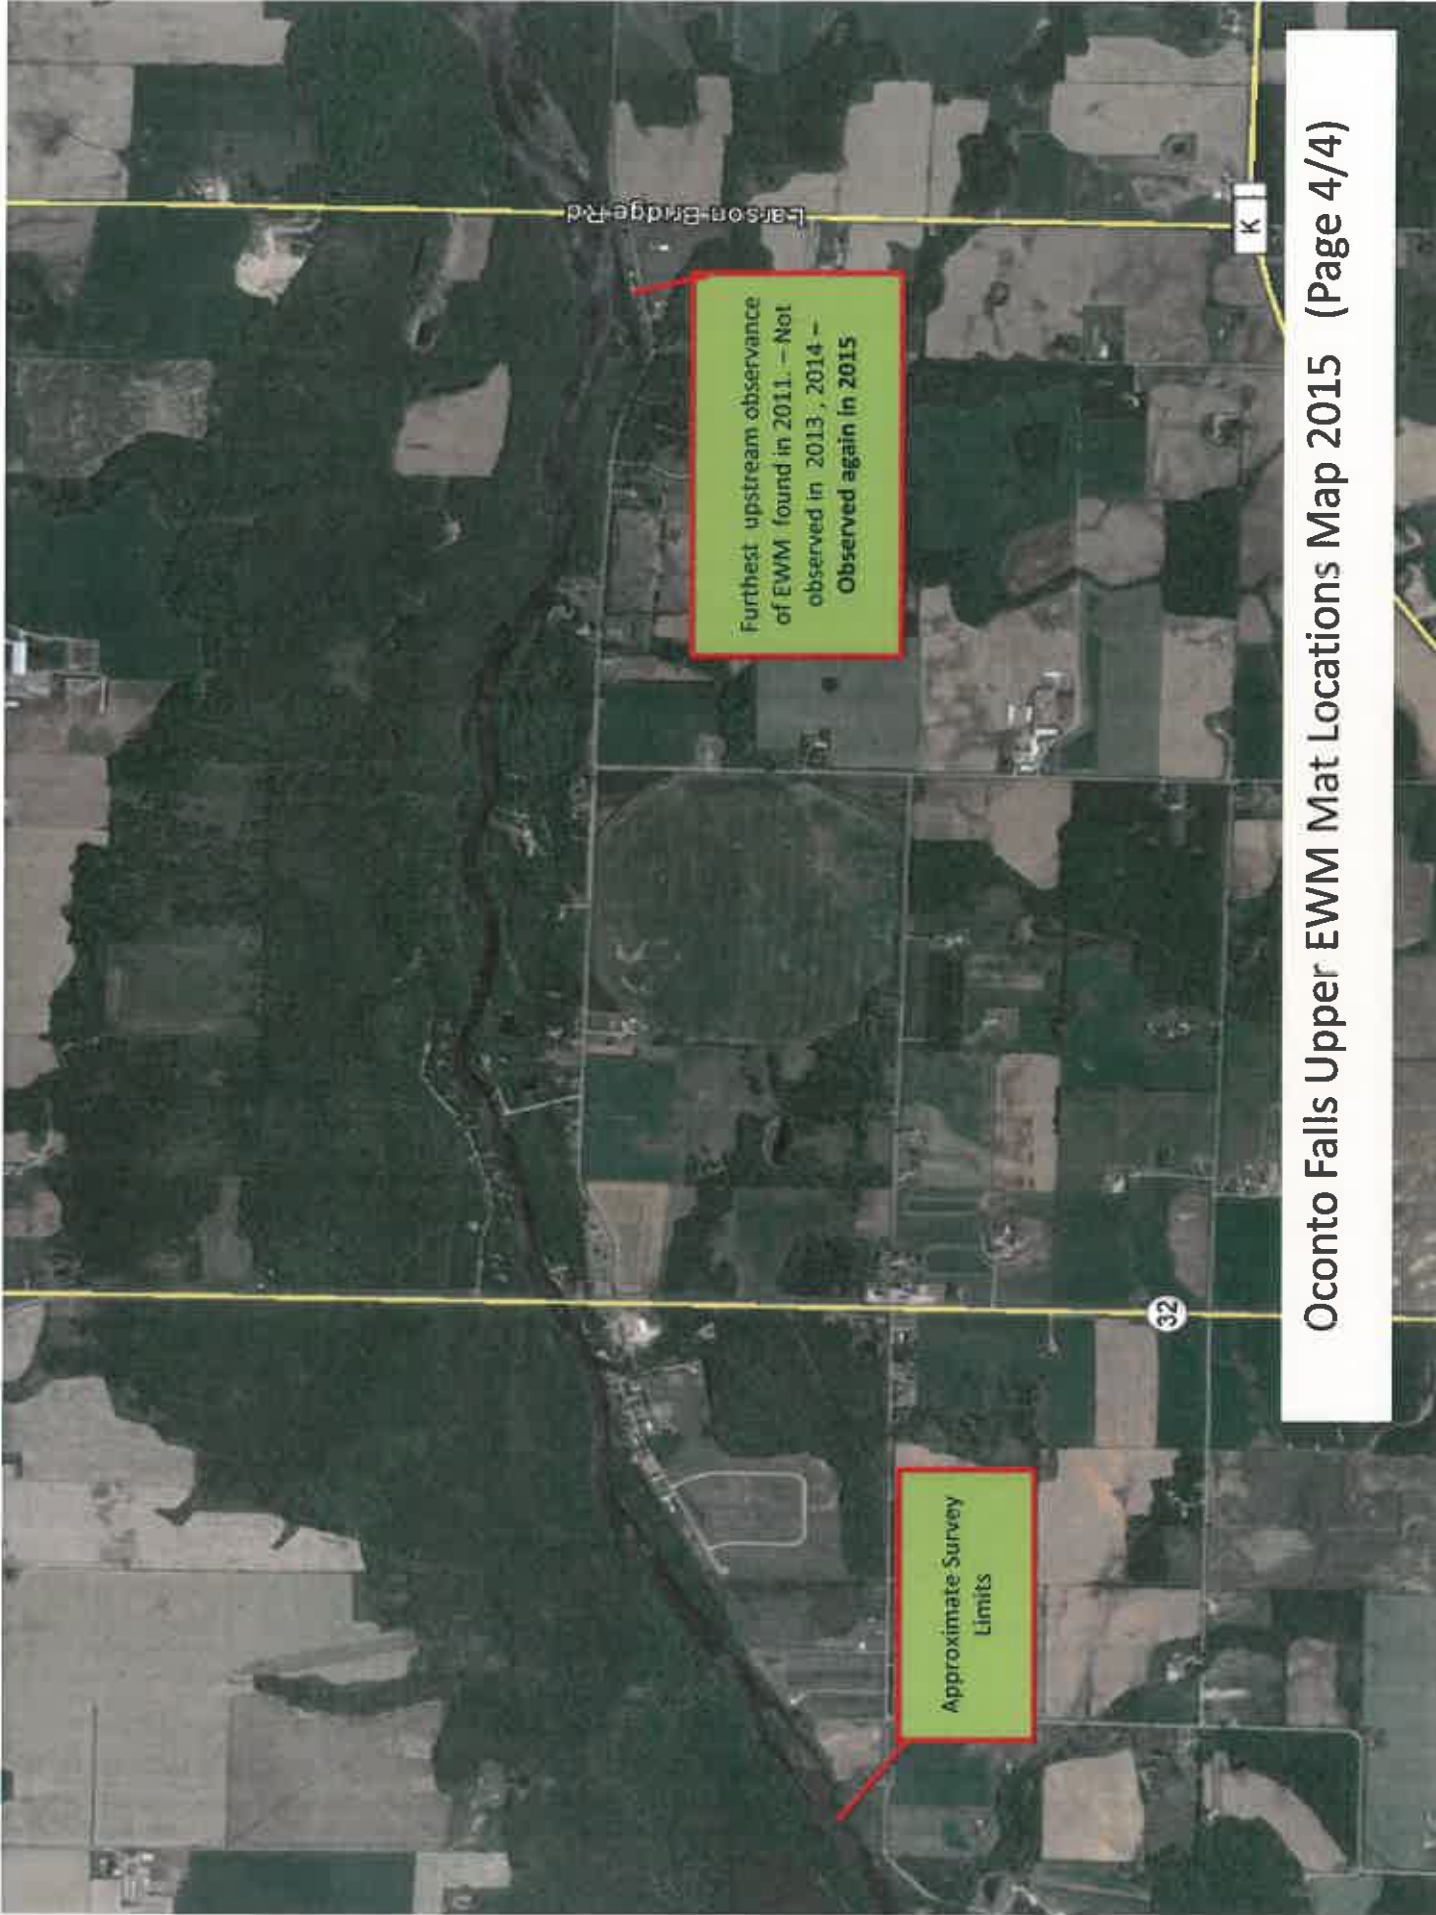
Oconto Falls Upper EWM Mat Locations Map 2015 (Page 4/4)

Each year during the survey the furthest upstream infestation of EWM is noted in the annual report. Since the baseline was established in 2000, EWM has made a constant progression upstream. In 2015, the furthest upstream infestation that could be located was just upstream of Larson Bridge Road.

Furthest upstream observance of EWM found in 2011. – Not observed in 2013, 2014 – Observed again in 2015

Approximate Survey Limits
