2015 Final Control Strategy

Professional Hand-Harvest

Lost Lake
 Vilas County, Wisconsin

**May 2015 EWM Locations
 & 2015 Final DASH Areas**

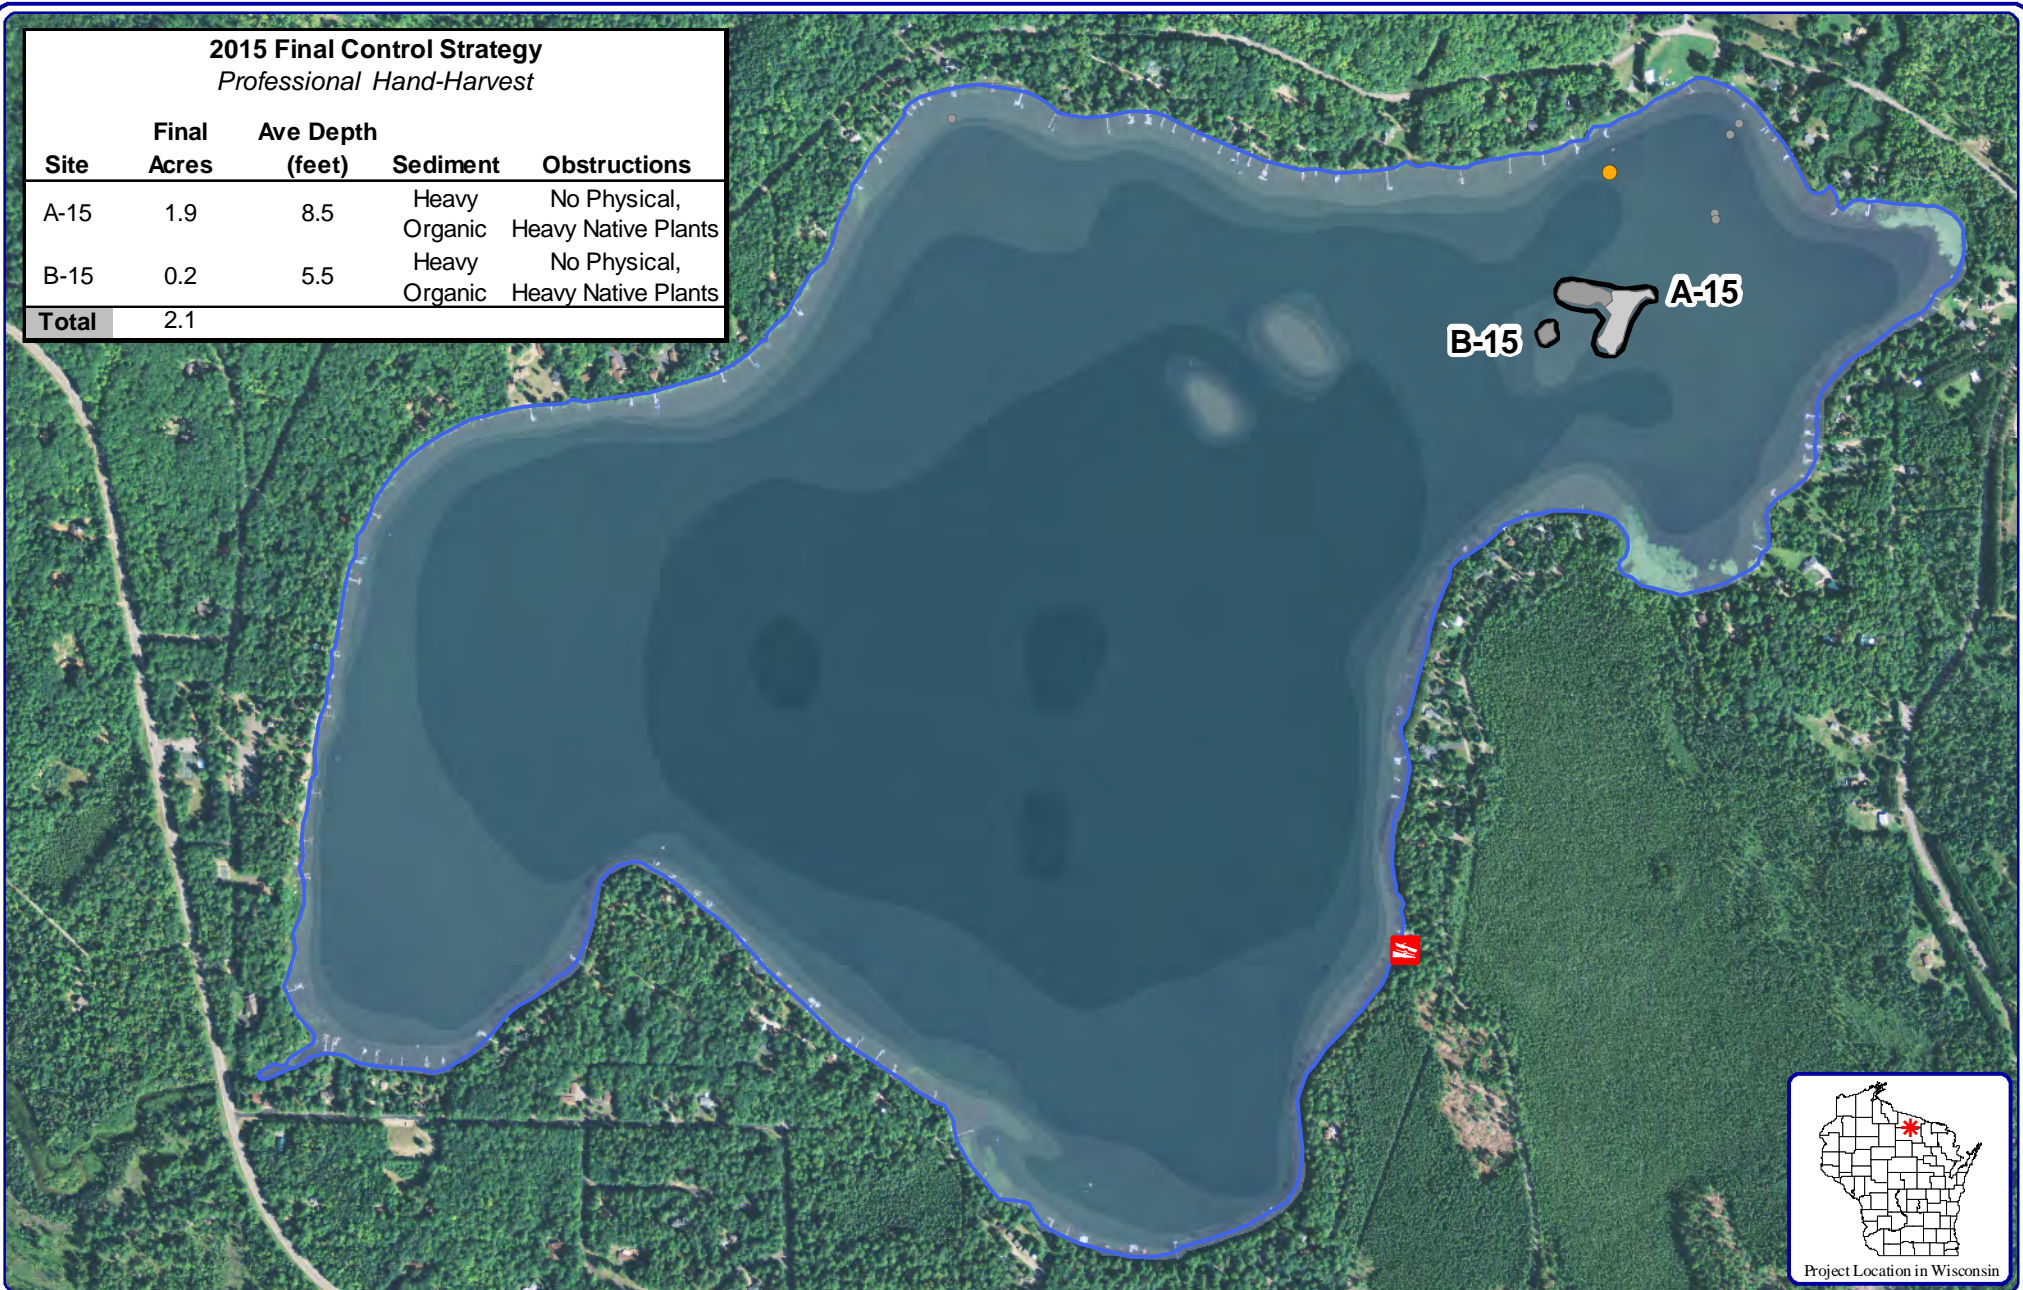
Site	Final Acres	Ave Depth (feet)	Sediment	Obstructions
A-15	1.9	8.5	Heavy Organic	No Physical, Heavy Native Plants
B-15	0.2	5.5	Heavy Organic	No Physical, Heavy Native Plants
Total	2.1

- Highly Scattered
- Scattered
- Dominant (none found)
- Highly Dominant (none found)
- Surface Matting (none found)
- Single or Few Plants
- Clump of Plants
- Small Plant Colony
- Final 2015 Hand Harvest Area
