Kewaunee River, Kewaunee Baseline Monitoring Report

(MWBC 90700)

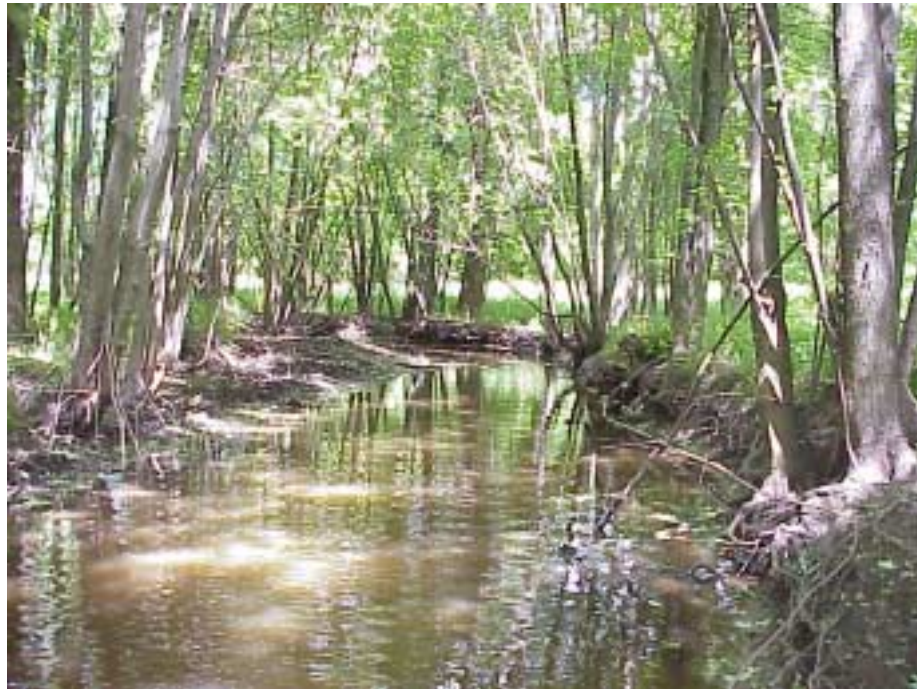
Figure 2. Looking upstream on the Kewaunee River from River Road, June 6, 2000.

The stream in this section ran through a wooded area and the banks of the river have been heavily eroded (Figure 2). This section of the river contained only runs and pools with 7 bends. The average width of the river in this stretch was 5.4 meters. There was one large logjam due to a downed tree near the end of the station (Figure 3).

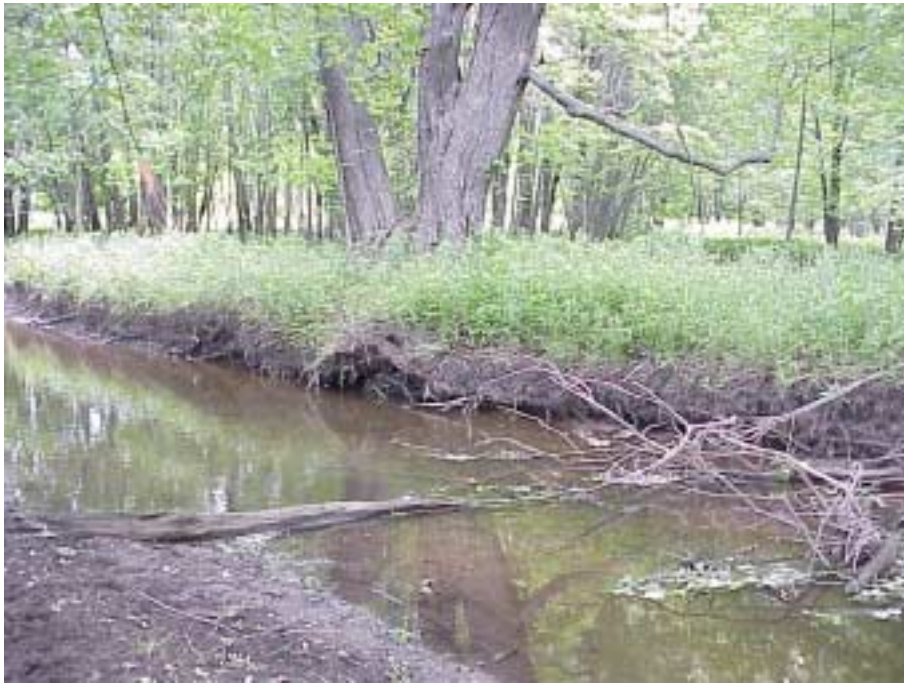
Figure 3. Looking downstream on the Kewaunee River from the end of the study section, June 6, 2000. Note the beginning of a tangle of trees found just above this section.

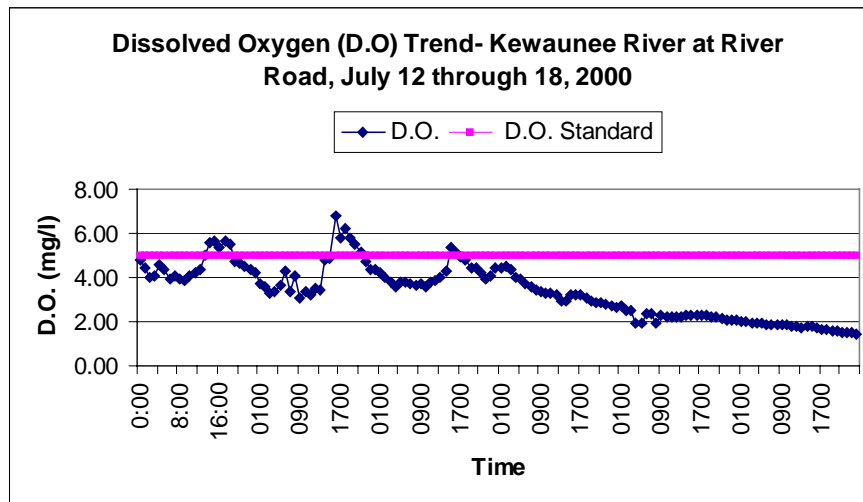
The dissolved oxygen data indicates that for much on the period of July 12 through July 18, D.O. levels were below the State standard of 5 mg/l (Figure 4). Low D.O. levels such as those recorded at this site certainly indicates the fish community at this site will be limited to those species that are tolerant of low levels of D.O.

Figure 4. Dissolved oxygen readings on the Kewaunee River at River Road, July 12 through July 18, 2001. The dissolved oxygen standard for this section of river is 5.0 mg/l.

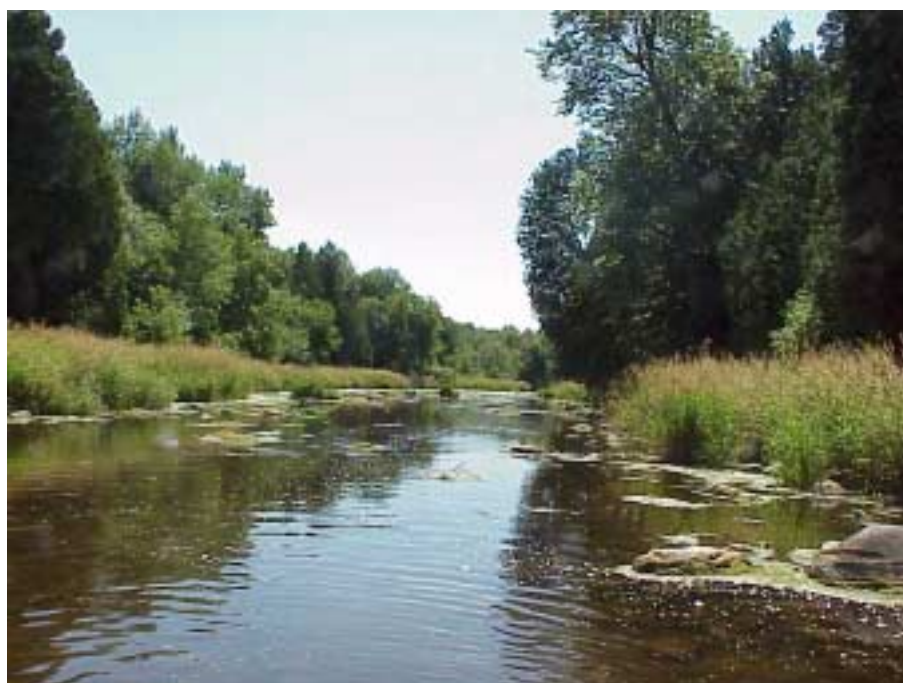
The Clyde’s Hill station was located at Lat. N44°31.056, Long. W087°35.273 and continued 595 meters upstream to Lat. N44°31.331, Long. W087°35.472 (Figures 5 and 6).

Figure 5. Looking upstream at the start of the Clyde’s Hill station. Note the abundant filamentous algae found on the boulders of this section.

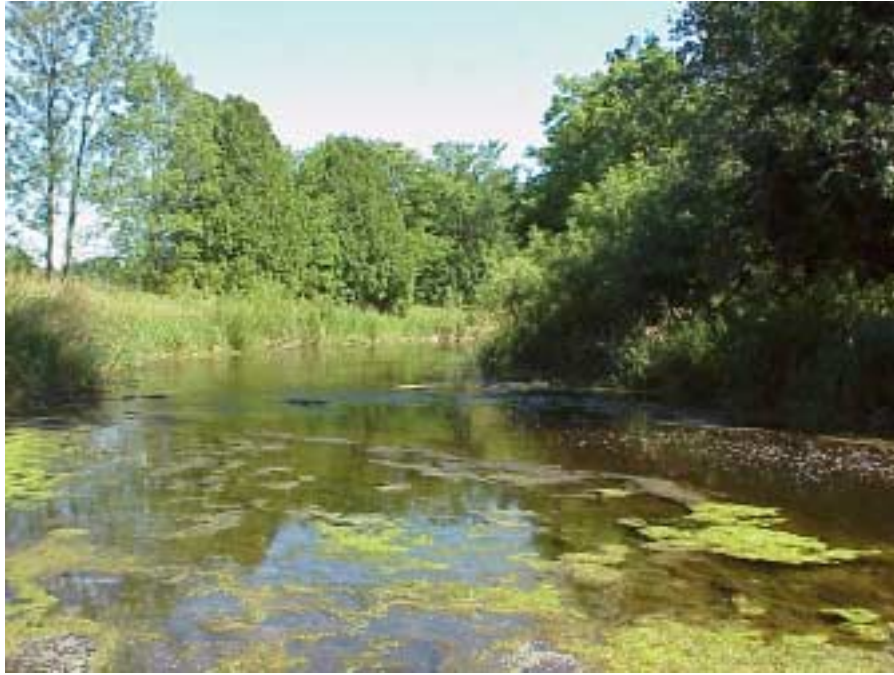
Figure 6. Looking downstream from the end of the Clyde's Hill station. Abundant filamentous algae was found at this station.

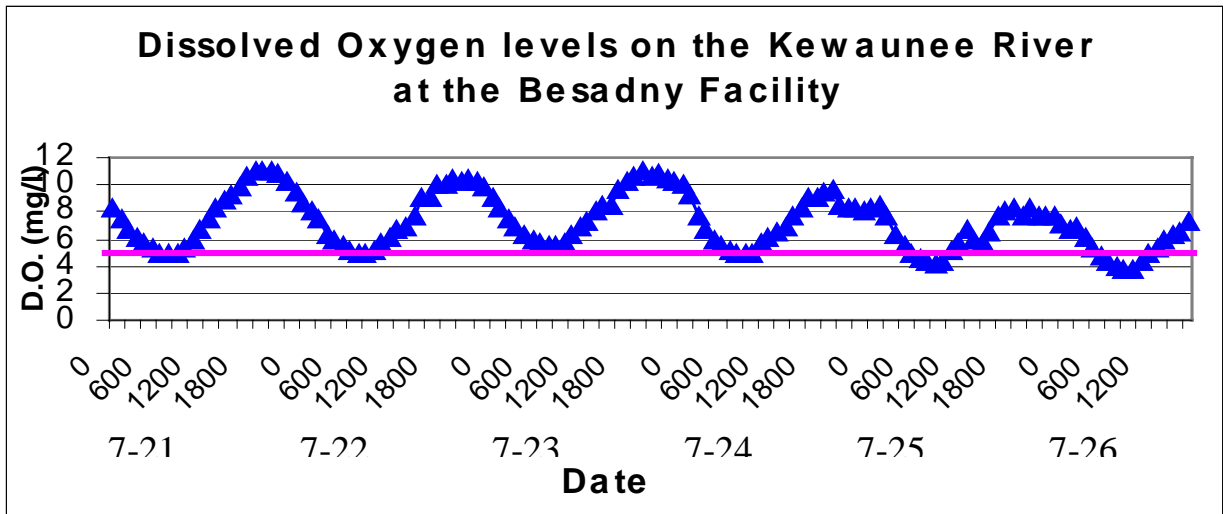
The dissolved oxygen data indicates that for much on the period of July 21 through July 26, D.O. levels were above the State standard of 5 mg/l (Figure 7). Daily D.O. sags are expected because of photosynthesis/respiration cycles, but when the D.O. drops below 5 mg/l at the Besadny Fisheries Facility, an important link in the DNR Lake Michigan fishery program there is a great amount of concern. Additionally, of great concern was that the trend was worsening with D.O. peaks declining in level and the amount of time below the D.O. standard increasing.

Figure 7. Dissolved oxygen levels measured on the Kewaunee River July 21 through July 26 at the Besadny Fisheries Facility. The State standard for dissolved Oxygen for this river section is shown by the horizontal line at 5 mg/l D.O.

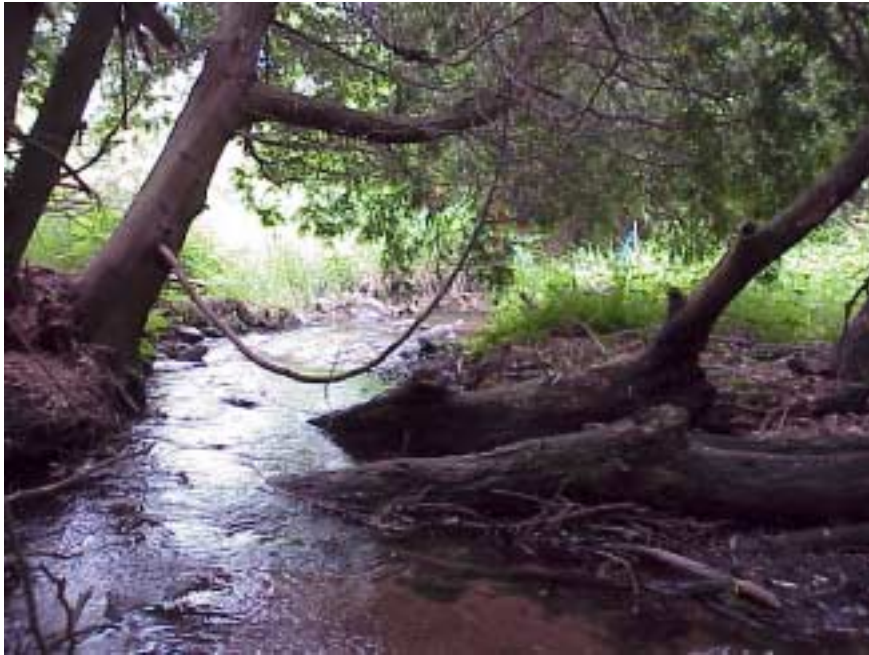
Figure 8. The start of the Little Scarboro study section. The grassy area in the top of the picture was one of the few open spots in this river section.

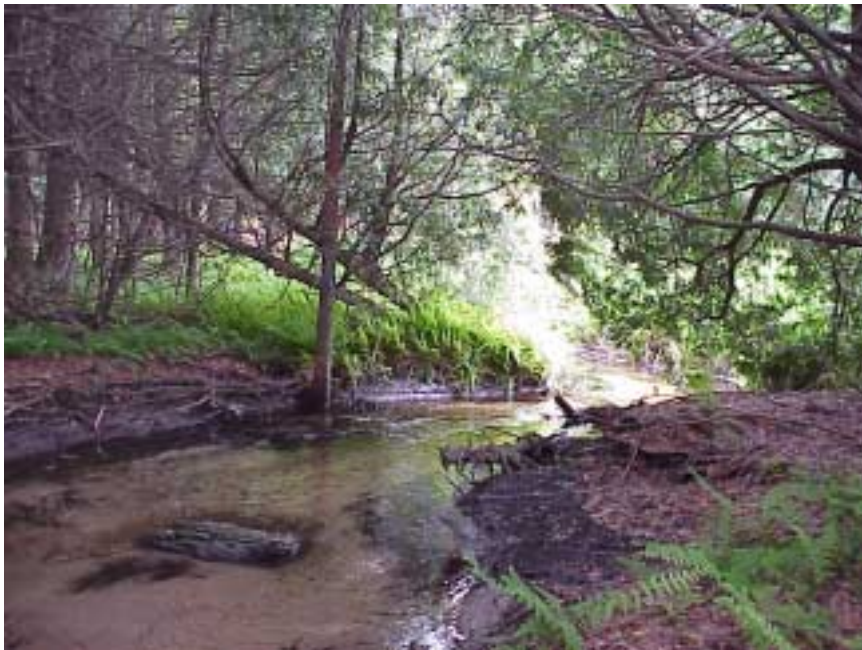
Figure 9. Looking downstream from the end of the study section. Note the sand bottom and the lack of vegetation on the banks.

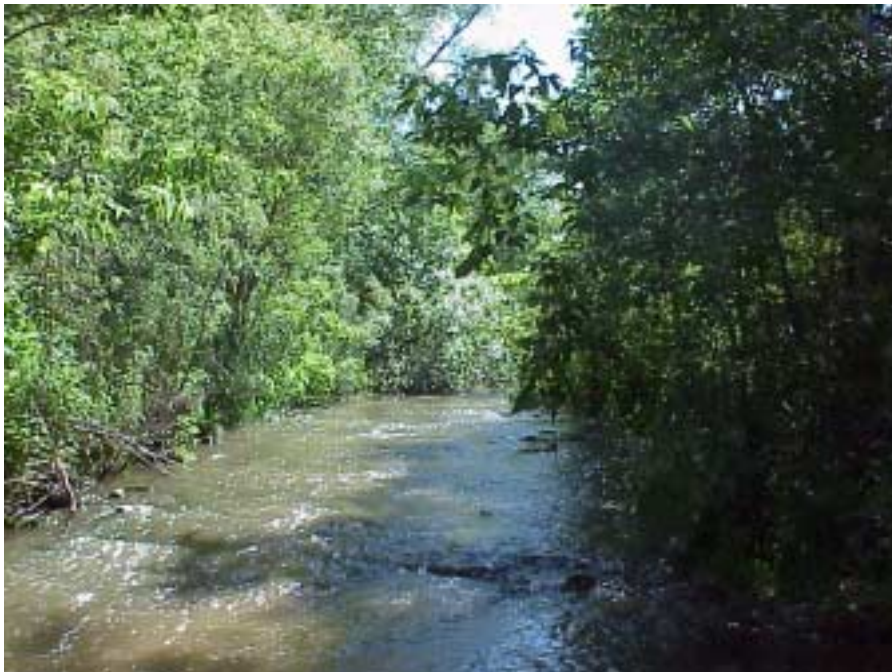
The study section was 147 meters long and was located downstream of County A (start Lat. N44°31.220, Long. W087°38.906, end Lat. N44°31.147, Long W087°38.974). The bottom of the stream was almost entirely bedrock with a few stretches containing some cobble (Figures 10 and 11).

Figure 10. Looking upstream at the start of the Scarboro Creek station.

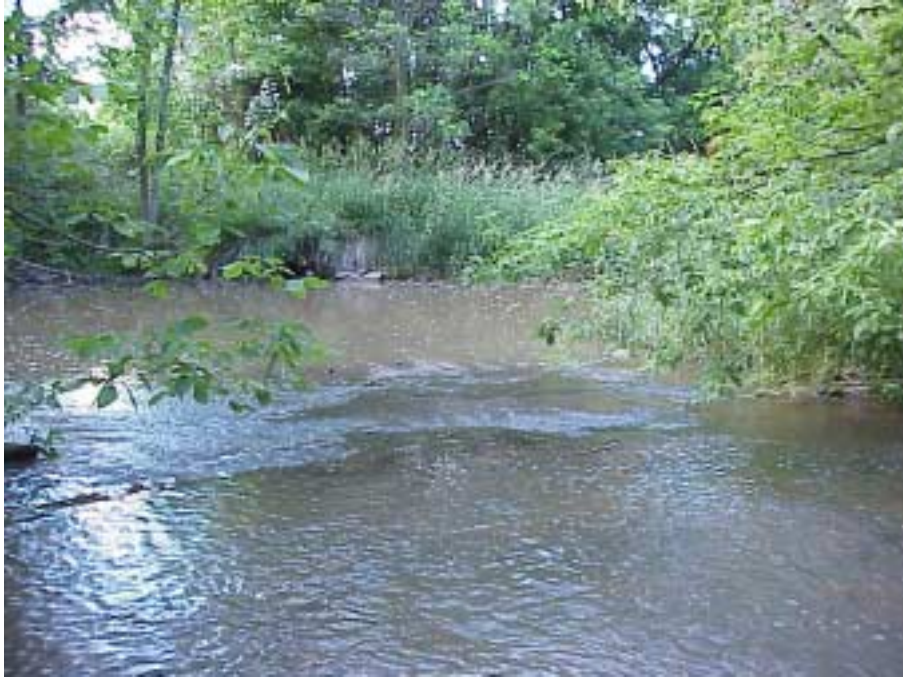
Figure 11. Looking downstream at the end of the study section. A large pool and open canopy dominated this location.

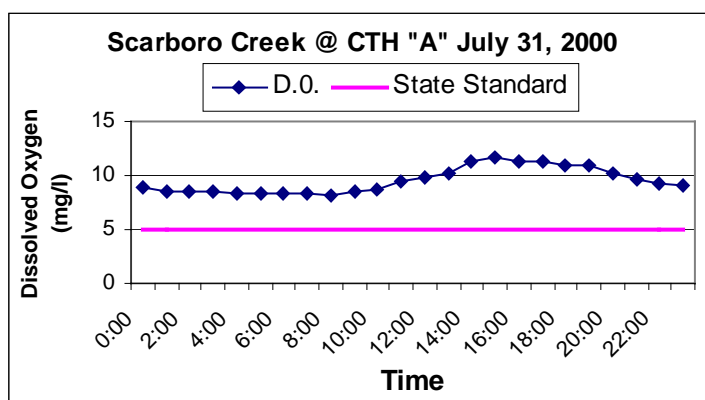
Dissolved oxygen readings taken at one hour intervals on July 31 from Scarboro Creek over a 24 hour period were typical of other readings from this site between July 26 through August 2, 2000 (Figure 12). There were no dissolved oxygen readings from this site below 5 mg/l, the state standard, during the study.

Figure 12. Dissolved oxygen levels measured on Scarboro Creek, July 31, 2000.

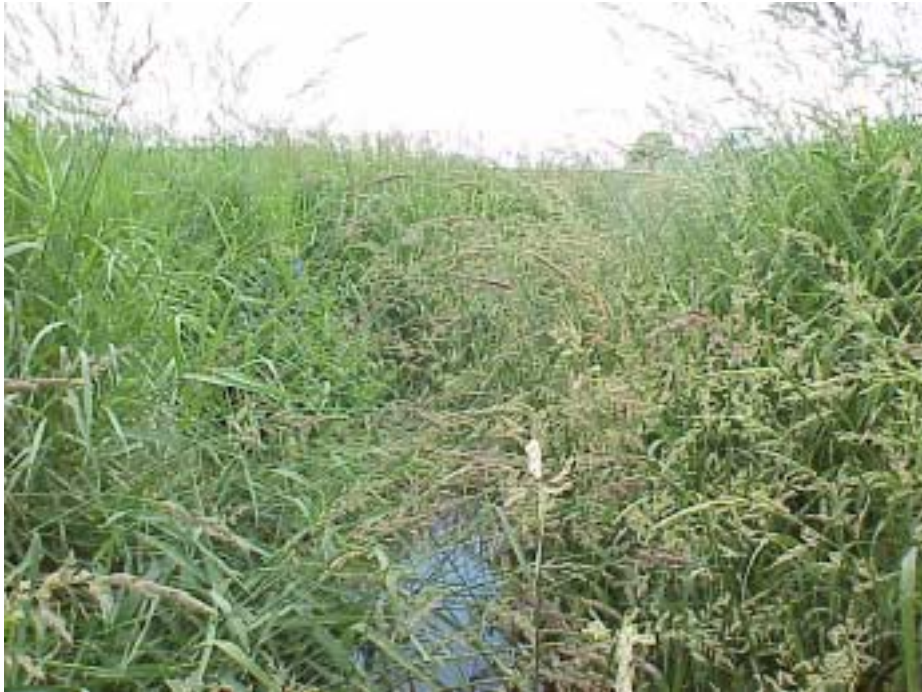
Figure 13. Looking upstream at the start of the study section. Note the small size of the stream and the abundance of reed canary grass. Looking downstream at the end of the study section was similar in stream size and vegetation cover.

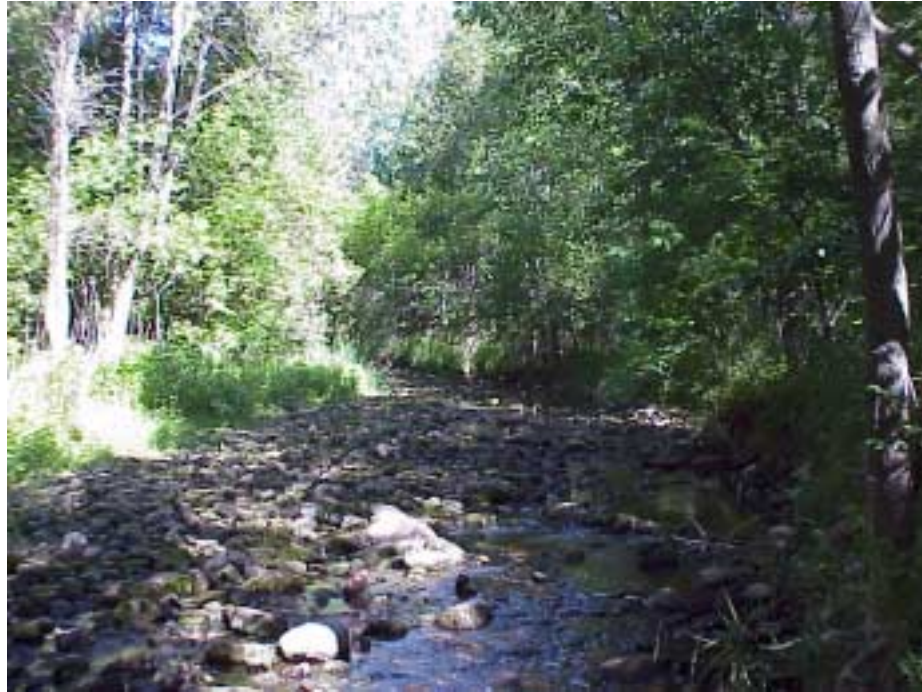
Figure 14. Looking upstream at the start of the study section on School Creek. Low water had exposed the cobble bottom creating pools within the stream thread.

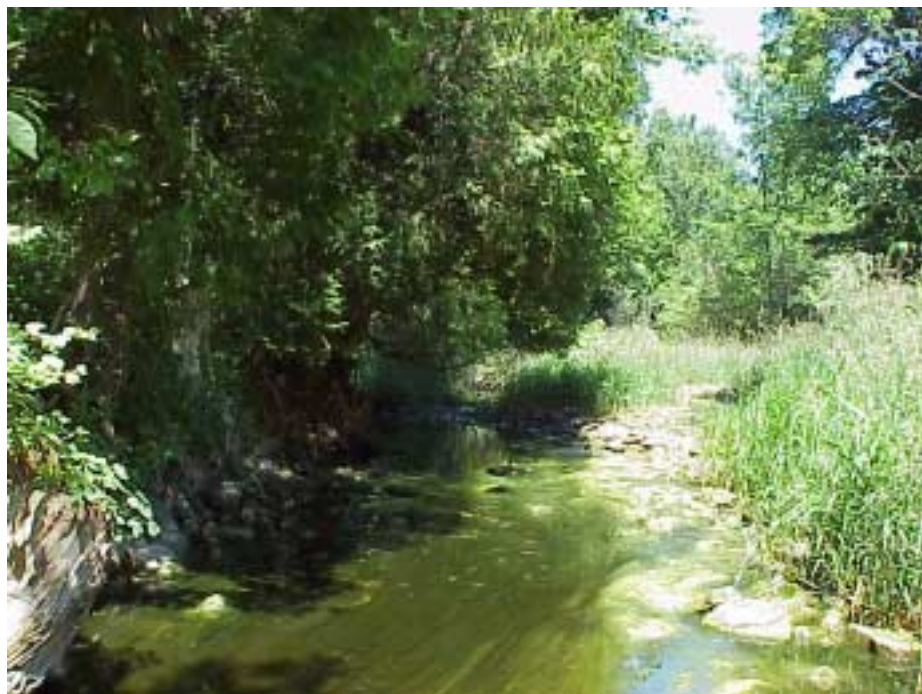
Figure 15. Looking upstream of the study section on School Creek. Note the heavy growth of filamentous algae at this location.

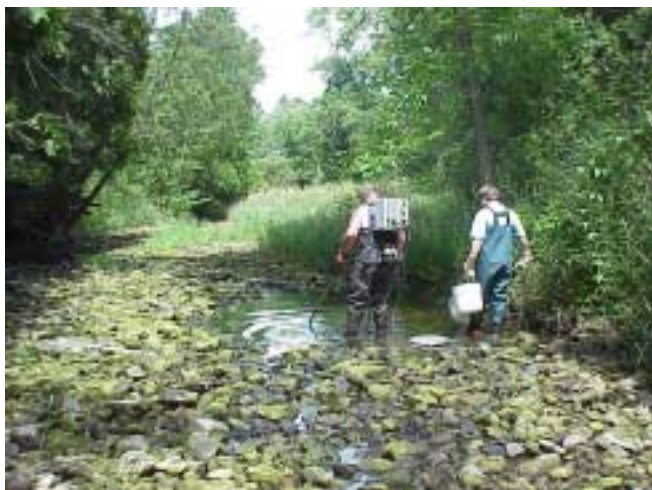
Low water created many isolated small pools that made electroshocking difficult (Figure 16). Abundant filamentous algae were observed in this stream that also made seeing shocked fish difficult reducing collection efficiency.

Figure 16. Electrofishing in a small pool created by low water on School Creek.

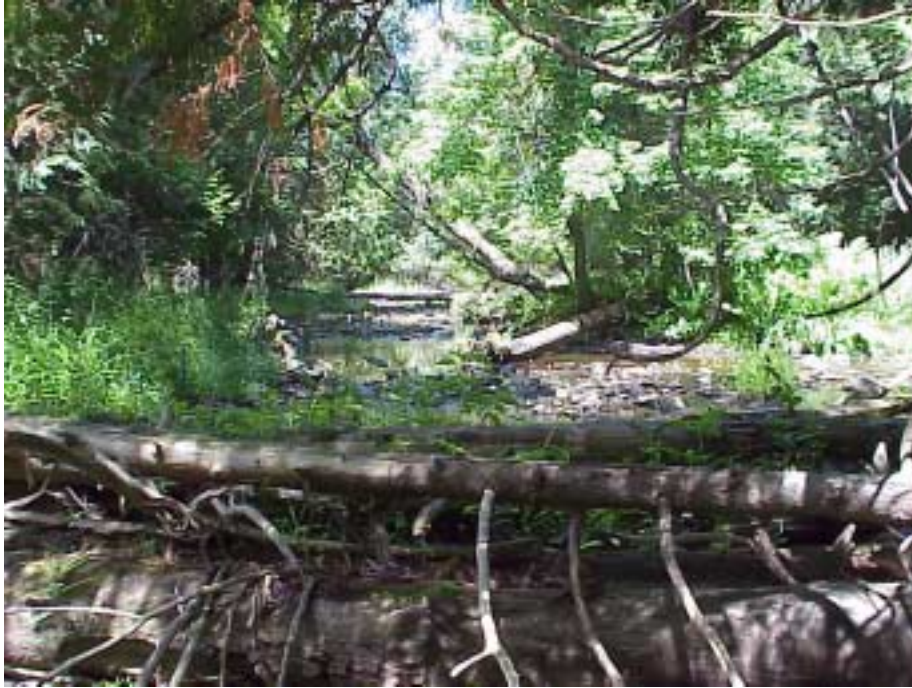
Figure 18. Looking upstream at the start of the study section. Downed wood and cobble are evident in the low flow conditions of the river.

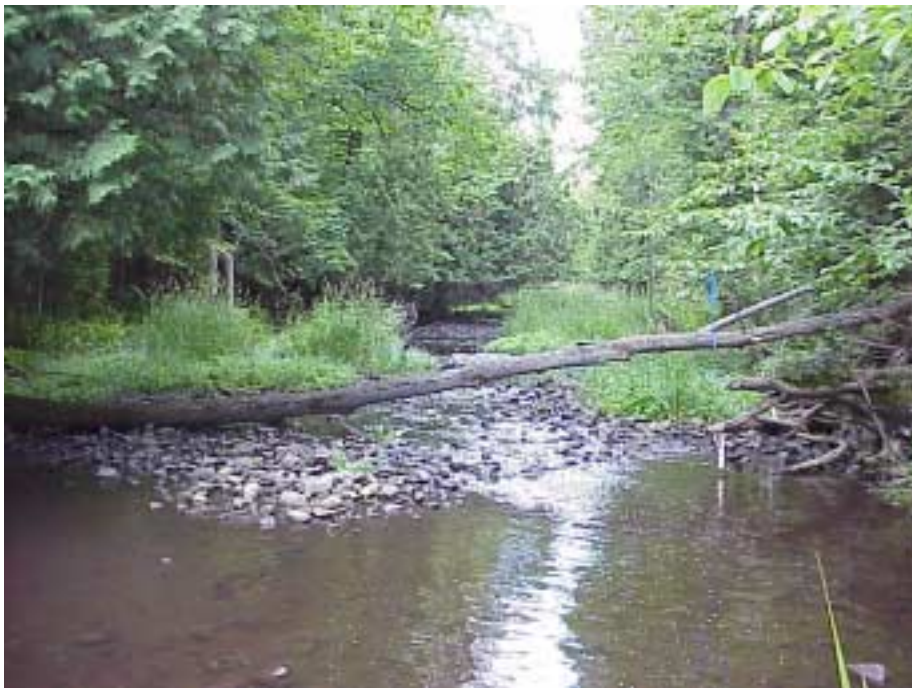
Figure 19. Looking upstream at a riffle that marked the end of the study section on Casco Creek.
