**An Aquatic Vegetation Survey of
Marshall Lake**
Vilas County, Wisconsin
January 2011

Created by: Brenton Butterfield, Tim Hoyman, & Eddie Heath
Onterra, LLC
De Pere, WI

Funded by: Town of Conover
Wisconsin Department of Natural Resources
(SPL-228-10)

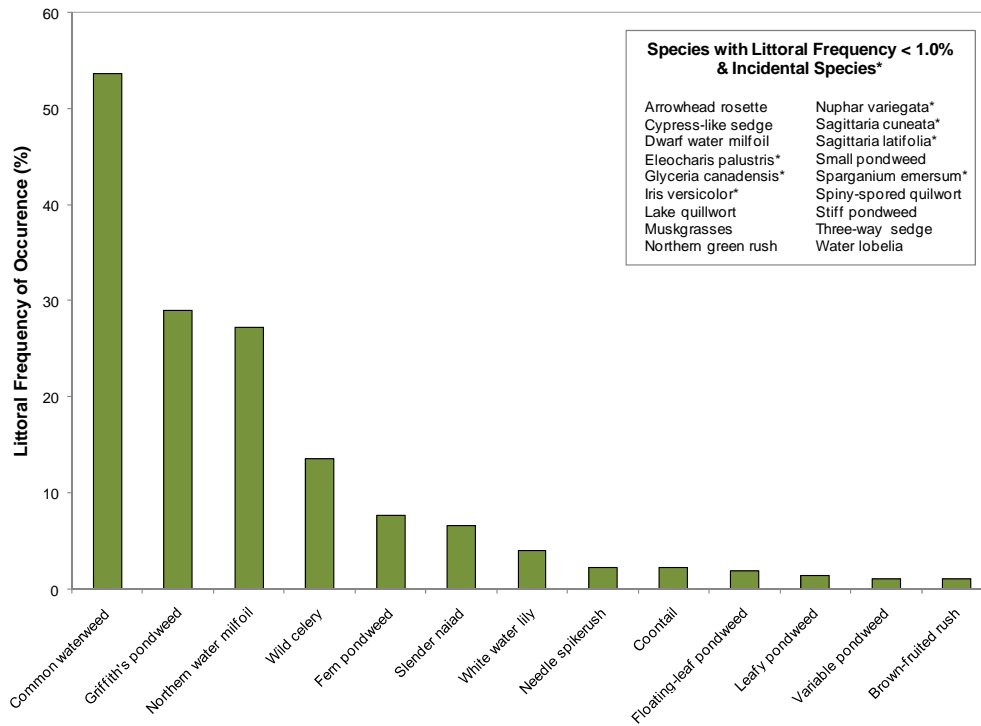
Figure 4. Marshall Lake aquatic plant littoral occurrence analysis. Created using data from July 2010 survey.

Figure 4 shows that of the 31 species located in Marshall Lake, the three most frequently encountered species were common waterweed, Griffith's pondweed, and northern water milfoil. Common waterweed, as its name suggests, is widespread in waterbodies throughout North America, and can often grow to densities that hamper navigation and recreational activities. Because it has the ability to attain essential nutrients directly from the water, common waterweed does not produce extensive root systems making it susceptible to uprooting by wave action and water movement. When this occurs, uprooted plants float and aggregate at the water's surface where they continue to grow and form dense mats. If they completely detach from the bottom, wind and water currents can carry these mats to shore.

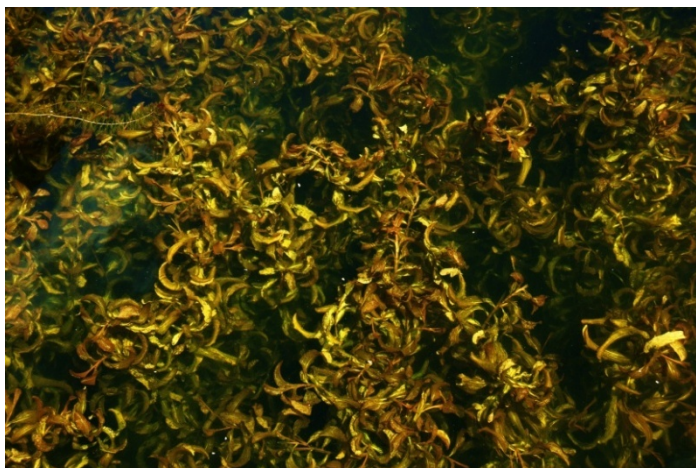
Photo 1. Griffith's pondweed (*Potamogeton x griffithii*) colony on Marshall Lake. Taken during July 2010 survey.

The second-most common plant in Marshall Lake is Griffith's pondweed. Griffith's pondweed is a hybrid between two high-quality native species: alpine pondweed (*Potamogeton alpinus*) and white-stem pondweed (*Potamogeton praelongus*). Hybridization within the pondweed genus is believed to be relatively common, and the hybrid pondweed in Marshall Lake possesses morphological attributes of both parental species (Photo 1). No individuals of either of the parental species were located within the lake, meaning this plant entered Marshall Lake as a hybrid or is a relic from a time when both parental species existed in the lake. Large, dense colonies of this plant were observed growing at or near the water surface. The data show that this plant was most abundant in shallower waters around the lake, primarily between 4 and 8 feet (Figure 5b), almost forming a ring around the lake.

However, navigation was more difficult in shallower areas near-shore and in the southern portion of the lake. These areas, mainly between 4 and 8 feet, were dominated by dense colonies of Griffith's pondweed. It appears that this pondweed is the primary cause of the conditions that are concerning lake stakeholders. The large colonies of this plant have not been observed by Onterra ecologists before, and little (if any) information is known on the ecology of hybridized pondweeds in terms of how they interact with the rest of the plant community.

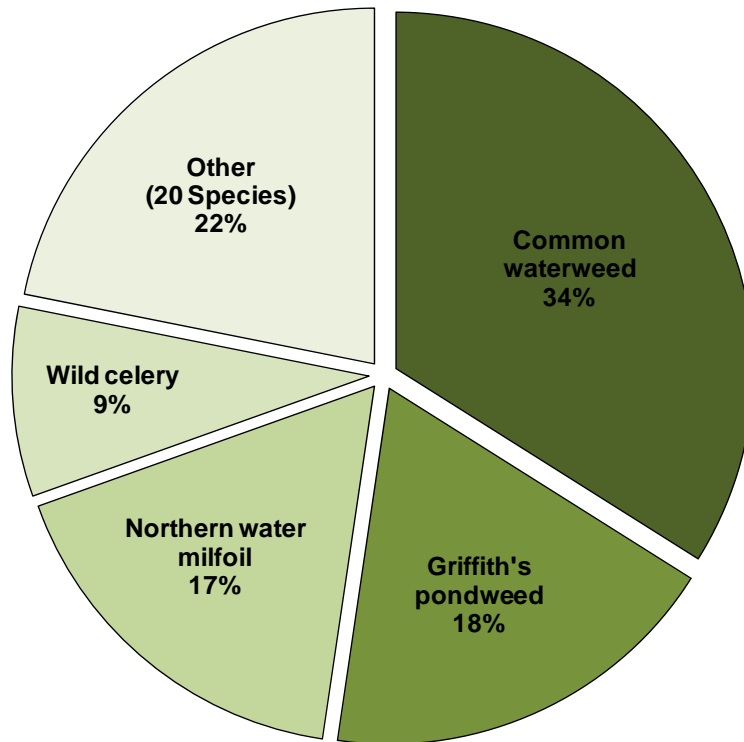
Figure 7. Marshall Lake aquatic plant relative occurrence analysis. Created using data from July 2010 survey.
