ECHO LAKE BARRON COUNTY

2014 AQUATIC PLANT MANAGEMENT
IMPLEMENTATION SUMMARY REPORT
WDNR WBIC: 2630100

Prepared by: Dave Blumer, Lake Educator

April 2, 2015

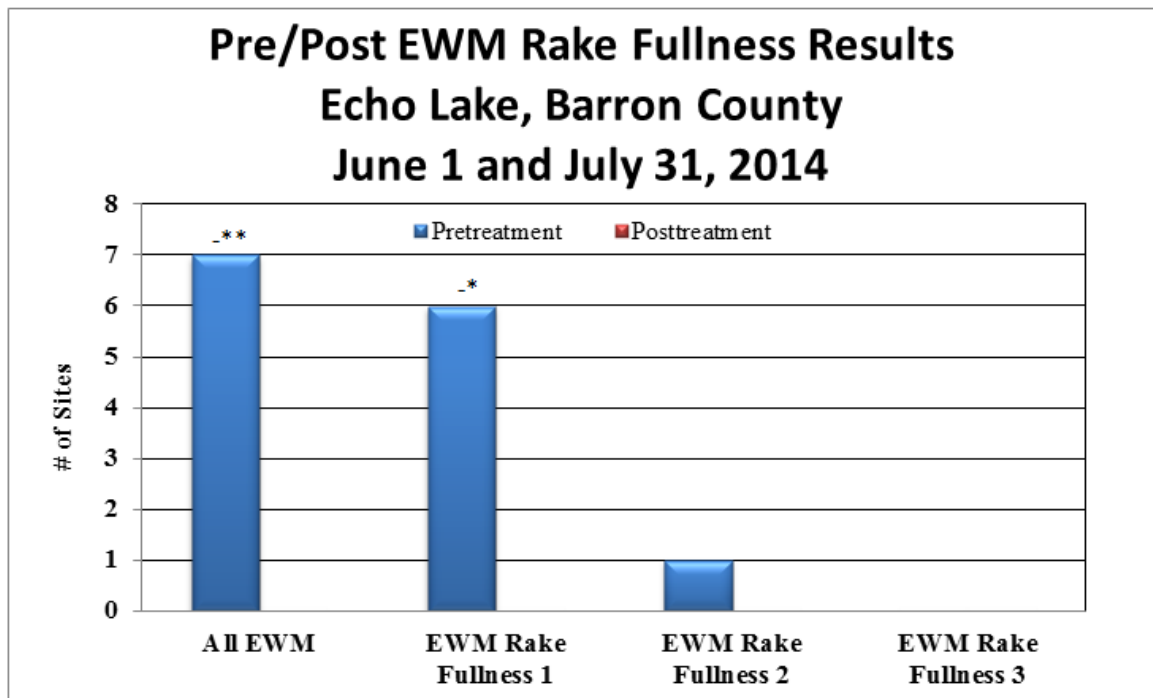
Figure 3: Pre/Post Changes in EWM Rake Fullness (ERS, 2013)

During the post-treatment survey, no EWM was found in any of the treatment areas. This decrease in total EWM was moderately significant (Figure 3).

Significant differences = * $p < .05$, ** $p < .01$, *** $p < .005$

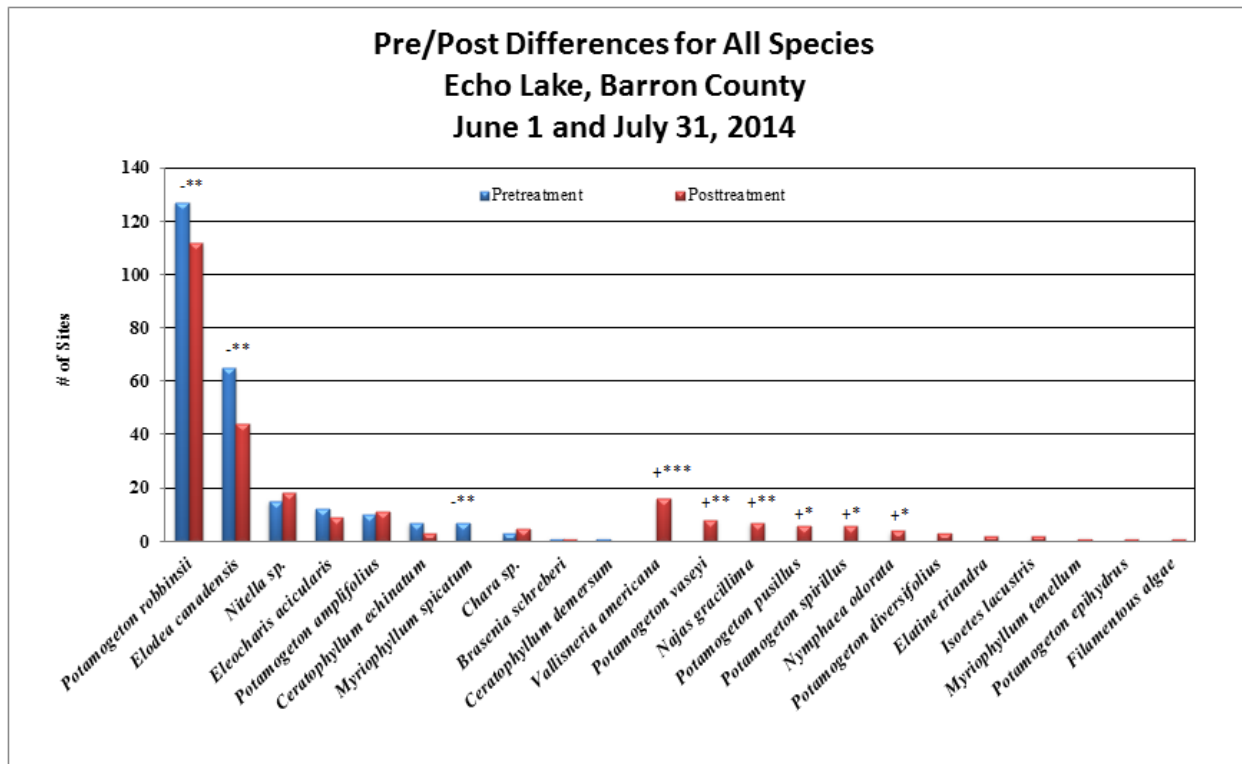
Figure 4: 2014 Pre/post changes in aquatic plants

Fern pondweed and common waterweed were the two most common native species in both the pre and post-treatment surveys both showed a moderately significant decline in distribution post-treatment. change post-treatment (Figure 4). Conversely, wild celery showed a highly significant increase; Vasey’s pondweed, and northern naiad showed moderately significant increases; small pondweed, spiral-fruited pondweed, and white water lily showed significant increases. More information related to the pre and post-treatment survey including species maps is available in Eurasian water milfoil (*Myriophyllum spicatum*) Pre/Post Herbicide and Fall Bed Mapping Surveys Echo Lake – WBIC: 2630200 Barron County, Wisconsin (Berg, 2014).

Significant differences = + $p < .05$, ** $p < .01$, *** $p < .005$

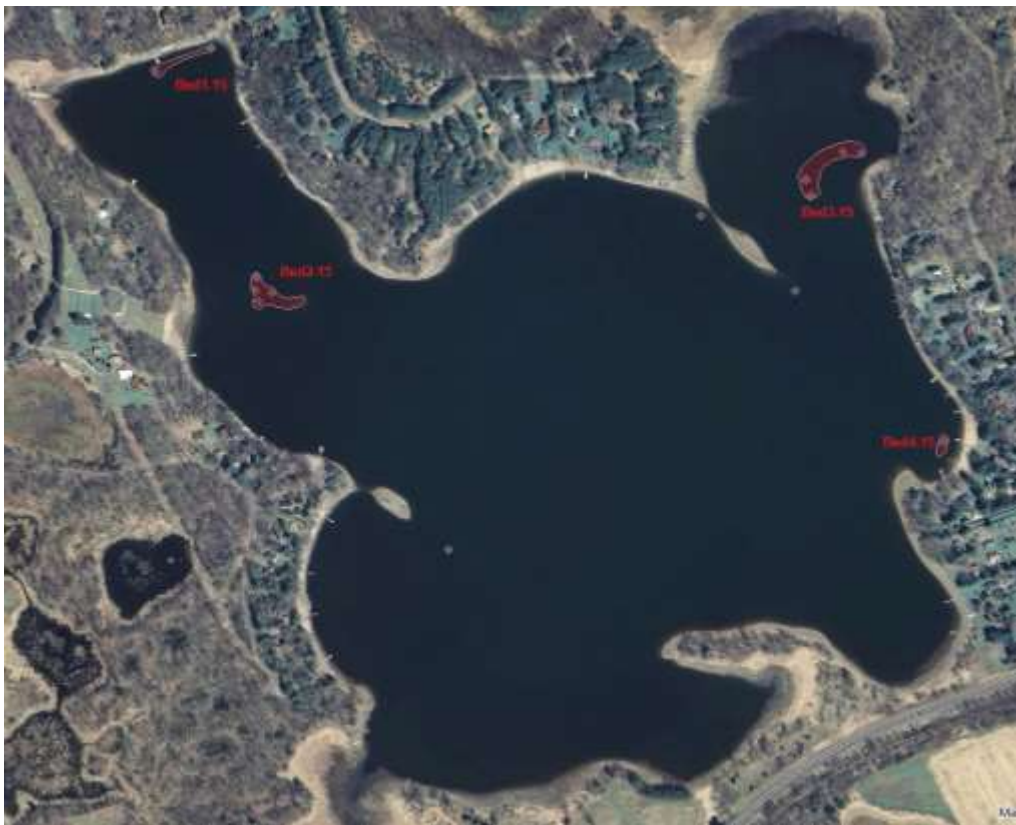
Figure 7: 2015 Proposed treatment areas

A EWM treatment proposal has been made for 2015 that includes 4 areas totaling 1.14 acres using Navigate granular herbicide at 3.5 - 4.0 ppm. The concentration of herbicide used depends on bed size and average depth of the treatment area (Table 3, Figure 7). Aquatic plant survey work to support management will be similar to past survey work, including a pre-treatment survey, post-treatment survey and a fall bed-mapping survey. It is possible though that the post-treatment survey will be combined with a bed mapping survey and done later in the season, depending on WDNR expectations. If that is done, then the true fall EWM bed-mapping would be discontinued.

2015 Echo Lake Preliminary EWM Treatment Plan 1-8-2015(DLB)						
Name	Acres	Mean Depth (feet)	Acre-feet	Target 2,4-D (ppm a.e.)	Navigate Application (pounds)	Navigate Dose (pounds/acre)
Bed1-15	0.16	4.5	0.72	4.00	40.9	256
Bed2-15	.35	7.0	2.45	4.00	139.2	398
Bed3-15	.56	6.0	3.36	3.50	167.0	298
Bed4-15	.07	5.0	0.35	4.00	19.9	284
TOTAL	1.14		6.88		366.9
