Please find below an illustrative description of the Amherst Millpond Local Needs Project. West District discussed the project and thought that some photographs would help explain the project more succinctly.

Amherst Millpond is a 48-acre impoundment on the Tomorrow River (a well-known trout stream) with a mean depth of five feet. Prior to the 2016 drawdown, the Millpond was mostly a very shallow open water lake with low diversity of submerged aquatic vegetation (SAV) and without a defined stream channel. The leaf-on aerial photograph below shows only a few islands of reed canary grass surrounded by open water, void of emergent vegetation (EV).

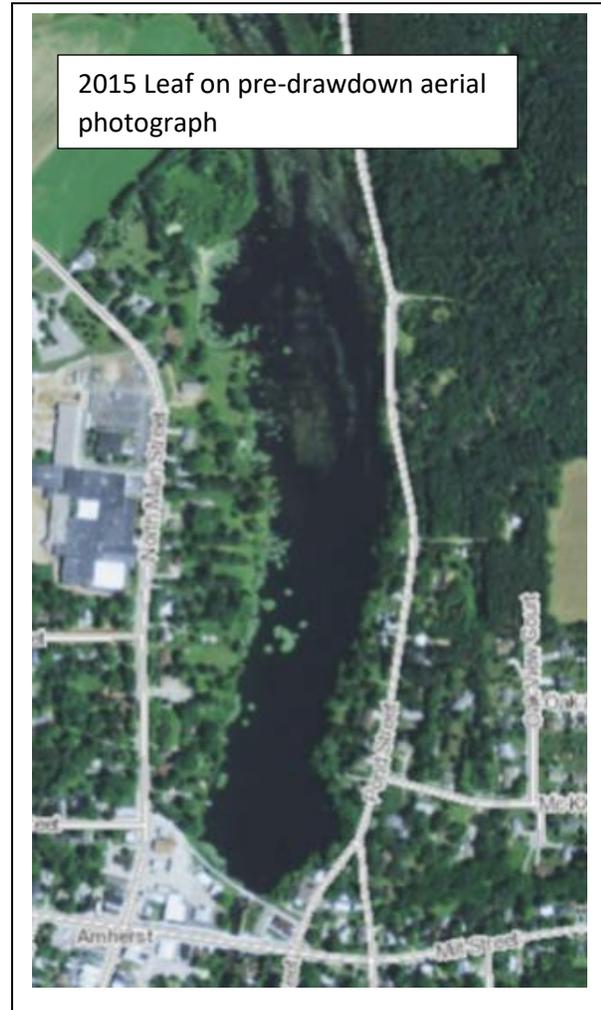
The millpond was drained in 2016 to repair the dam. The lake was in a drawdown for the growing season. During the drawdown, the river incised a deep channel along the east side of the pond, and emergent plants quickly recolonized the exposed sediments creating a very dense stand of emergent wetland species and some tree saplings (aspen and willow). As the water levels returned, the millpond reacted like most drawdowns where some plants were drowned out, leaving hydrophilic EV and a greater diversity of SAV. What is unique about this particular drawdown is that the borders of the new channel remained densely vegetated that maintain the main flow of the river to the new channel.

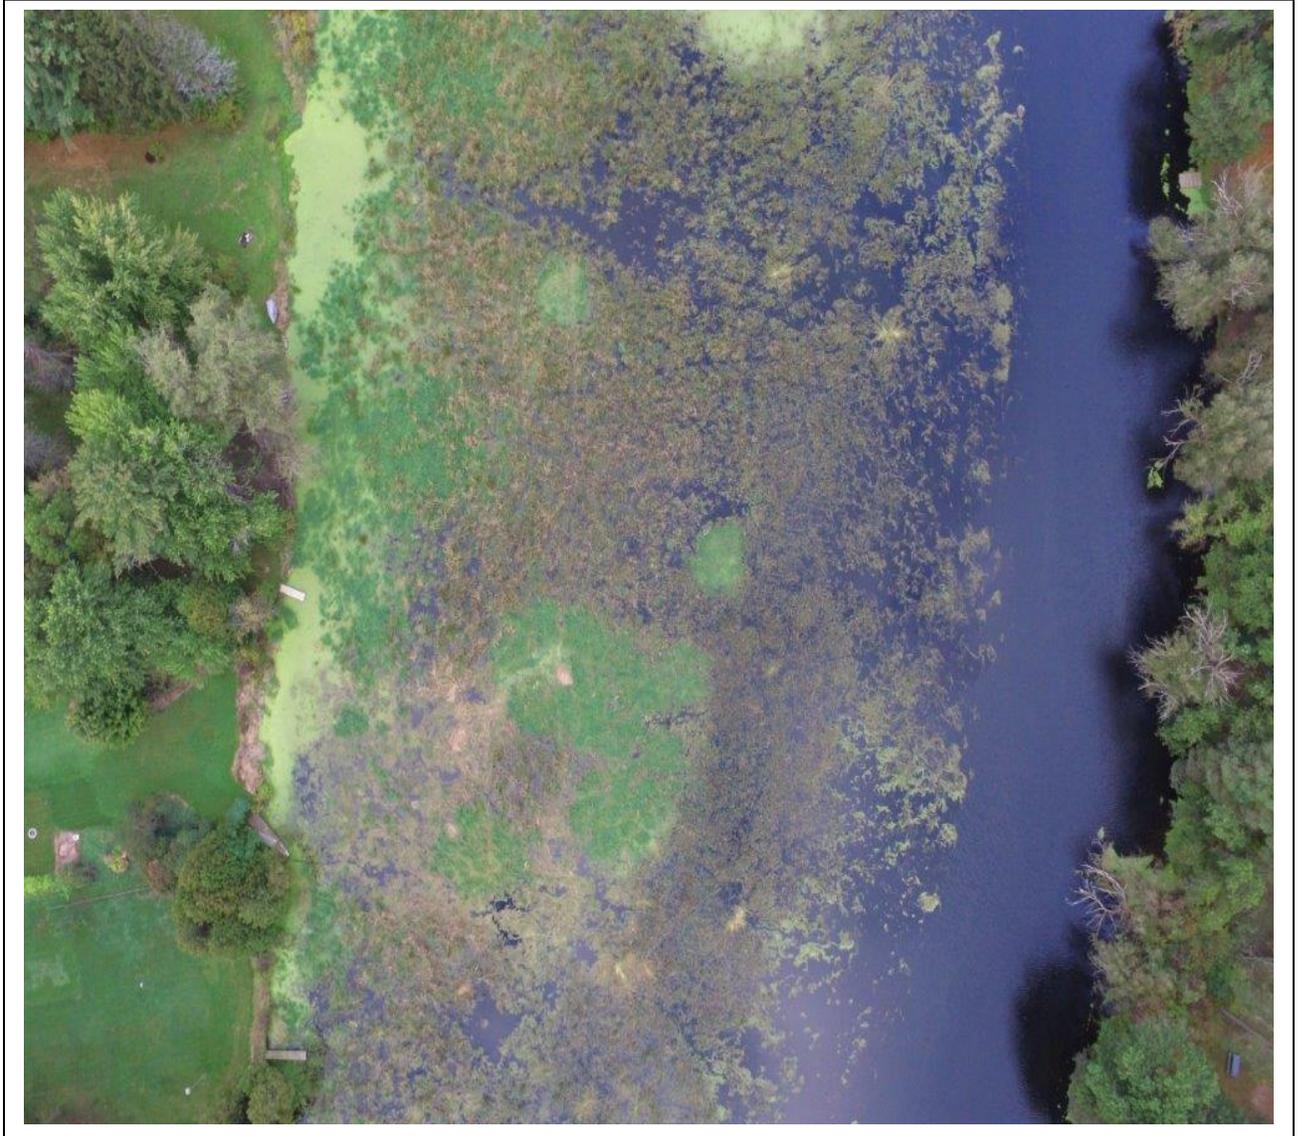
The new channel and dense vegetation along the stream corridor appear to be creating a riverine system with a flooded stream corridor instead of lacustrine system. The aerial photo attached in late-September still shows dense vegetation even after senescence.

The previously reed canary grass islands are visible in each photo. The surrounding EV appears to be dense enough to divert flow to the main channel, ultimately maintaining a riverine system.

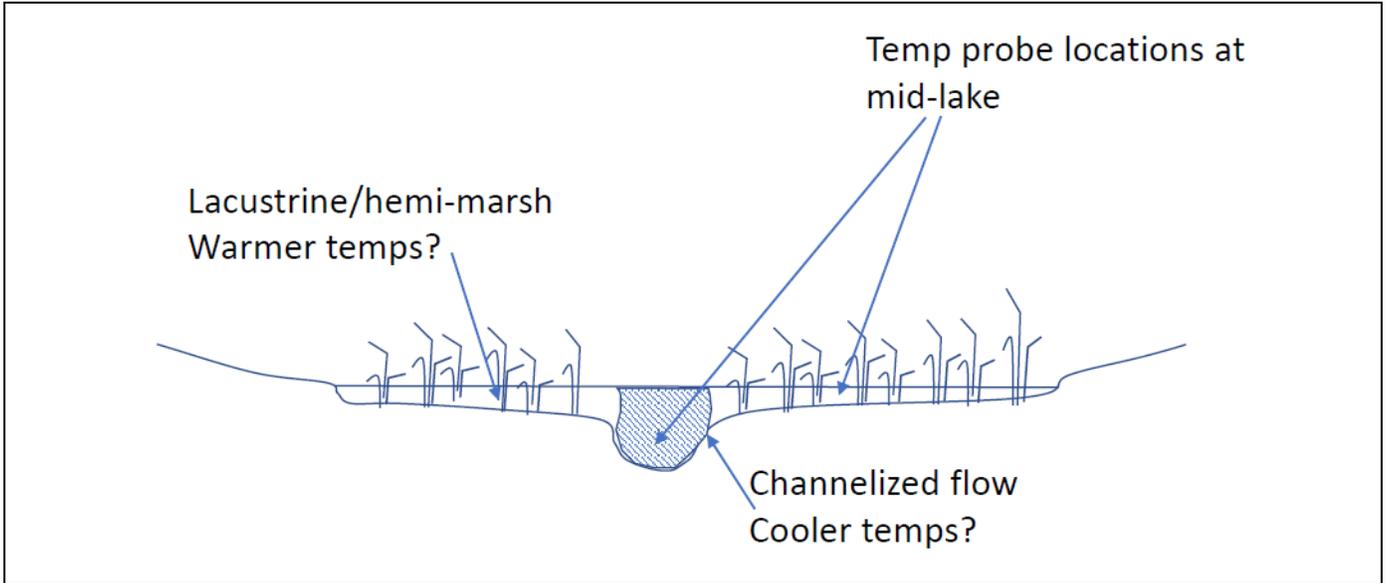
Water Resources staff will assist local volunteers to grab samples upstream, downstream and mid-lake to document any changes in water chemistry that might indicate separate or mixed systems. We will also help FM install temperature probes at the same locations. The schematic below shows how the temp probes will be deployed at the mid-lake location. These temperature data will be a good indicator of daily movement of water and determine if there are in fact, two separate temperature regimes.

Fish Management will supply the temperature probes and share data with Water Resources Staff for 2018 and compare it to a much larger temperature study conducted around 2000. Fish Management will also conduct the necessary fish survey work and share the results with Water resources and local citizens.
