Re: *Lake Belle View Restoration Project – 2017 Monitoring Update*
MARS Project Number: 1428-011

Lake Belle View Monitoring Progress Report

2014 Lake Drawdown and Commercial Seining Operation

Prepared by David W. Marshall and Richard Wedepohl

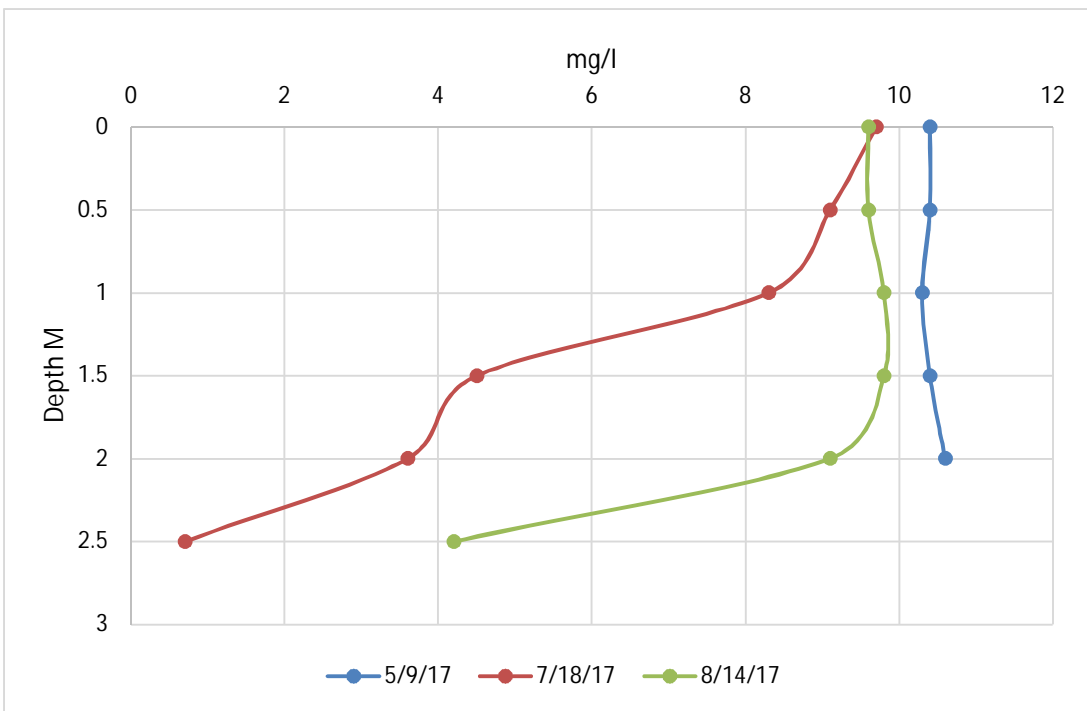
Figure 3: 2014, 2015 and 2017 Lake Belle View Dissolved Oxygen Profiles

A partial winterkill occurred in early 2014 and the resulting environmental stress had potential to benefit common carp at the expense of native fish populations. Deep hole dissolved oxygen profiles in Figure 3 demonstrate low dissolved oxygen levels measured during the winters of 2014 and 2015. The 2014 winterkill occurred due to very low dissolved oxygen concentrations that dropped below 1 mg/l throughout the water column. However, the loss of walleyes and some other large gamefish 2014 did not affect high numbers of panfish that may have overwintered in spring seeps elsewhere in the lake. Figures 4 displays nearshore fish shocking surveys in 2014 and 2015. In September 2014, two young of year common carp were collected and demonstrated recruitment for the first time in the lake. As part of citizen outreach and efforts to encourage carp removal from the lake, carp fishing contests were organized as part of the 2014 and 2015 Lake Fest events. Results demonstrated that common carp were still abundant in the lake following commercial harvests and additional carp removal efforts should continue. Figure 5 displays the length frequency distribution from the carp fishing contests.

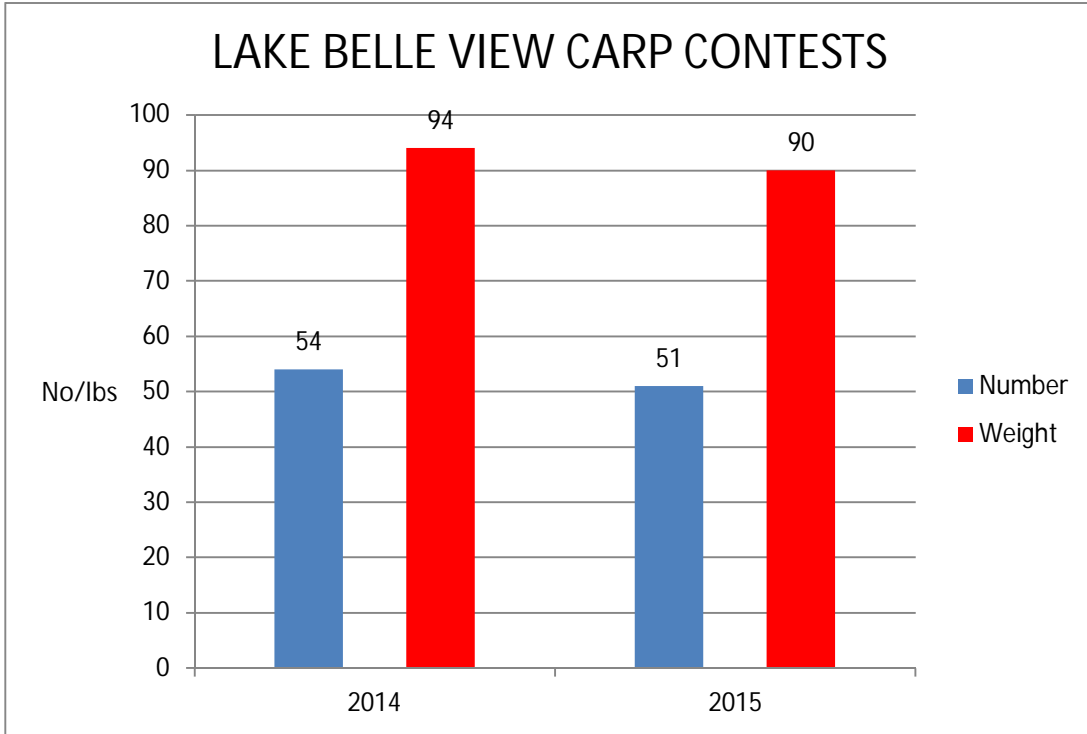
Figure 6: Carp Contest Harvest Data

Comparing the 2014 and 2015 data, carp recruitment occurred after the lake was constructed and some growth had occurred in 2015. In Figure 6, the catch and harvest rates did not change significantly comparing the 2014 and 2015 contests. Vertical temperature and conductivity profiles appear in Figures 7 and 8. In addition to relatively high phosphorus and chlorophyll concentrations in the lake, chloride was measured in 2015 and high concentrations were found; 55.4 mg/l (June 16, 2015), 50.4 mg/l (July 15, 2015) and 67.3 mg/l (August 11, 2015). These high concentrations reflect the urbanized watershed and impervious surfaces where road salt is applied
