Shoreland Inventory of the Pike Chain of Lakes, Price and Vilas Counties, Wisconsin

Date of Inventory: 2001
[includes Pike, Round, Turner and Amik Lakes]

Prepared by:
Blue Water Science
St. Paul, Minnesota
(651) 690.9602

September 2002

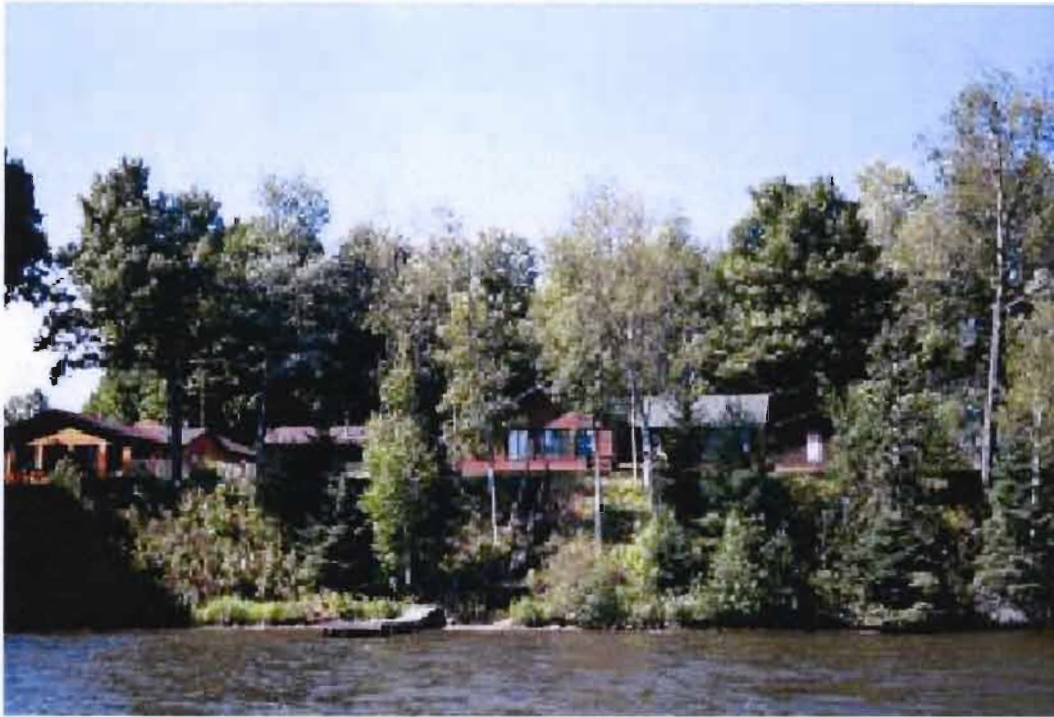
Figure 1. [top] This parcel would rate as having a shoreline with a buffer greater than 50% of the lot width and an understory with greater than 50% natural cover.

For each photograph we looked at the shoreline and the upland condition. Our criteria for natural conditions were the presence of 50% native vegetation in the understory and at least 50% natural vegetation along the shoreline in a strip at least 15 feet deep. We evaluated shorelines and uplands at the 75% natural level as well (Figure 1 illustrates the methodology).

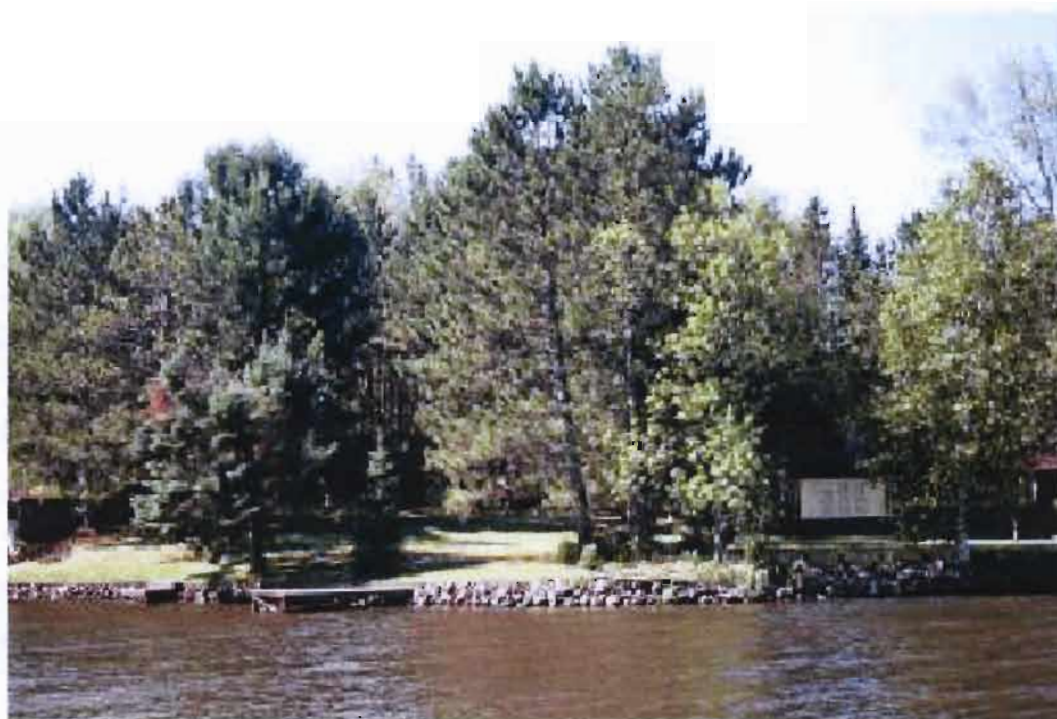
[bottom] This parcel would not qualify as having a natural shoreline buffer greater than 50% of the lot width. Also understory in the upland area would be rated as having less than 50% natural cover.

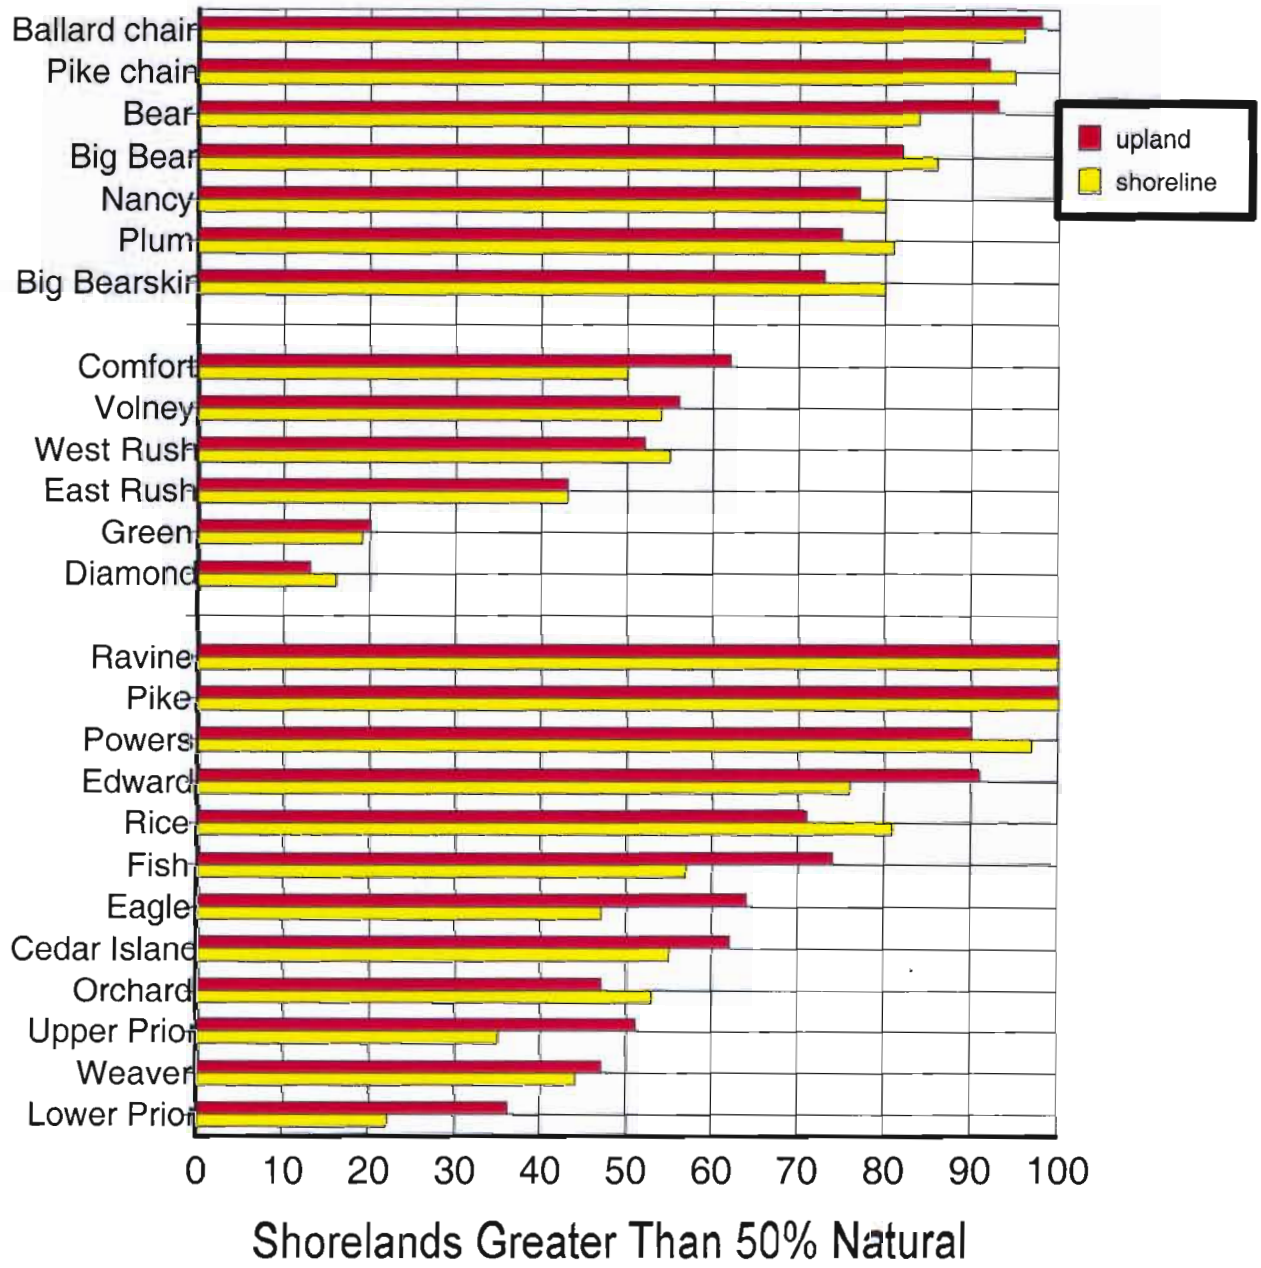
Figure 2. A summary of shoreland inventory results for lakes using an evaluation based on shoreland photographs. For each lake the percentage of shoreline and upland conditions with greater than 50% natural conditions is shown. The first tier of lakes are located in northern Wisconsin. The lower tier of lakes are in the Twin City Metropolitan area and are considered urban lakes. Although several lakes are “urban” lakes most of the shoreland is owned by the city and there is a high percentage of natural conditions. The middle tier of lakes are about an hour’s drive from the Twin Cities, and are not considered to be urban lakes, they are “country” lakes.

A comparison of the Pike Chain of Lakes conditions to other lakes in Minnesota and Wisconsin is shown in Table 2 and in Figure 2.

The Pike Lake Chain are northern Wisconsin lakes. It's natural shoreland conditions are slightly above average compared to the other northern Wisconsin lakes.

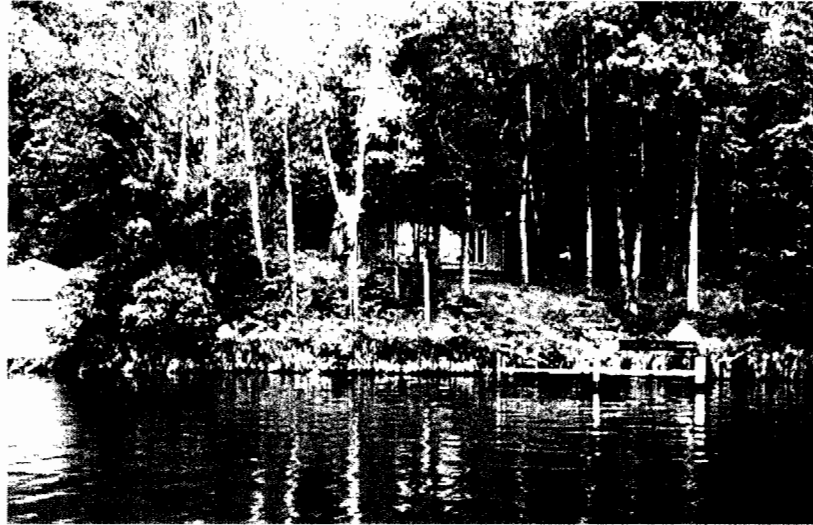
1. Naturalization: The easiest way to implement a natural shoreline setting is to select an area and leave it grow back naturally.

1. Naturalization: With this approach, the resident is going to allow an area to go natural. Whatever is present in the seedbank is what will grow. If they want to install a buffer along the shoreline, let a band of vegetation grow at least 15 feet deep from the shoreline back and preferably 25 feet or deeper. Just by not mowing will do the trick. Residents can check how it looks at the end of the summer. It will take up to three years for flowers and native grasses to grow up and be noticed. Residents can also select other spots on their property to “naturalize”.

Figure 3. Examples of three shoreland management options.

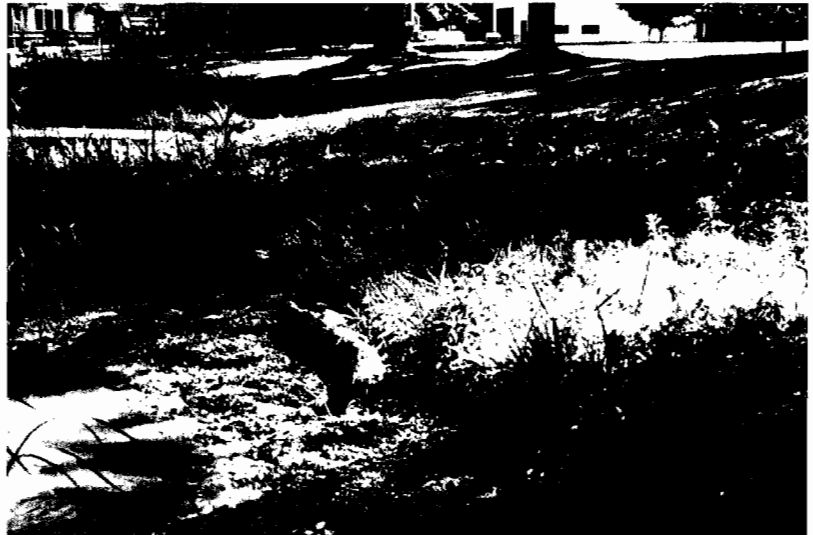
2. Accelerated Naturalization: To accelerate the naturalization, plant shrubs, wild flowers, or grasses into a shoreland area.

2. Accelerated Naturalization: After developing a plant list of species from the area, residents may want to mimic some features right away. They can lay out a planting scheme and plant right into existing vegetation. Several Minnesota nurseries can supply native plant stock and seeds. The nurseries can also help select plants and offer planting tips. Wildflowers can be interspersed with wild grasses and sedges. Mulch around the new seedlings. With this approach lake residents can accelerate the naturalization process.

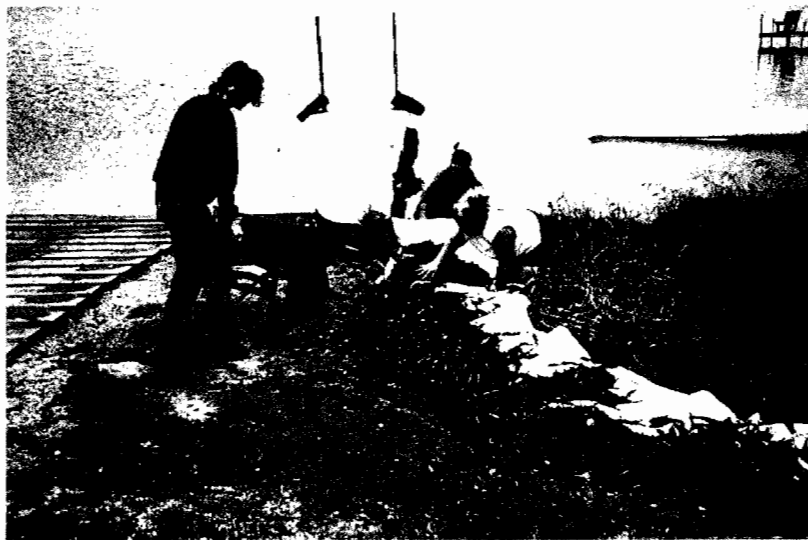
3. Restoration: This involves removing existing vegetation through the use of paper mats and/or mulching and planting a variety of native grasses, flowers, and shrubs into the shoreland area.

3. Reconstruction: To reestablish a native landscape with the resident’s input and vision, another option is to reconstruct the site with all new plants. Again plant selection should be based on plants growing in the area. Site preparation is a key factor. Residents will want to eliminate invasive weeds and eliminate turf. This can be done with either herbicides or by laying down newsprint or other types of paper followed by 4 to 6 inches of hardwood mulch. Plantings are made through the mulch. This is the most expensive of the three native landscaping categories. Residents can do the reconstruction all at once, or phase it in over 3 to 5 years. This allows them to budget annually and continue evolving the plan as time goes by.
