BAIRD CREEK WATERSHED MANAGEMENT STUDY

INTRODUCTION

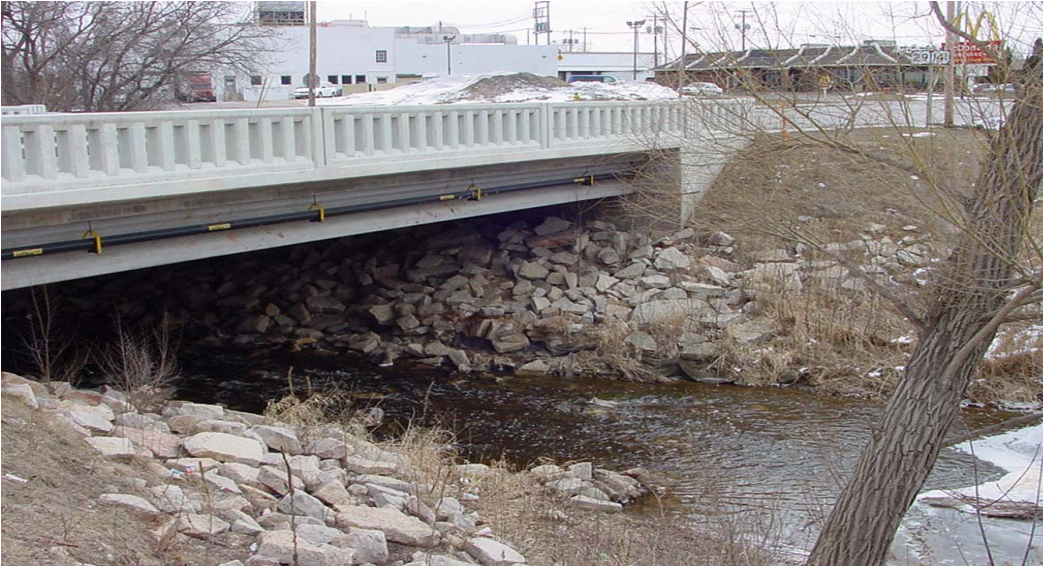
Figure 2 – Main Street Site

Habitat Study - the habitat section began 17.5 meters upstream from the Main Street bridge crossing and continued upstream 368.9 m. The bottom was composed primarily of silt with one transect having some (20-30%) sand and gravel. This section of the river was the farthest downstream and contained three runs, two pools and two bends. The stream in this section ran through an urban/industrial setting with truck trailer storage on the north bank and manufacturing/retail on the south bank. The width of the stream in this section ranged from 9.5 m to 12.2 m with a mean stream width of 10.54m. The depth of water ranged from 0.165 m to 1.14 m. A habitat rating form was completed and a score of 18 indicated poor habitat quality

Discharge – As shown in Table 1, the calculated discharge at Main Street ranged from a low of 0 cubic feet per second (cfs) to 45.4 cfs. The average flow was 11.2 cfs. The flow at this site was the most consistent over the study period. Due to this station's close proximity to its confluence with the East River, it is possible that a seiche effect could influence flow at certain times.

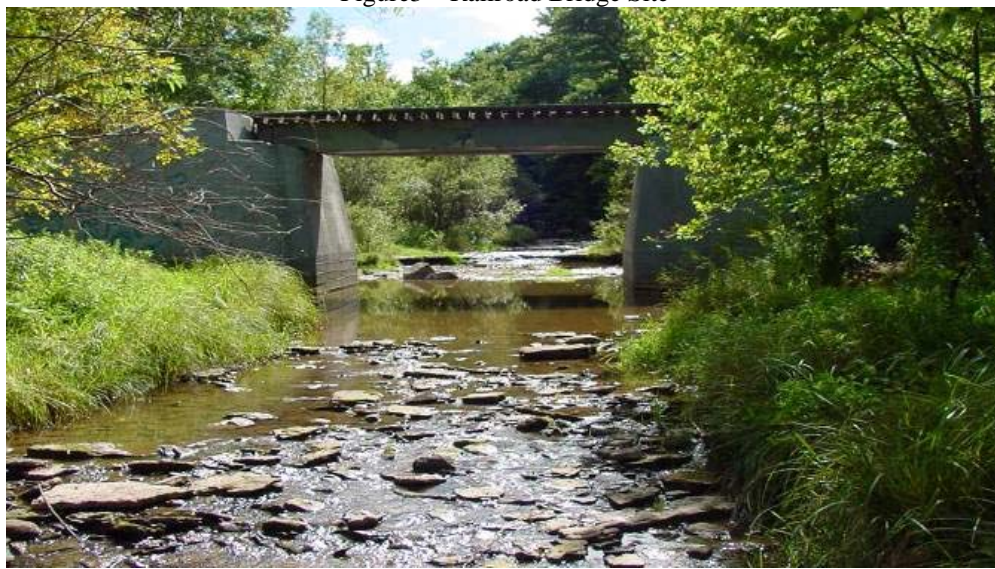
Figure3 – Railroad Bridge Site

Habitat Study Section – the habitat section began 271.7 meters downstream of the railroad trestle and continued 179.2 meters downstream. The stream bottom consisted primarily of limestone bedrock and boulders with lesser amounts of rubble and gravel. Very little silt and detritus was observed. There were no macrophytes or algae observed. This section of the river contained five runs, three pools and six riffle areas. The stream section runs through the Baird Creek Parkway with the adjoining stream bank vegetated with trees and shrubs. Stream width ranged from 2.3 meters to 8.7 m with a mean stream width of 5.12 m. The water in this section was shallow ranging from 0.01m to 0.30m deep. The habitat rating score was 65 indicating good habitat quality.

Discharge - The calculated discharge in Table 1 ranged from 0 cfs to 44.2 cfs at this location. No flow was recorded on three occasions and ice cover prevented the stage recording on two occasions. The average discharge for the 2 year period was calculated to be 9.4 cfs. Generally the flow was low, less than 1cfs during the summer months. The Telog data logging recorder was installed within the parkway adjacent to a heavily used trail. The recorder performed well and the data was downloaded and is available for analysis. Unfortunately some of the data is suspect because on at least three occasions during the study the cable and probe had been tampered with and found laying on the stream bank.

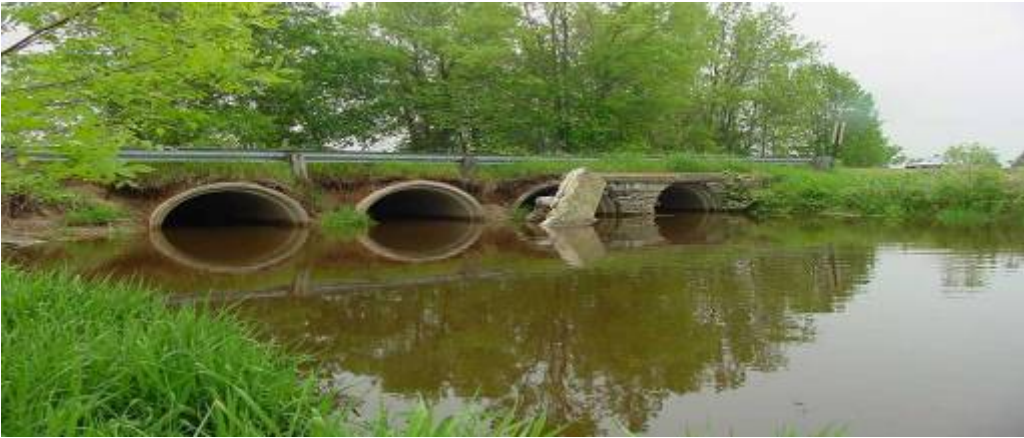
Figure 4 –Northview Rd.

The water chemistry and flow stage measurements were taken at the Northview Road bridge crossing. Due to little or no flow at this site later in the year, the habitat and biological assessments were taken at a downstream crossing at Woodside Rd.

Discharge – Table 1 shows a calculated stream discharge at Northview Rd ranging from 35.7 on April 11, 2001 to no discharge on nine occasions. There was ice cover recorded 4 times preventing the recording of the stage. Average discharge over the study period was 9.28 cfs. In April of 2002, a section of the Northview bridge used as a reference point to measure stage collapsed into Baird Creek. A new reference point was established at the top of the middle culvert. This required additional flow measurements and development of a new discharge rating curve, adding variability to the discharge calculations. Discharge at this site was intermittent during the summer and fall of 2001 and 2002.

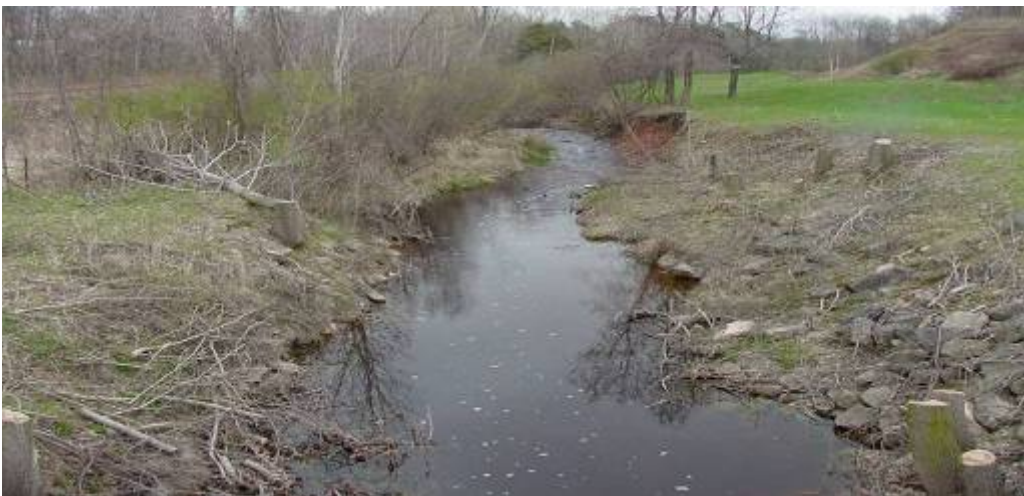
Figure 5 – Woodside Rd.

Habitat Study Section – The habitat evaluation section began 43.5m upstream of the Woodside Rd. bridge crossing and extended 108.8m upstream. The bottom was composed primarily of rubble and gravel with minor amounts of sand and silt. The section had 8 riffles totaling 41.5 m, 10 runs for 53.45m and 3 pools totaling 14m. The riparian land use within 5m of the stream was primarily shrubs, however the overall land use in this area is developed/agriculture. The minimum stream depth was 0.02 m and the maximum depth was 0.315m . The stream width ranged from 2.4m to 4.1m with a calculated mean stream width of 3.1m. The habitat rating score for this section was 52 indicating good habitat.
