# SAND LAKE, BARRON COUNTY

2017 AQUATIC PLANT MANAGEMENT  
SUMMARY REPORT  
WDNR WBIC: 2661100

Prepared by: Dave Blumer, Lake Educator

January 12, 2019

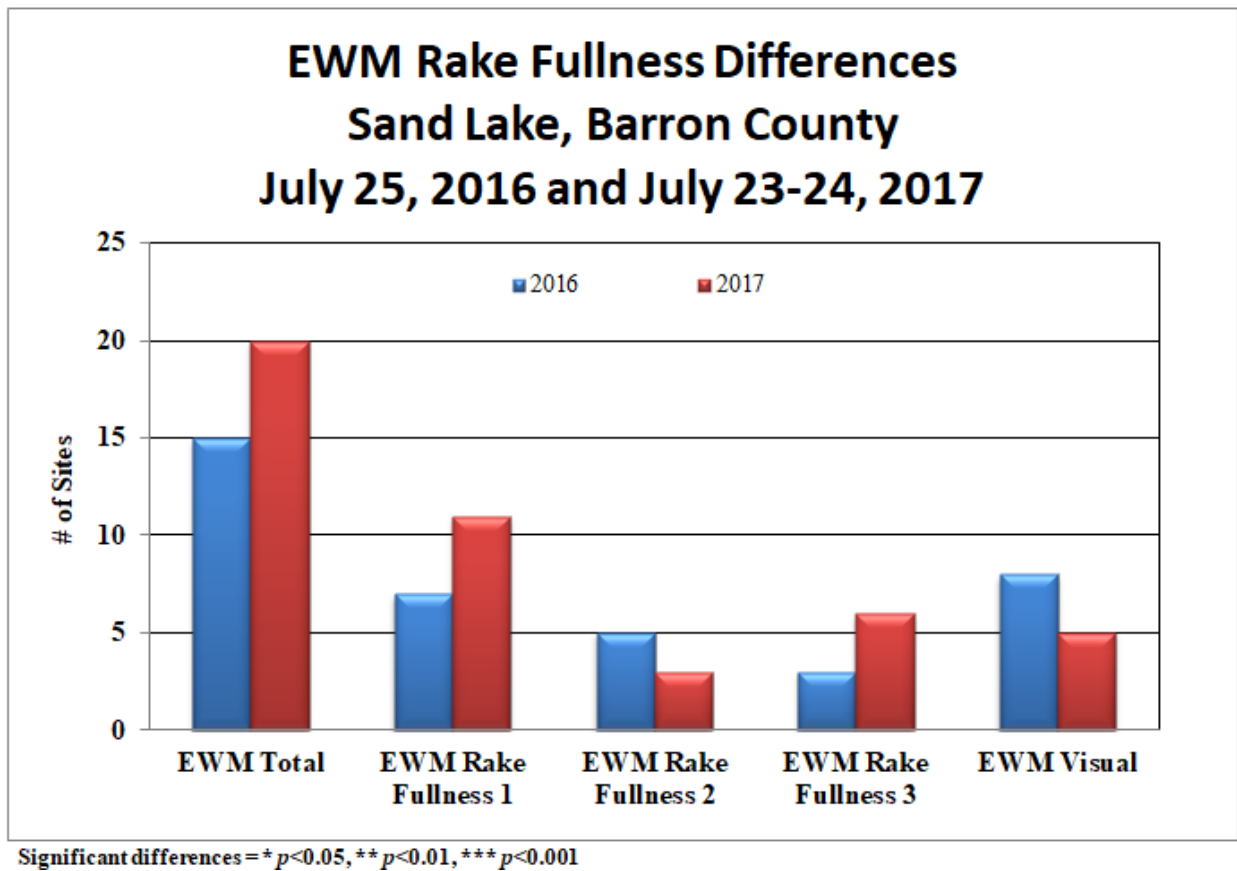
Figure 4: Comparison of EWM Density 2016 and 2017 (Berg, 2017)

Eurasian water-milfoil was found at 15 points during the 2016 survey (3.19% of littoral points with plants). Of these, three points had a rake fullness of 3, five were a 2, and the remaining seven were a 1 for a mean rake fullness of 1.73. EWM was recorded as a visual at eight points. During the 2017 survey, EWM was present at 20 points (4.22% of points with vegetation) and accounted for 1.05 of the total relative frequency. Six points had a rake fullness of 3, three were a 2, and 11 were a 1 for a mean rake of 1.75. EWM was also recorded as a visual at five points. Although both the distribution and density increased in 2017, none of these values represented a significant change over the 2016 survey. Likewise, none of the changes in rake fullness were significant (Figure 4).

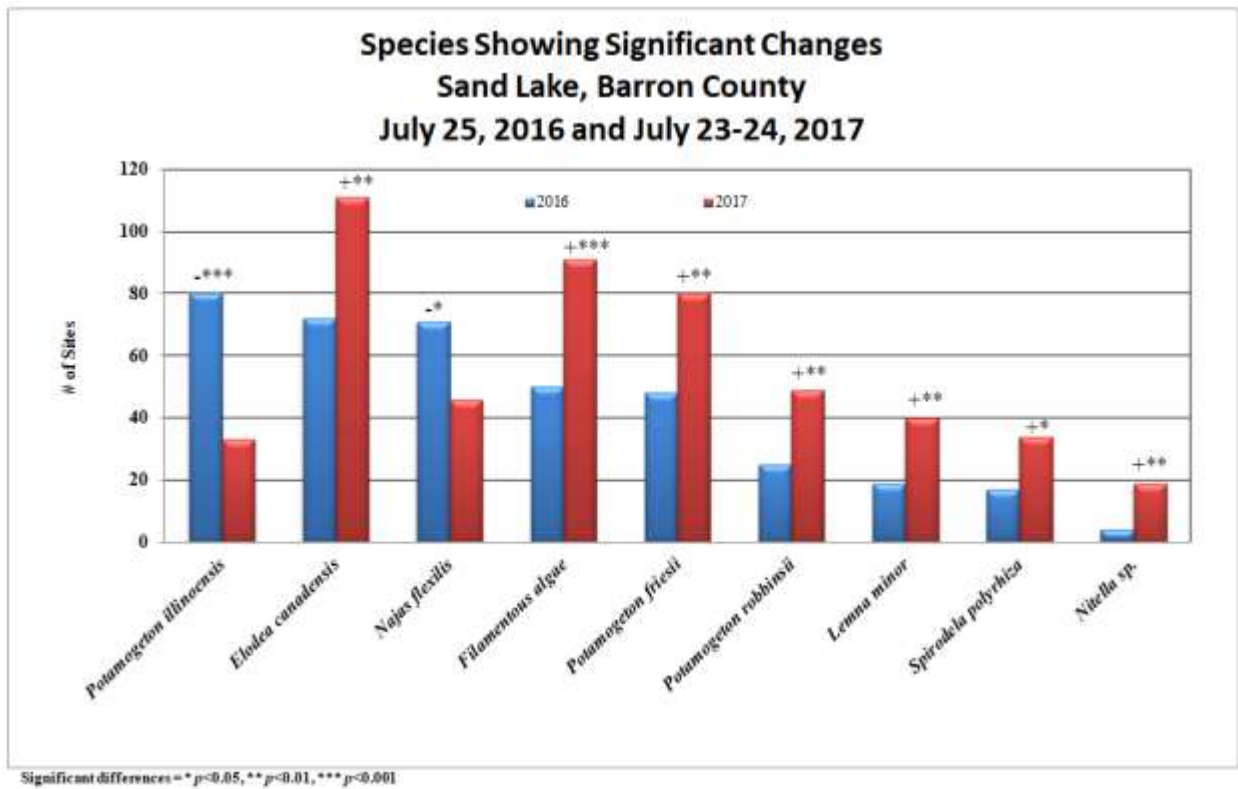
**Figure 9: Species with a significant change from 2016 to 2017 (Berg, 2017)**

When considering only distribution, nine species experienced significant changes. ERS documented a highly significant decline in Illinois pondweed; and a significant decline in Slender naiad. Conversely, they found highly significant increases in Common waterweed and filamentous algae; moderately significant increases in Fries' pondweed, Fern pondweed, Small duckweed, and Nitella; and a significant increase in Large duckweed (Figure 9).

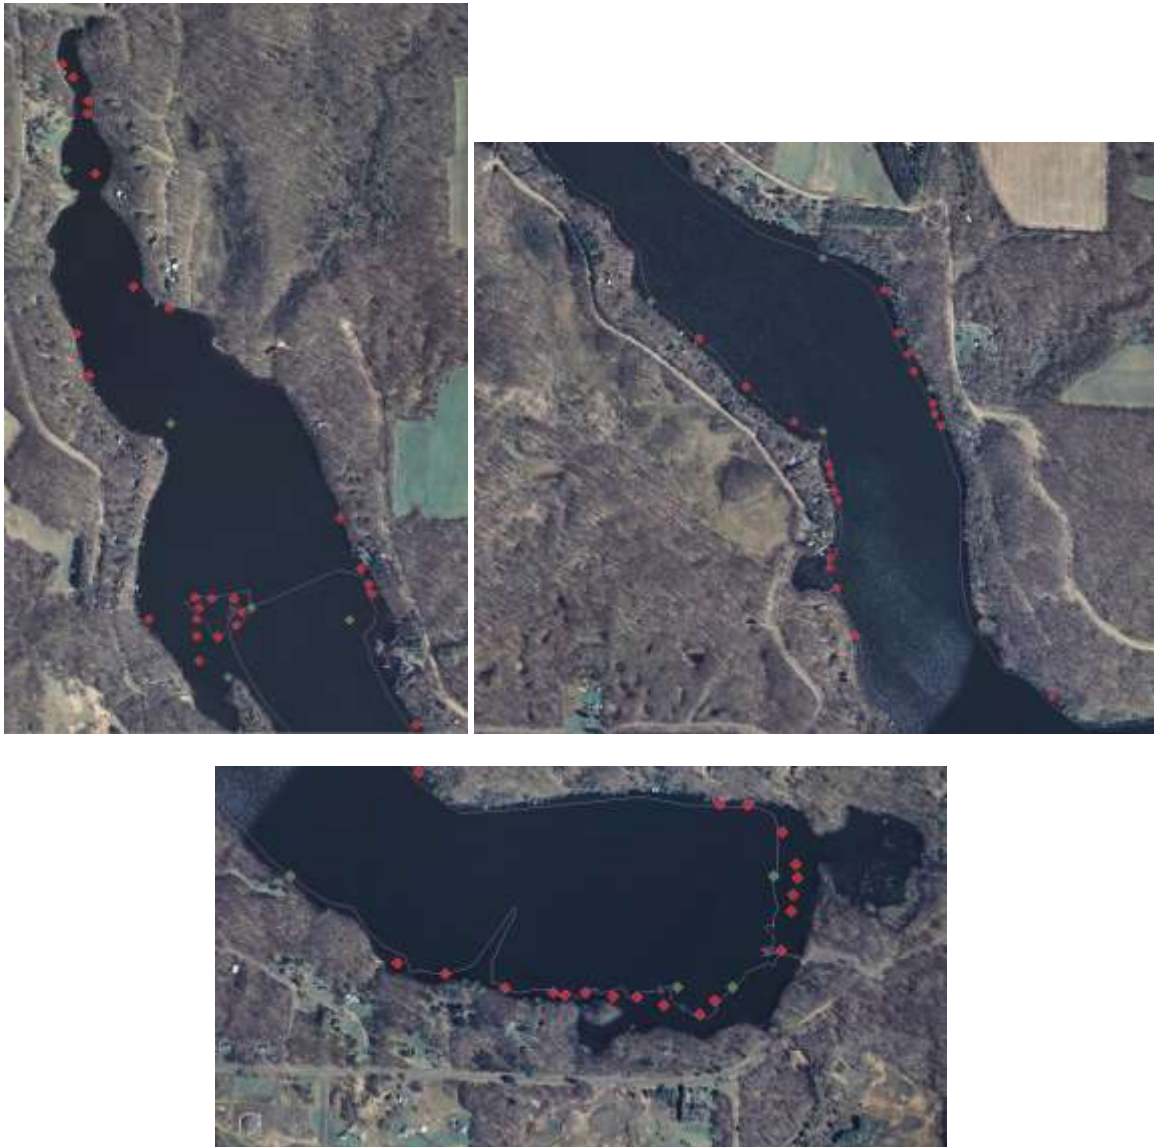
Figure 10: 2017 fall EWM meandering survey results (green dots = summer PI points with EWM; red dots = fall meandering survey points with EWM)

In the fall of 2017, LEAPS completed an informal meandering visual survey of EWM in Sand Lake. What was found was disturbing to say the least. EWM had increased greatly from the levels it was found at during the summer PI survey. During this three year EWM control project, a new way of tracking herbicide impacts to EWM and to native aquatic plant is being employed. The summer PI surveys in the littoral zone of Sand Lake have taken the place of a more formal pre and post-treatment survey followed by a fall bed-mapping survey approach that has been used in the past. Based on the 2017 informal meandering survey results, using only a summer PI survey to document impacts is not enough.

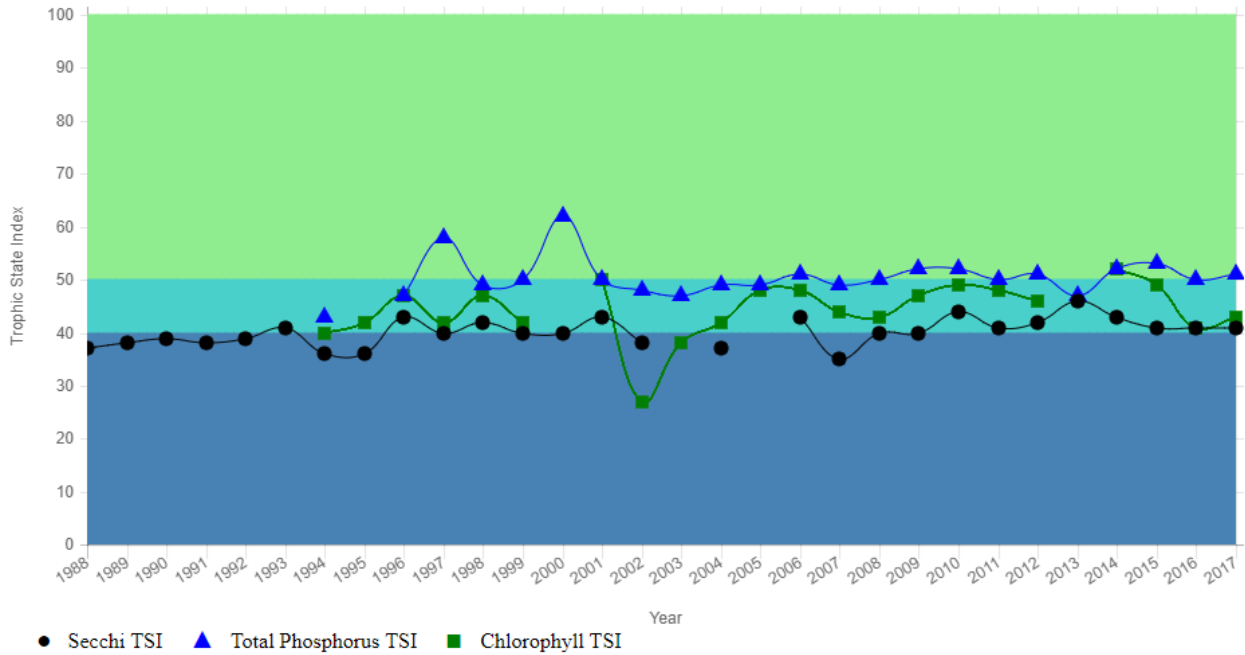
Figure 12: 2017 Summer (July and August) TSI values for total phosphorus and chlorophyll-a at the Near Deepest Pt on Sand Lake

Figure 12 shows the average summer Trophic State Index (TSI) value for total phosphorus, chlorophyll, and Secchi disk readings. The overall Trophic State Index (based on chlorophyll) for Sand Lake - Near Deepest Pt was 43. This TSI suggests that Sand Lake - Near Deepest Pt was mesotrophic. Despite being 2 points higher than the TSI found in 2016, Sand Lake is still on the low side of being mesotrophic. Mesotrophic lakes are characterized by moderately clear water, but have an increasing chance of low dissolved oxygen in deep water during the summer. These conditions accurately describe Sand Lake in 2017.
