Comprehensive Lake Management Plan for Big Bear Lake, Burnett County, Wisconsin

June 2003

Prepared by **Steve McComas, Blue Water Science**
with contributions from Wisconsin Department of Natural Resources
and the Big Bear Lake Association

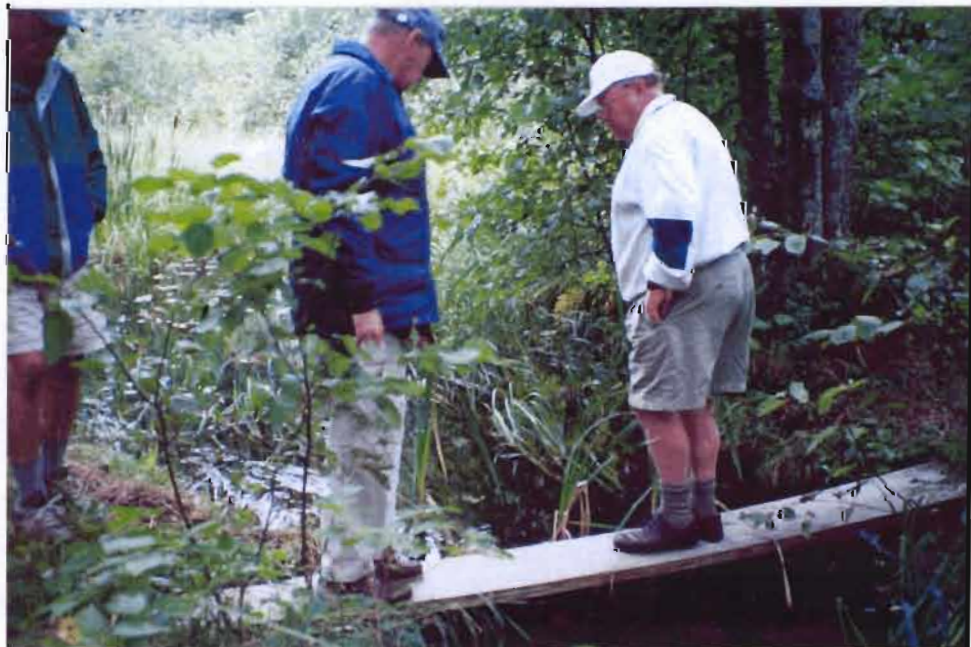
Figure 5. Jeff Henderson, Big Bear Lake, observes inflowing water to Big Bear Lake. The surface inflow is one source of water, but rainfall and groundwater are larger water sources.

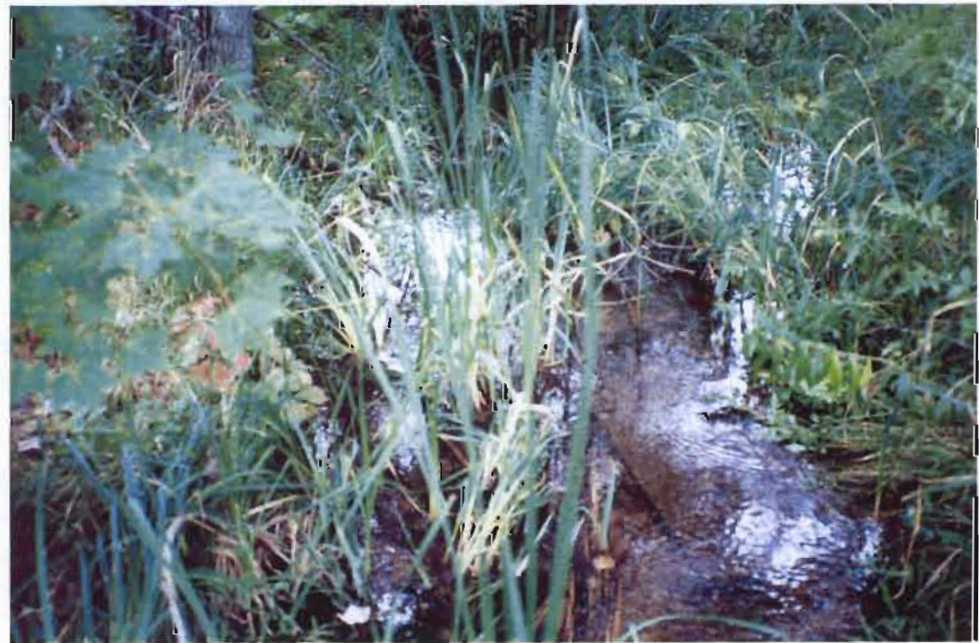
Figure 6. An inflowing stream to Big Bear Lake has low nutrient concentrations which is desirable for maintaining low fertility in Big Bear.

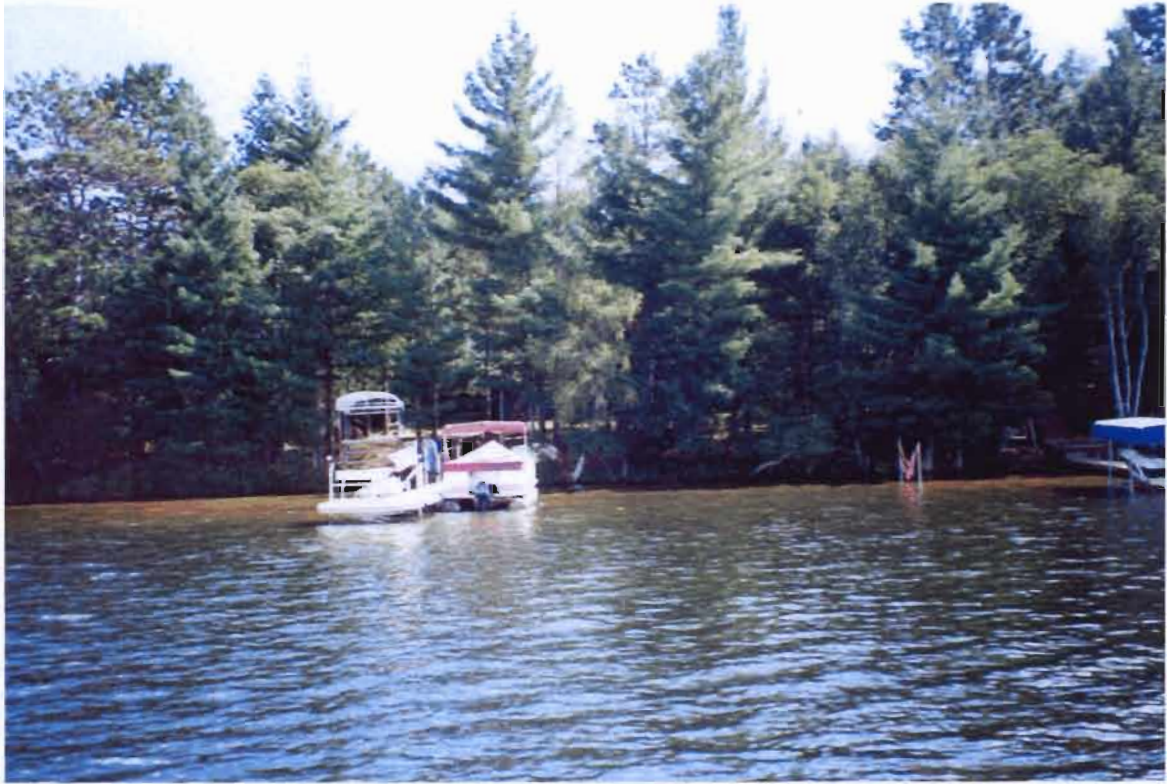
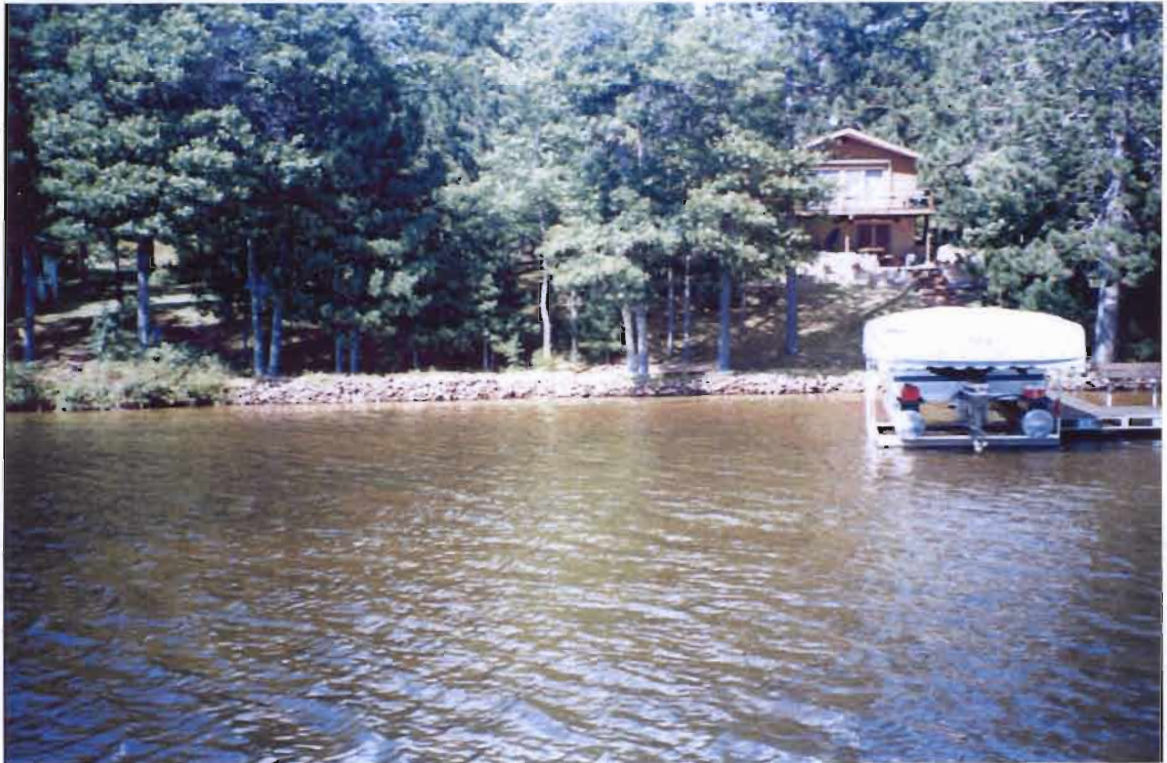
Figure 7. [top] This parcel would rate as having a shoreline with a buffer greater than 50% of the lot width and an understory with greater than 50% natural cover. [bottom] This parcel would not qualify as having a natural shoreline buffer greater than 50% of the lot width. Also understory in the upland area would be rated as having less than 50% natural cover.

Examples of shoreland conditions around Big Bear are shown in Figure 7.

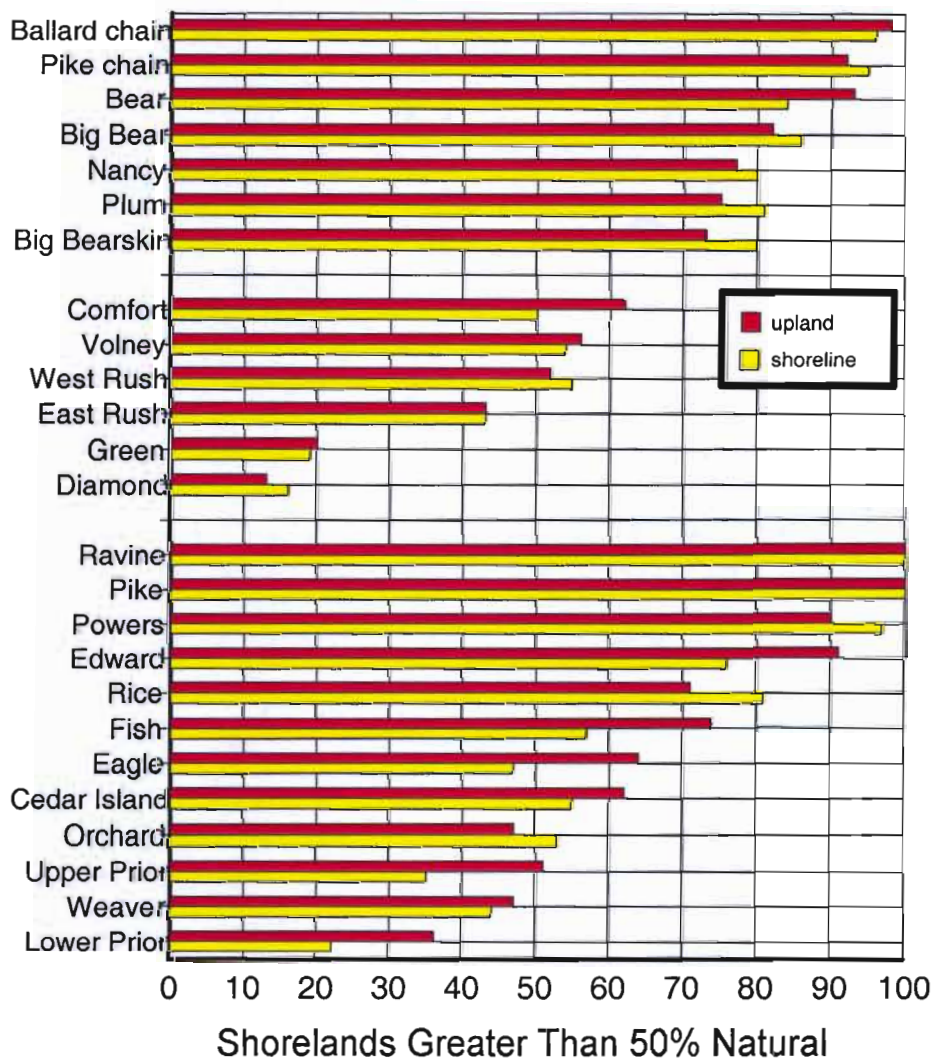
Figure 8. A summary of shoreland inventory results for 25 lakes using an evaluation based on shoreland photographs. For each lake the percentage of shoreline and upland conditions with greater than 50% natural conditions is shown.

A comparison of Big Bear Lake conditions to other lakes in Wisconsin and Minnesota is shown in Figure 8.

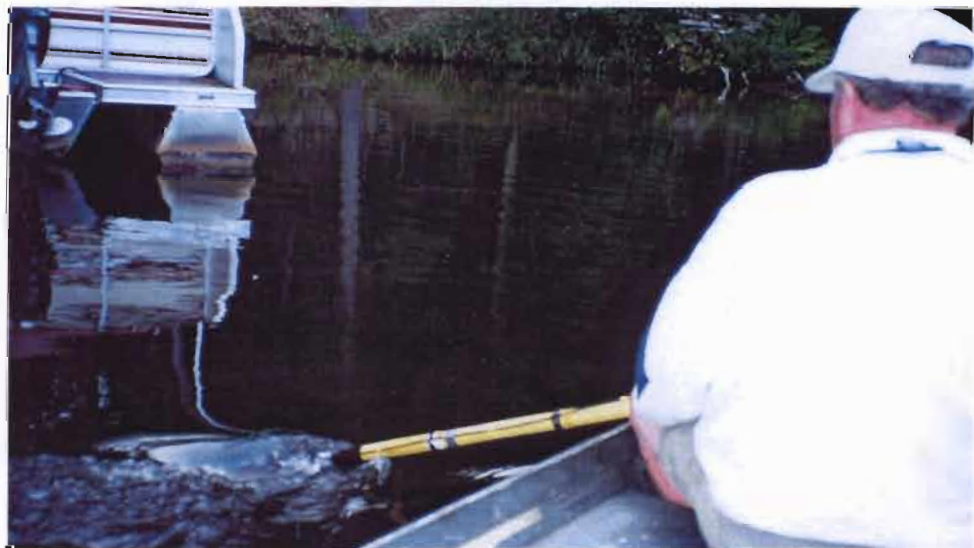
Figure 9. The submerged probe used in the conductivity survey is shown here. The entire nearshore area of Big bear Lake was surveyed.

Specific conductance or conductivity is a measure of dissolved salts in the water. The unit of measurement is microSiemens/cm² or micro umhos/cm². . . both are used. The saltier the water the higher the conductivity. For example oceans have higher conductivity than fresh water. For the conductivity survey on Big Bear Lake we used a YSI (Yellow Springs Instruments) probe attached to the end of an eight-foot pole. The survey used two people. One person held the probe under the surface of the water and recorded the reading off of a conductivity meter while the other person maneuvered the boat around the perimeter of Big Bear Lake.

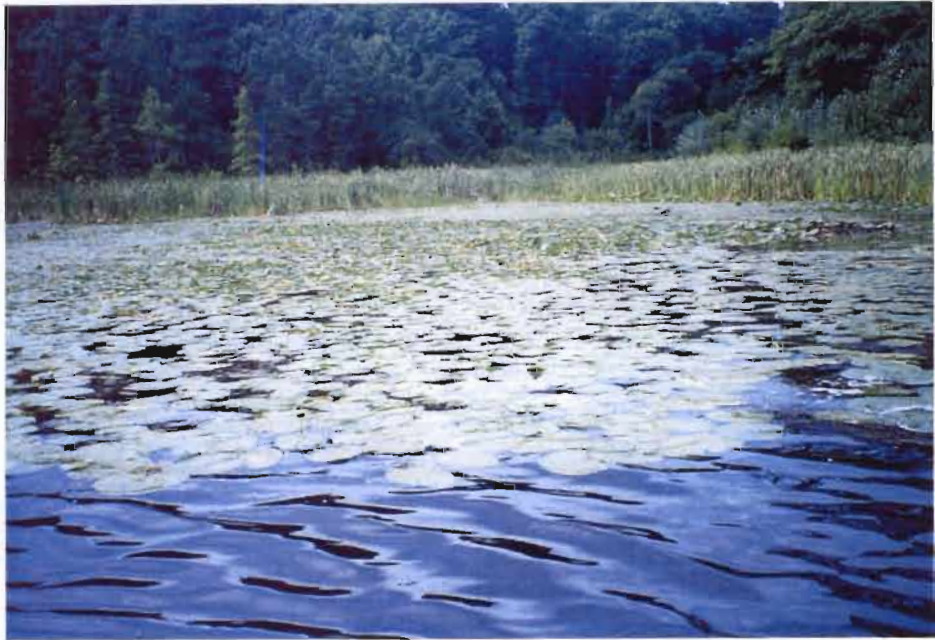
Figure 10. Big Bear Lake conductivity survey results for September 13, 2002.

Results are shown in Figure 10. The background or base conductivity was 63 umhos/cm. Several areas around Big Bear Lake had readings above background. However, because of a lack of homes or because the homes are far removed from the lakeshore, it does not appear that the elevated conductivity is from septic leachate discharges entering Big Bear Lake. Rather, the results suggest that Big Bear Lake may be receiving groundwater inflows that have slightly elevated conductivity concentrations. There is a location by the wetland that has low conductivity. This could be a source of groundwater into Big Bear Lake.

Wetland on the southwest side of the lake appeared to be an area of groundwater inflow.

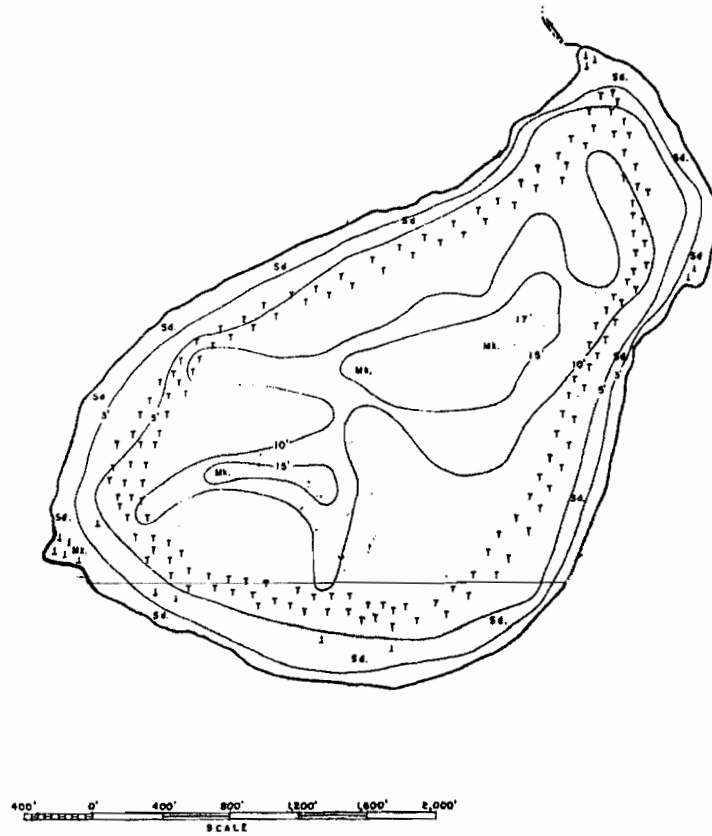
Figure 13. Big bear Lake contour map.

Big Bear Lake is approximately 189 acres in size, with a watershed of 900 acres. The average depth of Big Bear Lake is 2.7 meters (9 feet) with a maximum depth of 5.2 meters (17 feet) (Table 6). A lake contour map is shown in Figure 13. Big Bear Lake is located in an area of Wisconsin that is dominated by forests.
