LAKE PLANNING STUDY

SOUTH LAKE

JUNE 2005

LAKE PLANNING STUDY FOR SOUTH LAKE

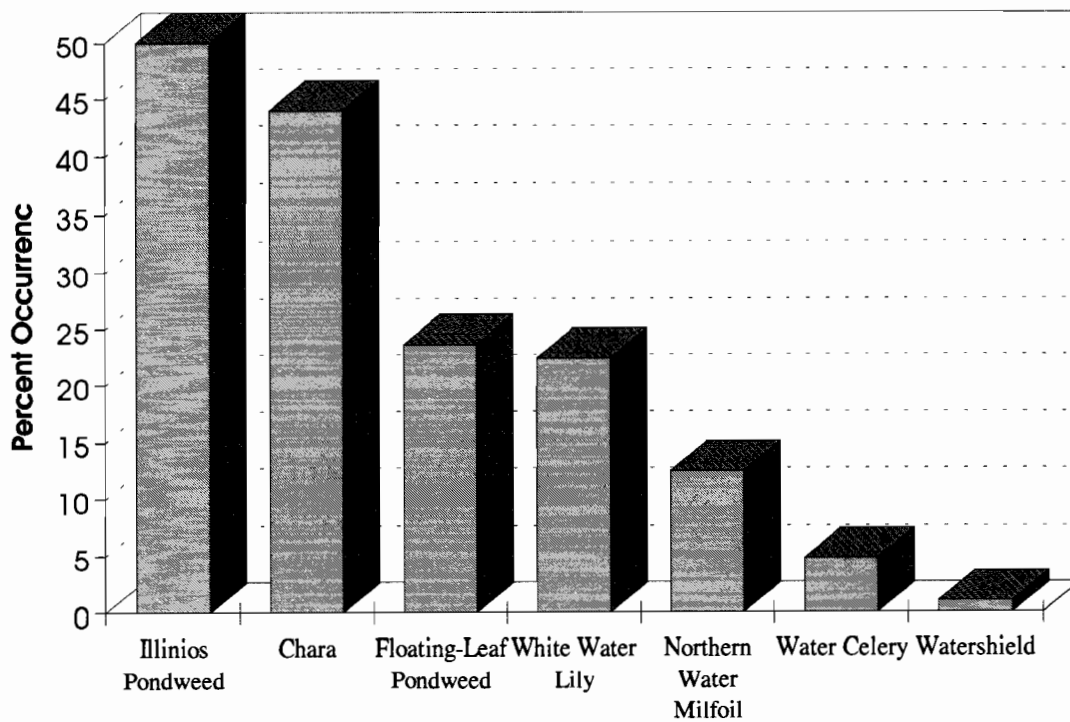
Occurrence of Aquatic Plants on South Lake

All the aquatic plants identified in South Lake inhabiting greater than 1% of the area are provided in the following figure:

Plant Identification and Percent Occurrence on South Lake

The most prominent aquatic plant found on South Lake is Illinois pondweed. Illinois pondweed was found to inhabit approximately 50 percent of South Lake. Illinois pondweed is a broad-leaved aquatic plant that provides an attractive cover for fish, such as panfish, largemouth bass, muskellunge and northern pike. Illinois pondweed also supports insects valuable as food for fish and ducklings (Ref. #11 & 12).

The second most prominent aquatic plant found at South Lake is Chara. Chara was found to inhabit approximately 44 percent of South Lake. Even though Chara looks like a plant, it is actually a type of algae. Chara grows entirely below the water surface. It covers a large portion of the lake bottom. Chara has stem-like branches with forked leaves. It has a hollow stem, rough-textured leaves and smells similar to musk when crushed. Chara provides cover for fish and supports insects that provide food for fish and waterfowl (Ref. #11). See Appendix "F" - Guide to Wisconsin Aquatic Plants for a pictorial representation of Chara.

Floating-Leaf Pondweed was found to inhabit approximately 24 percent of South Lake. Floating-Leaf Pondweed provides good cover for fish, such as panfish, largemouth bass, muskellunge and northern pike. Floating-Leaf Pondweed also supports insects valuable as food for fish and ducklings (Ref. #11).

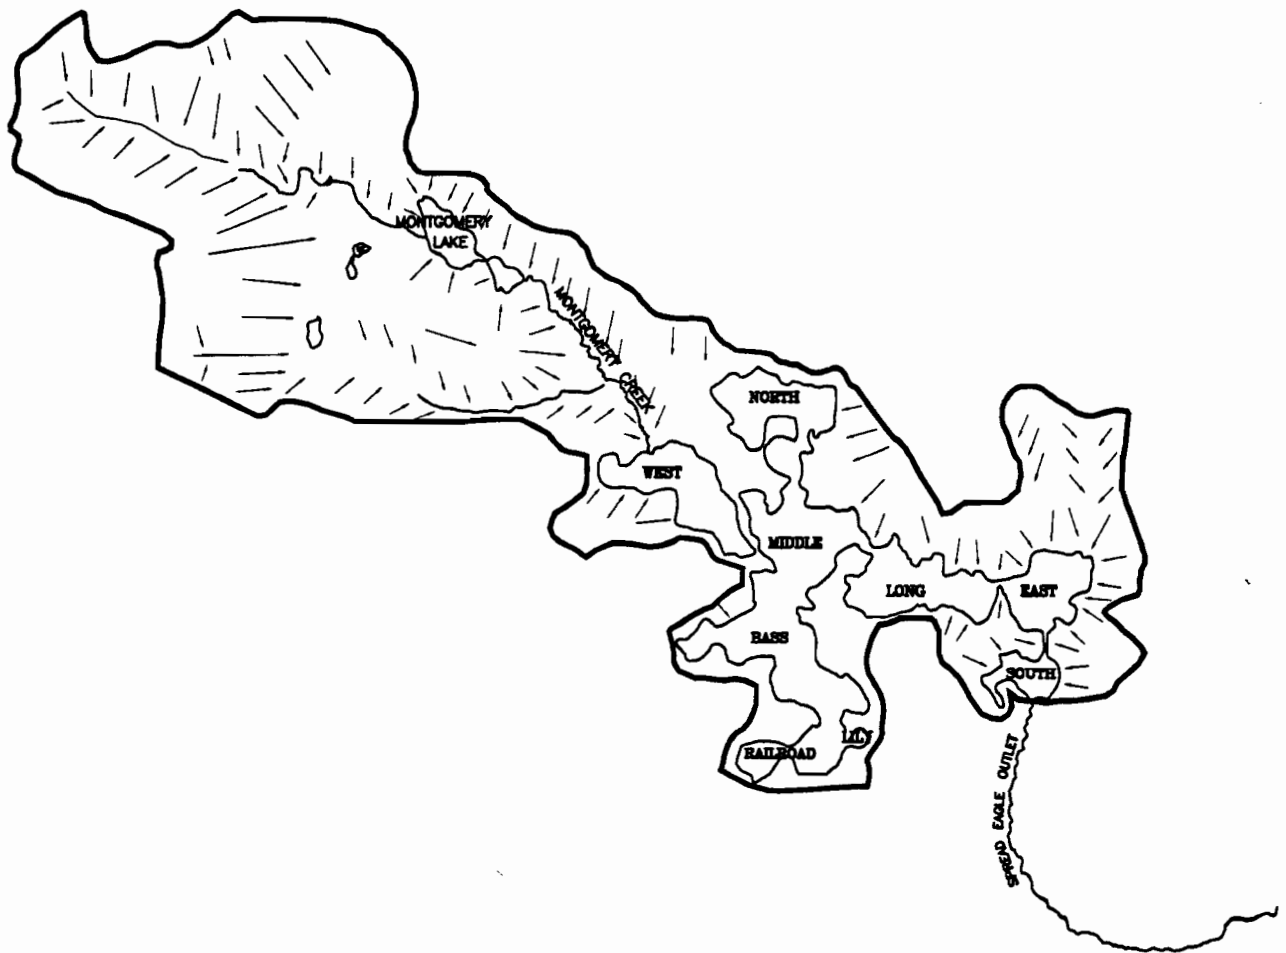
WATERSHED AREA OF THE SPREAD EAGLE CHAIN OF LAKES		
SCALE: 1"=4000'	APPROVED BY:	DRAWN BY: SMF
DATE: 4/1/05		REVISED:
SPREAD EAGLE CHAIN OF LAKES ASSOCIATION Florence, Wisconsin		
MMA, INC. - Florence, WI		FIGURE NUMBER: 6

ARROWS INDICATE SURFACE RUNOFF PATTERNS AND WATER FLOW DIRECTION

The watershed area of the Spread Eagle Chain of Lakes consists of approximately 3,200 acres located primarily to the northwest of the Spread Eagle Chain of Lakes. Runoff from the watershed of Montgomery Lake flows down Montgomery Creek to West Lake. The watershed consists predominantly of forest and wetlands with a scattering of residential development. The inlet to West Lake supplies much of the water coming into the Spread Eagle Chain of Lakes; springs and precipitation supply the remainder.
