Bone Lake 2018 CLP Evaluation

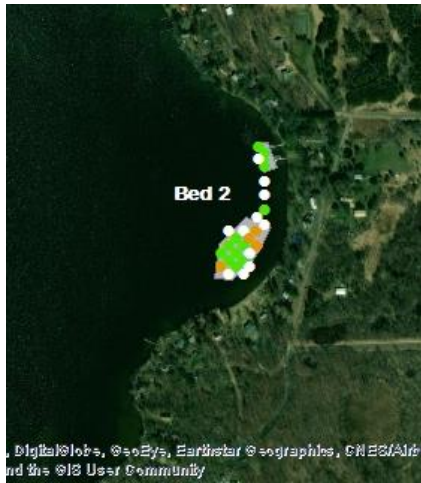
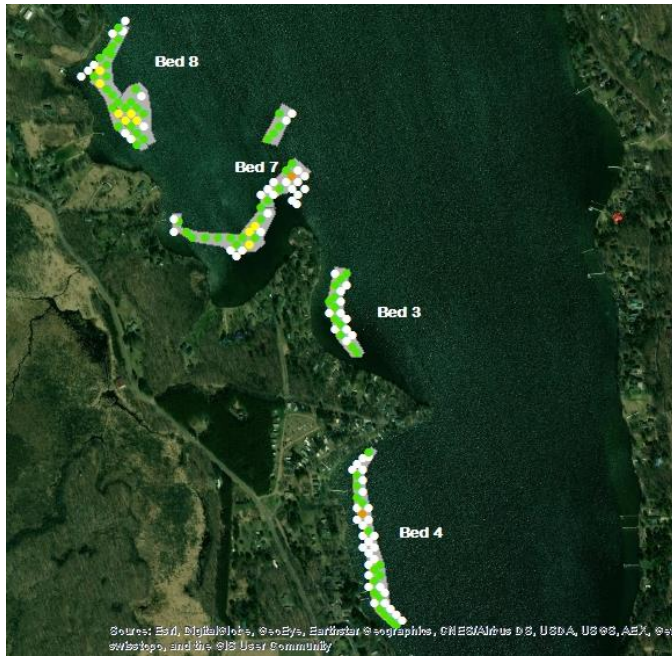
Figure 2: Pretreatment maps from survey in April, 2018.

Green=present; white=absent; brown=viewed near sample point.

Figure 2 shows the pretreatment maps from May 2018. Table one summarizes the pretreatment FOO and post treatment FOO density for 2017 and 2018 for comparison. Figures 3-4 show the post treatment density maps from June 2018.

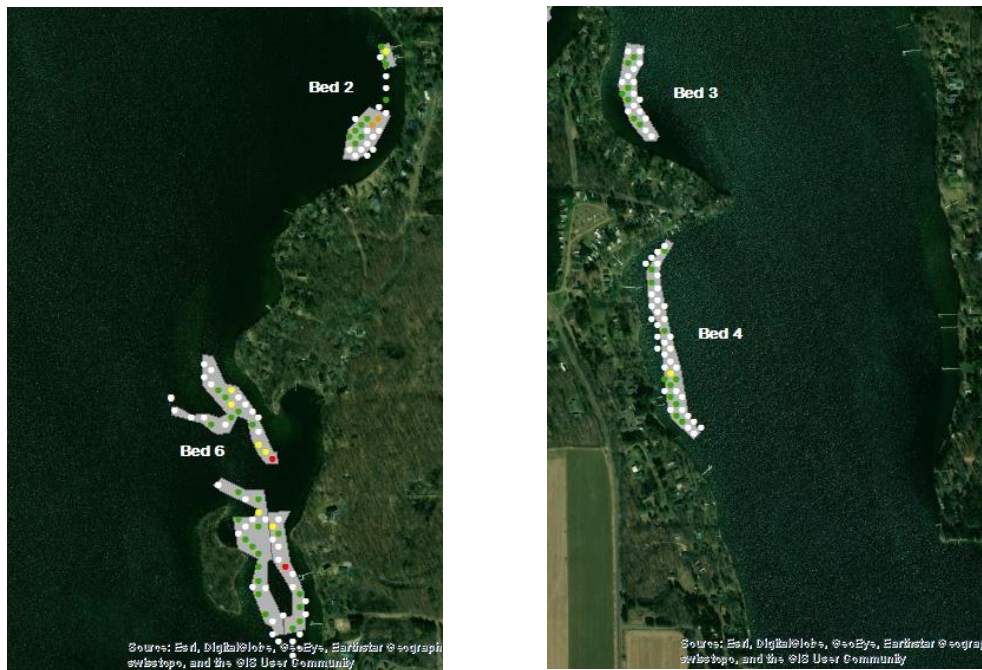
Figure 3: "Post" treatment maps for Beds 2,3,4 and 6.

As would be expected, the lack of treatment resulted in a significant increase in CLP frequency from 2017 to 2018. Comparing the pretreatment frequency from 2017 to 2018 resulted in a significant reduction. This demonstrates likely long term reduction from previous management. Interestingly, the "post" treatment frequency in 2018 was slightly lower than the pretreatment frequency. This could be sampling location variation, which would indicate the CLP is more sporadic in coverage in some areas, or the CLP naturally declined from May to June.

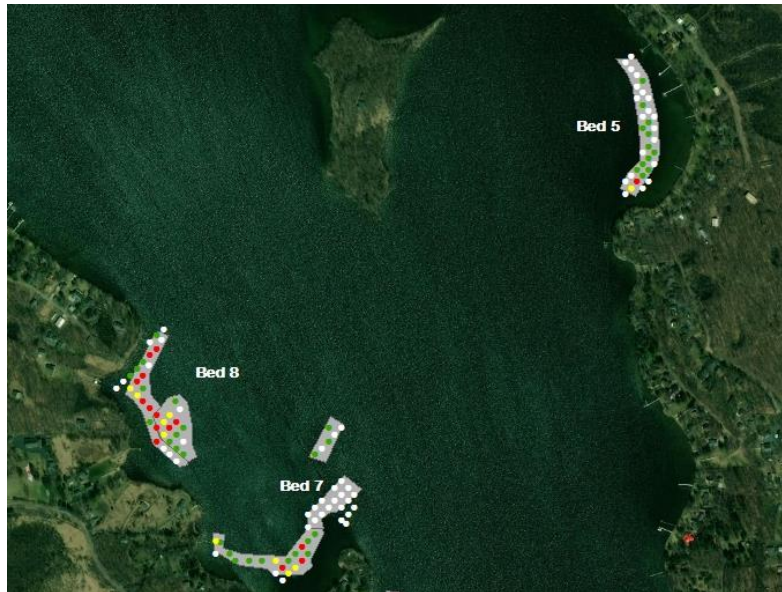
Figure 4: "Post treatment map for Beds 5,7 and 8.

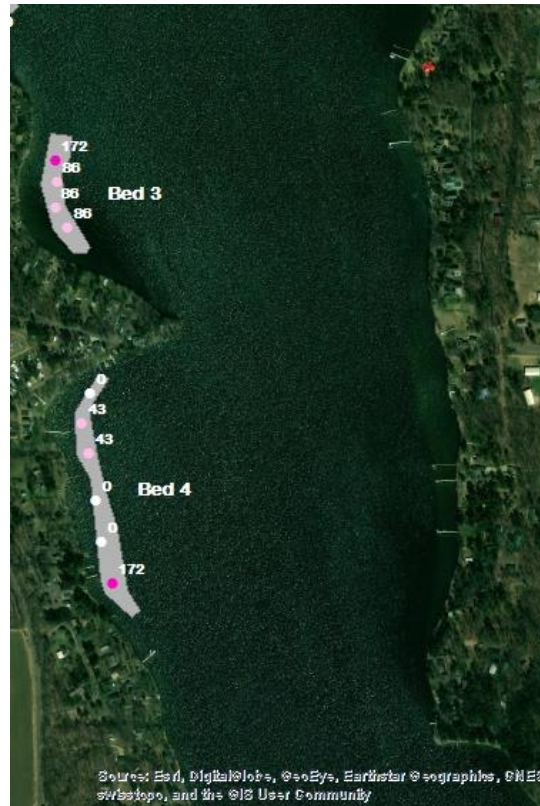
Figure 6: Turion density map from Oct. 2018 for Beds 3 and 4.

In Oct. bottom samples are collected within each treatment bed to evaluate the turion (reproductive structures of CLP) density. A decline in turion density is the desired outcome of effective, long term CLP reduction from the herbicide treatment. Table 3 summarizes the 2018 data and compares to previous years. Figures 5-7 show the turion density within each treatment bed. Figures 8 and 9 are graphs that show long term trends with each bed and overall.

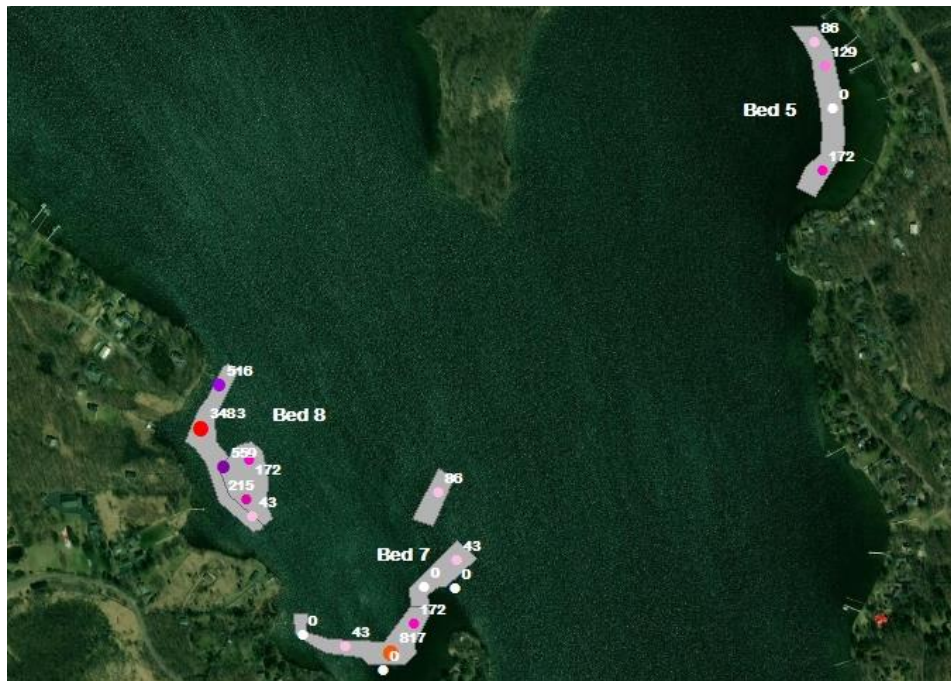
Figure 7: Turion density map from Oct. 2018 for Beds 5,7 and 8.

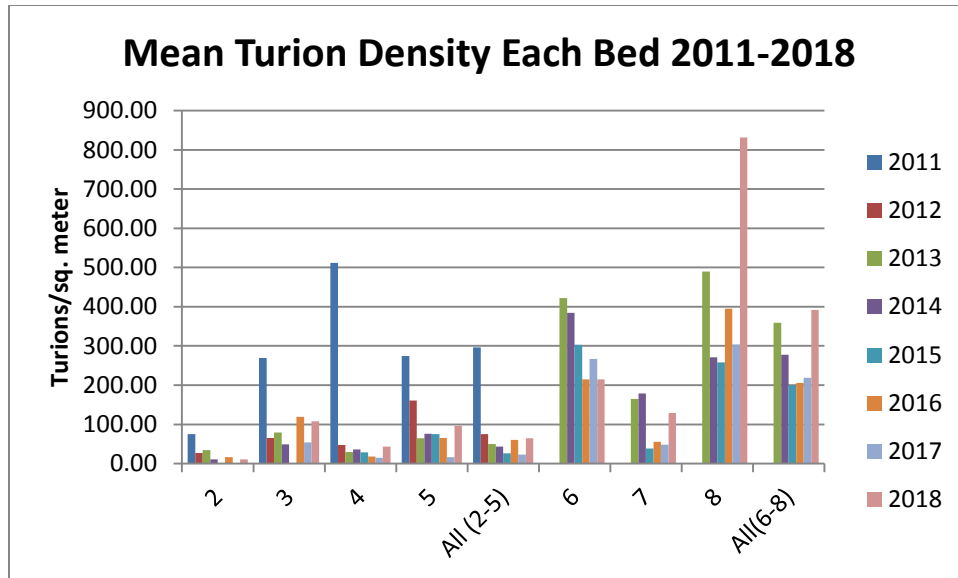
Figure 8: Graph of turion density for each bed from 2011 to 2018.

As would be expected, the turion density increased overall in 2018. This is due to the fact that CLP was not treated and the CLP plants grew and produced turions, which settled into the sediment. The overall trends shown in the line graph of all beds indicate that Beds 2-5, which have been treated for a longer period, have much lower turion density than beds 6-8. Beds 2-5 increased some in 2018, but remain relatively low compared to Beds 6-8.

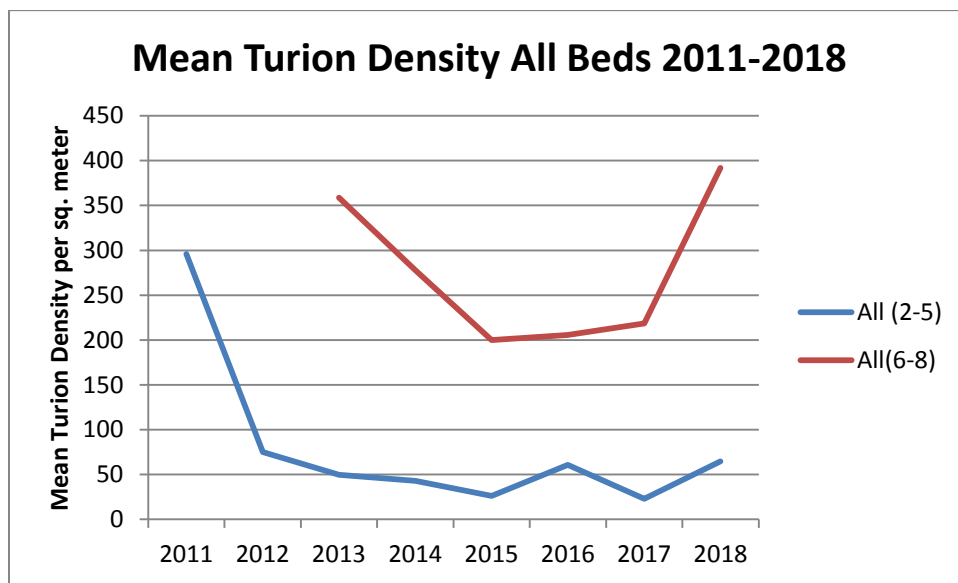
Figure 9: Graph showing turion density trends. Beds 2-5 are separated from 6-8 as these beds have been treated for different numbers of years.
