# Emma Lake

## Emma Lake AIS Monitoring and Water Clarity Report

Field Date: June 14<sup>th</sup>, 2018  
WBIC: 983500  
Previous AIS Findings: None  
New AIS Findings: None  
Field Crew: Stephanie Boismenuue, AIS Coordinator, Aubrey Nycz, AIS Project Leader, Vanessa Niemczyk, AIS Project Assistant, and Jody Partin, AIS Project Assistant, Oneida County Land and Water Conservation Department  
Report By: Vanessa Niemczyk

WBIC: 983500  
Previous AIS Findings: None  
New AIS Findings: None  
Field Date: July 15, 2016  
Field Crew: Stephanie Boismenu, AIS Coordinator, and Aubrey Nycz, AIS Project Assistant, Oneida County Land and Water Conservation Department  
Report By: Aubrey Nycz

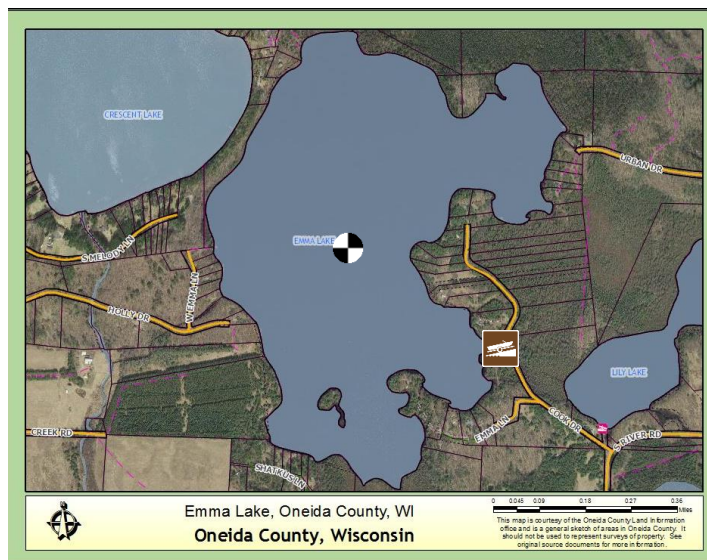
Figure 2. Map of Emma Lake with boat landing and location of Secchi disk reading labeled.

Secchi: The Secchi reading on this lake was 4 feet out of a 17 foot maximum depth. The water color was a brownish color, and appeared murky when glancing across the lake.

Public boat landing
-

Deep hole & location of Secchi disk reading

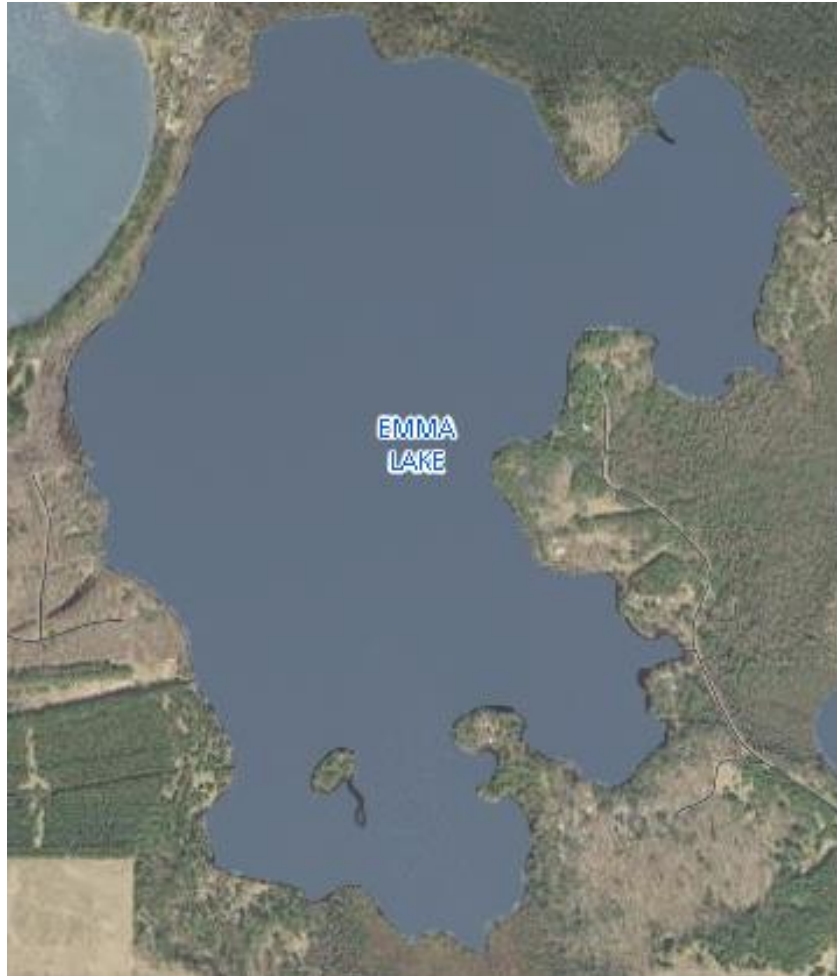
**Figure 2.** Map of Emma Lake; the red circle shows where we entered the lake, the yellow square shows where the deep hole can be found, the green triangle shows where we obtained our Secchi Disk coordinates.

The Secchi reading on this lake was 3.5 feet out of a 17 foot max depth. The water color was a dark tea color, so I was not surprised that we could not see very far into the water.

WDNR Secchi Disk Readings: Emma Lake - Deep Hole LATITUDE 45.59 LONGITUDE -89.50
