Madeline Lake

Oneida County, Wisconsin

Madeline Lake AIS Boat Launch and Shoreline Surveillance Monitoring Report

Madeline Lake AIS Monitoring and Water Clarity Report

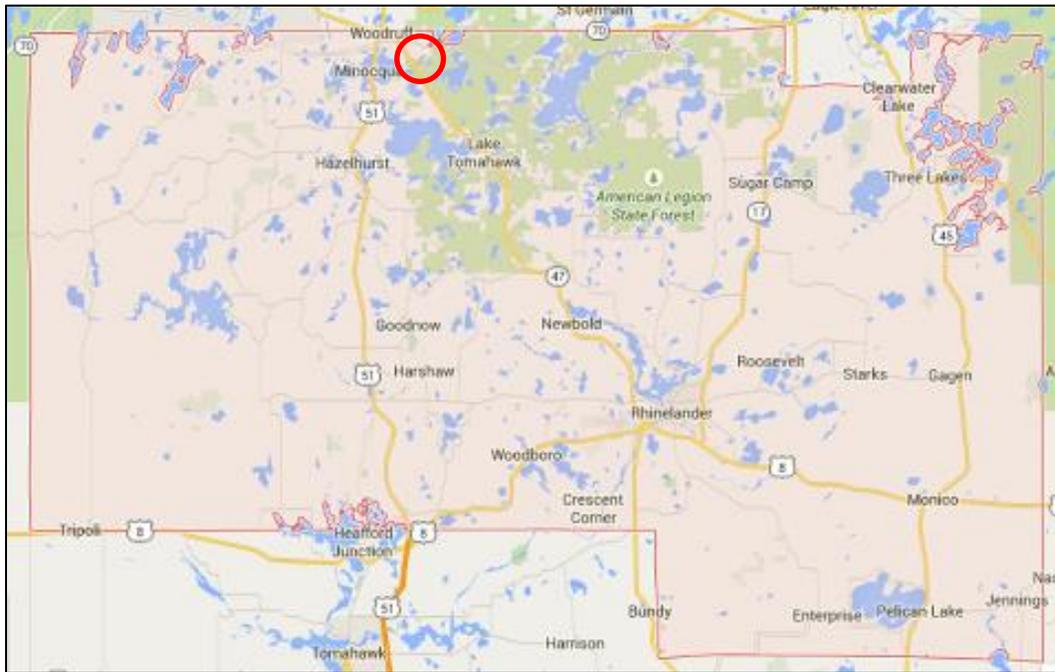
Figure 2. AIS Boat Launch and Shoreline Surveillance Monitoring Location.

On May 31, 2020, Aubrey Nycz, AIS Lead Project Assistant, visited the Madeline Lake boat landing located on Boat Landing Road, in Oneida and Vilas Counties, to perform an AIS landing check (Figure 1). The main duties performed at AIS landing checks are to inspect shoreline vegetation, shallow aquatic vegetation, deeper aquatic vegetation (via rake), look for invasive animals, and replace old signs if needed. A GPS unit can be used to mark where the AIS check is performed, and to also mark invasive organisms if found. For today's landing check, I used the GPS on my phone to gather coordinates.

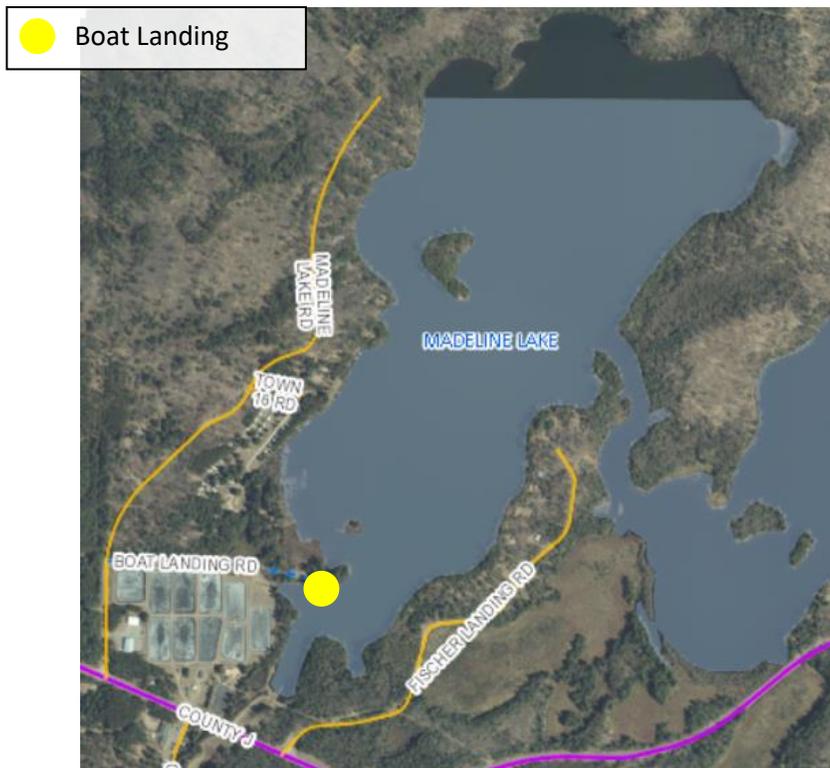
Madeline Lake contains a variety of invasive species. According to the Wisconsin Department of Natural Resources, Banded Mystery Snails, Chinese Mystery Snails, Purple Loosestrife, and Rusty Crayfish are already present in the lake. While monitoring at the boat landing, I did not find any invasive species.

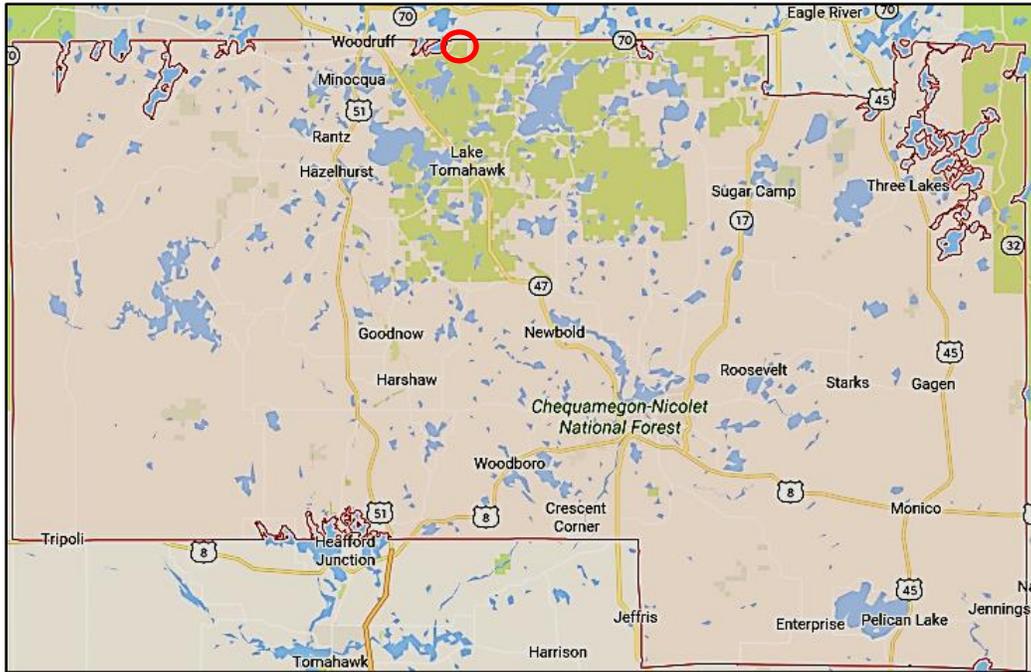
Figure 2. Map of Madeline Lake with boat landing and location of Secchi disk reading labeled.

To observe the water clarity and quality of Madeline Lake, Aubrey and I went to the deep hole towards the eastern side of the lake. After locating the deep hole with our sonar unit, we used a Secchi disk to measure water clarity and a dissolved oxygen meter to measure water health. Oxygen is needed for a healthy fish population, and also for plants to respire at night as well. The

Secchi: The Secchi reading on this lake was 10.5 feet out of a 17 foot maximum depth. The water color was a greenish color, and appeared murky when glancing across the lake.

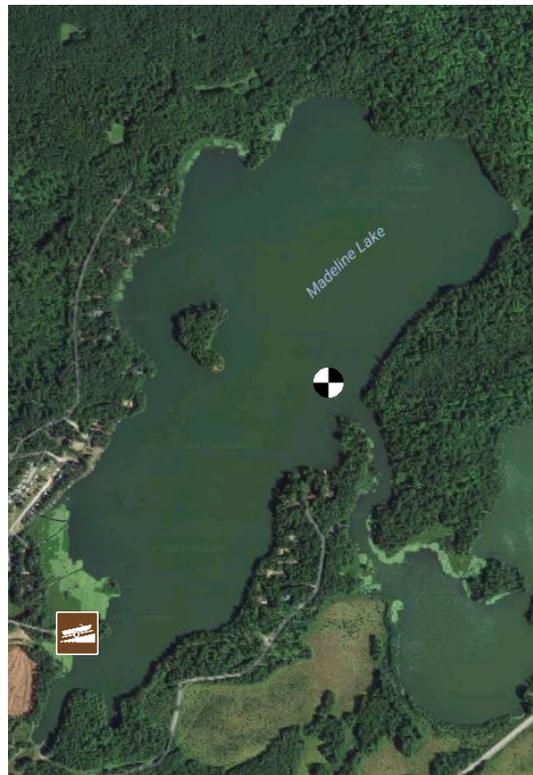
Public boat landing

Deep hole & location of Secchi disk reading

Secchi Disk Readings:
Madeline Lake - Deep Hole
Coordinates – 45.89
-89.64

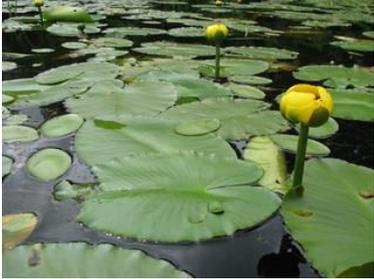
<p>Bullhead Pond Lily (Spatterdock)</p> <p><i>Nuphar variegata</i></p>	<p>An aquatic plant with heart-shaped leaves that can grow to be 15 inches long. This plant also has a yellow, cup-shaped flower. This plant is native.</p>

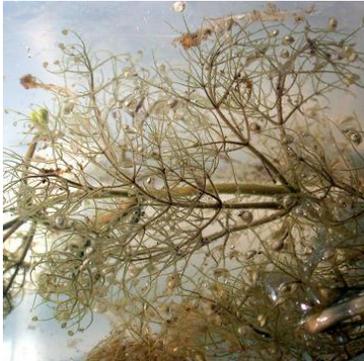
<p>Large Purple Bladderwort</p> <p><i>Utricularia purpurea</i></p>	<p>An aquatic plant with leaves containing small sacks that trap small invertebrates. This plant usually has unrooted stems that easily tangle with other plants. In the water, this plant tends to look cloudy or slimy. This plant is native.</p>
