# Bass Lake

## **Bass Lake AIS Monitoring and Water Clarity Report**

WBIC: 970000  
Previous AIS Findings: None  
New AIS Findings: None  
Field Date: July 8<sup>th</sup>, 2020  
Field Crew: Aubrey Nycz, Lead AIS Project Assistant, and Rachel Cook, AIS Project Assistant, Oneida County Land and Water Conservation Department  
Report By: Rachel Cook

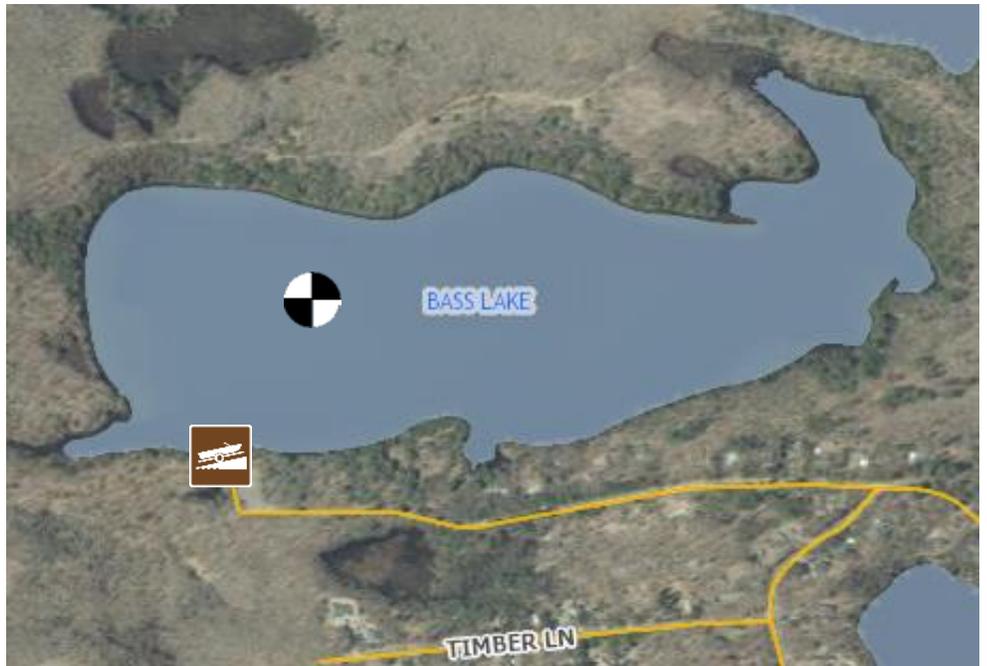
**Figure 2.** Map of Bass Lake with boat landing and location of Secchi disk reading labeled.

Deep hole & Secchi Disk Reading
-

Boat Landing

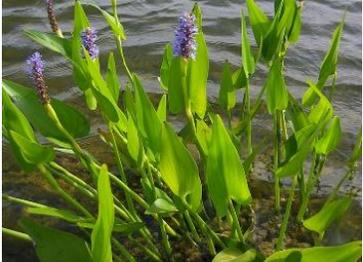
<b>Common Name</b> <b>Scientific Plant Name</b>	<b>Description</b>	<b>Image</b>
<p>Pickerel Weed</p> <p><i>Pontederia cordata</i></p>	<p>An aquatic plant with thin, bright green leaves. Emergent leaves tend to be arrow shaped with 6 parted, blue flowers. This plant is native.</p>

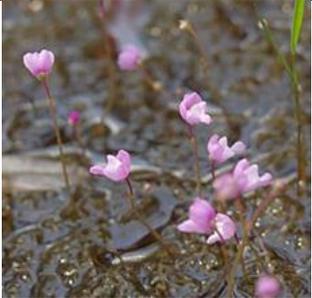
<p>Photo Credit: <i>asapaquatics.com</i></p>
<p>Large Purple Bladderwort</p> <p><i>(Utricularia purpurea)</i></p>	<p>Long stems up to several feet, often forming large patches. Leaves fine, arranged in whorls of 5-7, with scattered tiny bladders on the tips of the leaves. Flowers are purple, 5-parted, 2-lipped, the lower lip having three lobes and a yellow spot. This plant is native.</p>
