Buffalo Lake

Buffalo Lake AIS Monitoring and Water Clarity Report

Field Dates: June 15th and June 16th, 2020
WBIC: 974200
Previous AIS Findings: Chinese Mystery Snail, Purple Loosestrife
New AIS Findings: Yellow Iris
Field Crew: Aubrey Nycz, AIS Project Leader, and Rachel Cook, AIS Project Assistant,
Oneida County Land and Water Conservation Department
Report By: Rachel Cook

Field Date: August 2nd, 2017
WBIC: 974200
Previous AIS Findings: Chinese Mystery Snail
New AIS Findings: Purple Loosestrife
Field Crew: Aubrey Nycz, AIS Project Leader, and Thomas Boisvert, AIS Project Assistant, Oneida County Land and Water Conservation Department
Report By: Thomas Boisvert

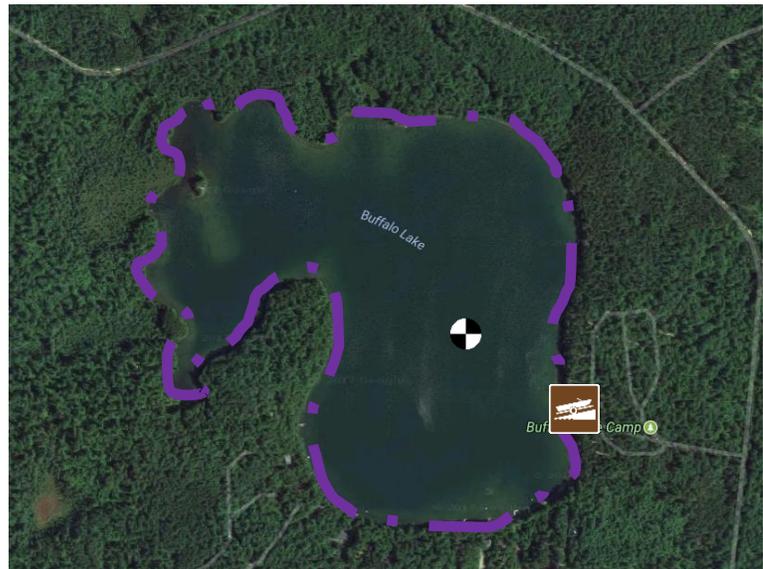
Figure 2. Map of Buffalo Lake with boat landing and location of Secchi disk reading labeled.

Purple Loosestrife was found along 80% of the shoreline on Buffalo Lake. Two yellow iris plants were found in the southwest corner of the lake on the shoreline.

Secchi: The Secchi reading on this lake was 12 feet out of a 25 foot maximum depth. The water looked clear and a blue/gray color, and the surface was a little wavy due to some wind.

Deep hole & location of Secchi disk reading
-

Boat Landing
-

Purple Loosestrife

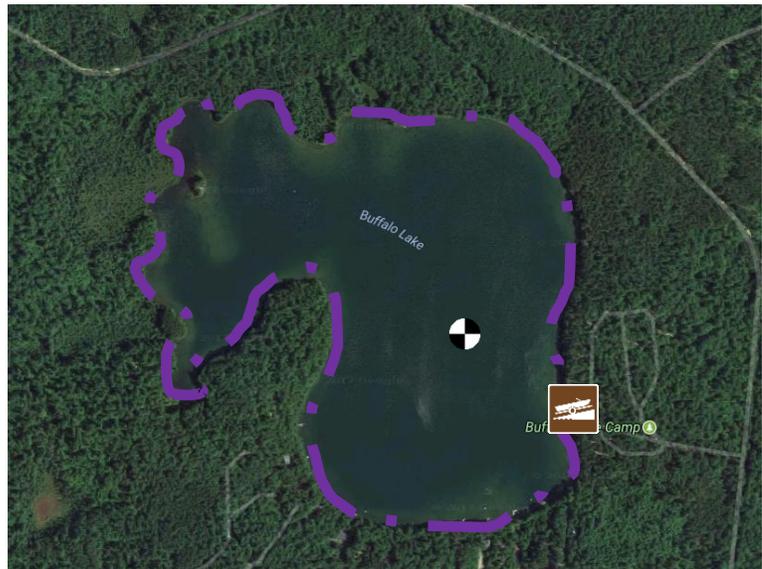
Figure 2. Map of Buffalo Lake with boat landing and location of Secchi disk reading labeled.

Purple Loosestrife was found along 80% of the shoreline on Buffalo Lake.

Secchi: The Secchi reading on this lake was 13 feet out of a 27 foot maximum depth. The water color was a grayish color, and was hard to see down with the waves on the lake.

Deep hole & location of Secchi disk reading
- Secchi Disk Readings:
Buffalo Lake - Deep Hole
Coordinates - Not Available
-

Boat Landing
-

Purple Loosestrife
