Hanson Lake

Hanson Lake AIS Monitoring and Water Clarity Report

Field Date: July 16th, 2020
 WBIC: 988200
 Previous AIS Findings: None
 New AIS Findings: None
 Field Crew: Aubrey Nycz, AIS Project Leader, and Rachel Cook, AIS Project Assistant,
 Oneida County Land and Water Conservation Department
 Report By: Rachel Cook

Field Date: July 18th, 2018
WBIC: 988200
Previous AIS Findings: None
New AIS Findings: None
Field Crew: Aubrey Nycz, AIS Project Leader, and Thomas Boisvert, AIS Project Assistant, Oneida County Land and Water Conservation Department
Report By: Thomas Boisvert

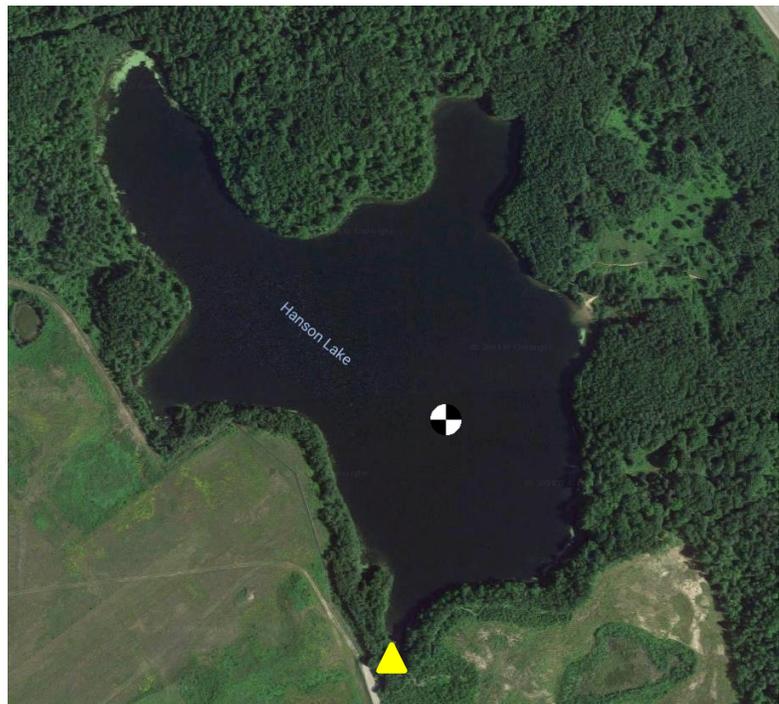
Figure 2. Map of Hanson Lake with the location of the Secchi disk reading labeled.

Deep hole & location of Secchi disk reading
-

Public Boat Landing
