ECHO LAKE BARRON COUNTY

2017 AQUATIC PLANT MANAGEMENT
IMPLEMENTATION SUMMARY REPORT
WDNR WBIC: 2630100

Prepared by: Dave Blumer, Lake Educator

January 15, 2018

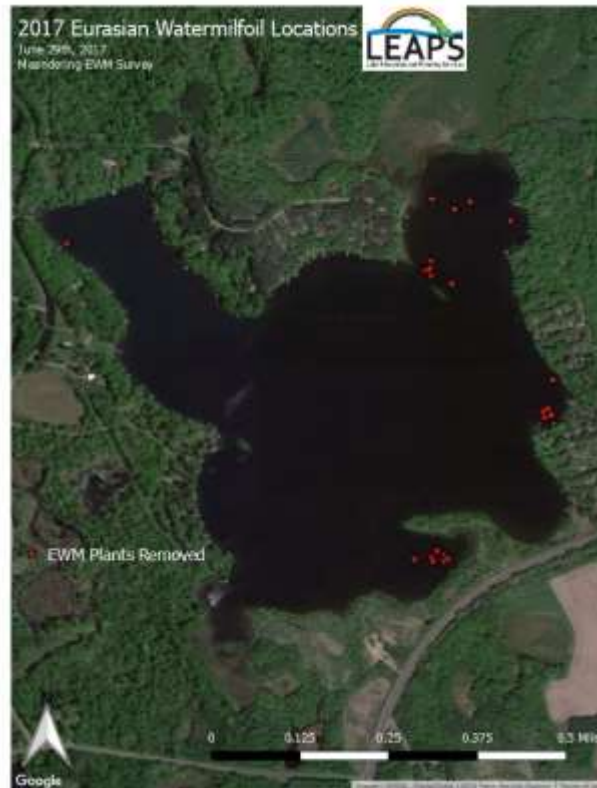
Figure 3: 2017 EWM Meandering Survey Physical Removal

In addition to the chemical treatment, the ELA also supported a meandering rake removal survey around the lake. This survey occurred on September 21st. During this survey, Dave Blumer from LEAPS and ELA president Mike Clohisy found and removed approximately 20 EWM plants spread around the lake (Figure 3). There was no EWM found in the treatment area.

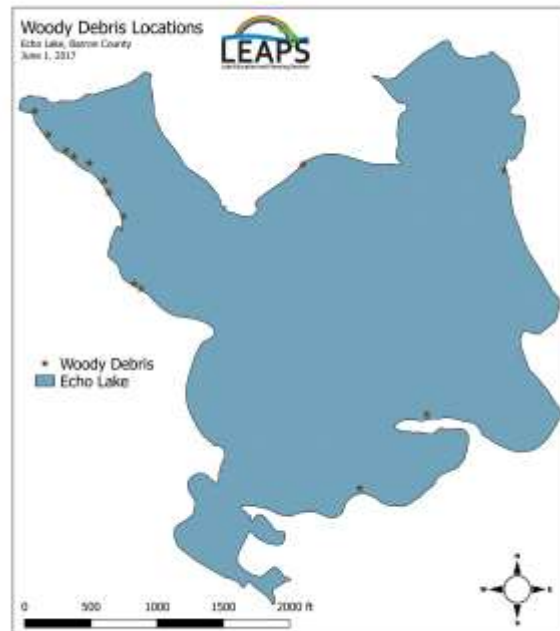
Figure 5: Woody debris around Echo Lake

This survey is intended to provide management recommendations to individual property owners based on an assessment of their property. The protocol involves photographing each parcel from the lake which is then matched to land use information about the riparian zone. For this survey, the riparian zone is defined as the strip of land, along the shore, from the high water level back 35 feet. The information collected includes ground cover which includes lawn, impervious surfaces, and native plants. Additional land use information includes the number of human structures in the riparian zone and various other runoff concerns. This protocol also assesses the amount of woody debris present in the lake however this is done for the entire lake instead of for each individual parcel. Woody debris provides habitat for fish, birds, and numerous other types of wildlife as well as providing some protection from bank erosion. The WDNR protocol defines woody debris as wood in no deeper than 2 feet of water that is at least 4 inches in diameter, at the widest point, and at least 5 feet long. This survey only found 15 pieces of qualifying woody debris around Echo Lake
