ECHO LAKE BARRON COUNTY

2018 AQUATIC PLANT MANAGEMENT
IMPLEMENTATION SUMMARY REPORT
WDNR WBIC: 2630100

Prepared by: Dave Blumer, Lake Educator

July 11, 2019

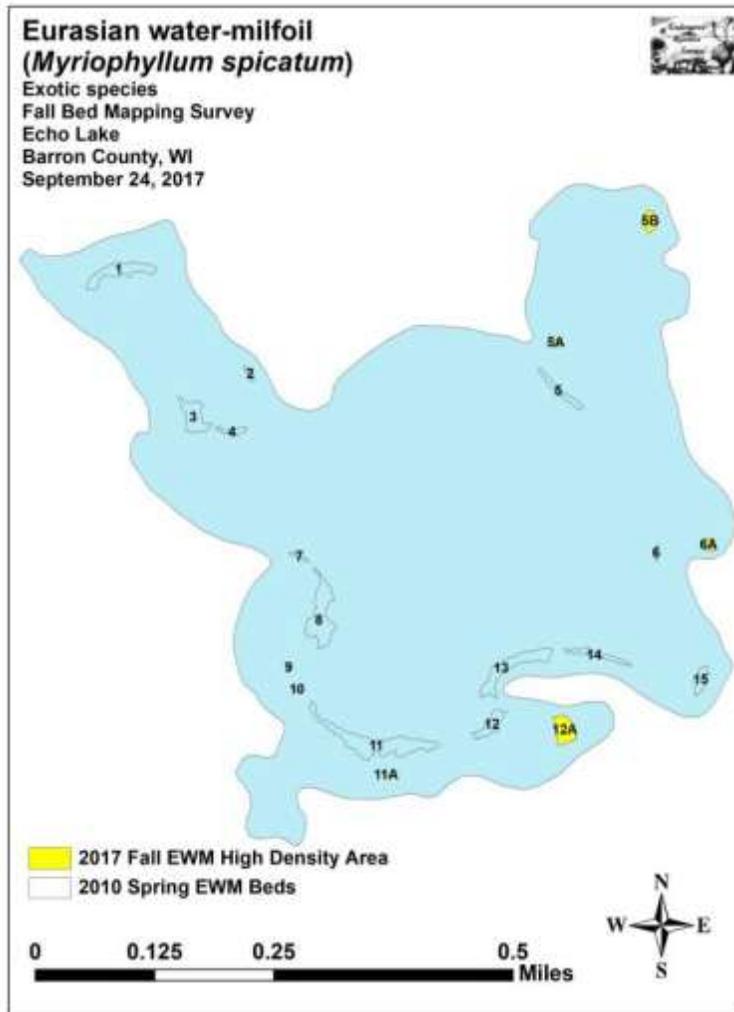
Figure 1: 2017 Fall EWM bed mapping survey

Two surveys in the fall of 2017 identified five EWM high density areas with dozens of individual or small clusters of plants (Figures 1 & 2). Individual plants in shallower water were rake removed or diver removed, but those in deeper water were not. It is the EWM in these high density areas that were targeted for chemical treatment in the spring of 2018.

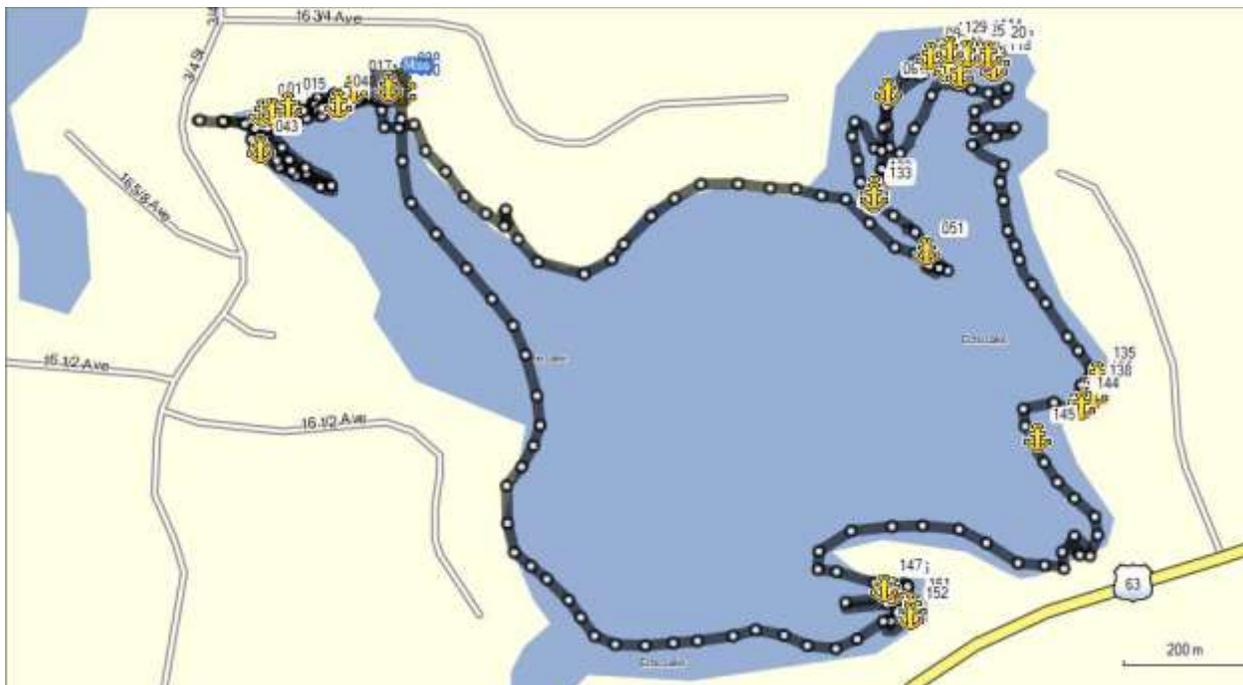
Figure 4: July 22, 2018 EWM meandering survey and physical removal

ERS returned to the lake on July 22, 2018 and repeated the earlier survey. Between the June 18 and July 22 surveys there was a sharp uptick in EWM as 143 individual and small clumps of plants were found and rake removed. Like in June, the majority of plants were along the northwest shore and in the northeast bay. A few plants were found in the south bay along the highway and in the east central bay (Figure 4).

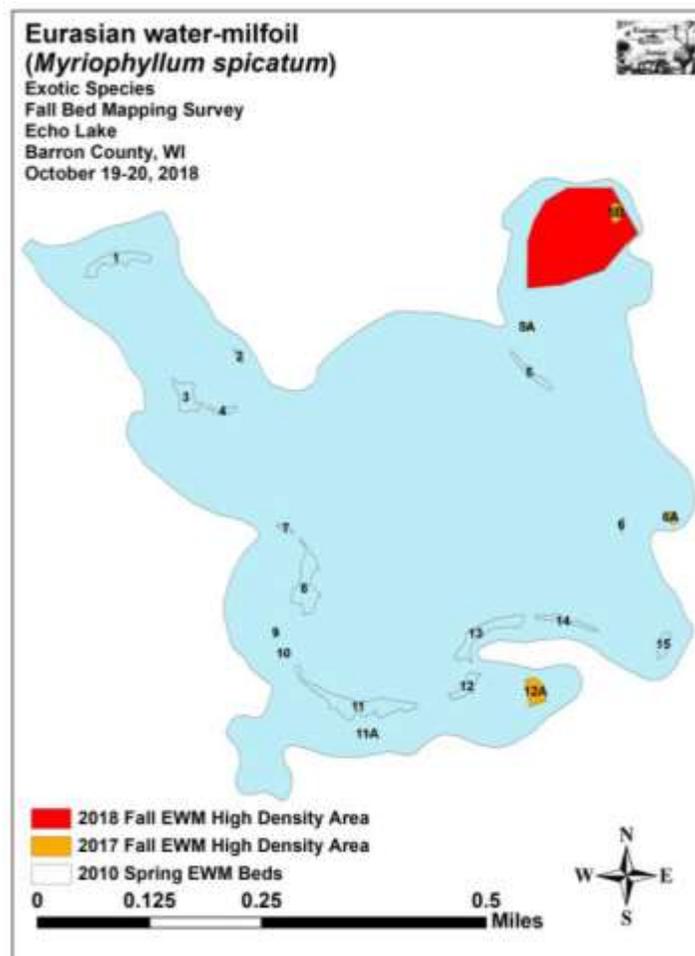
Figure 5: 2017 and 2018 EWM high density areas (ERS, 2018)

Finally, ERS returned to the lake in October to do a fall survey and rake removal. During the survey, 180 plants were found. Like 2017, no true beds of EWM were mapped however; the northeast bay where 165 of the 180 were located, a high density area was delineated covering 6.38 acres. This was more than five acres greater than the total of all five high density areas delineated in the fall of 2017 and the highest total acreage in the last seven years (Table 2, Figure 5). A few additional plants were found along the northwest shore, but rake removal earlier in the season seemed to be effective at keeping the levels down. Only a couple of plants were found in the southeast bay along the highway during the October survey, and these were rake removed.

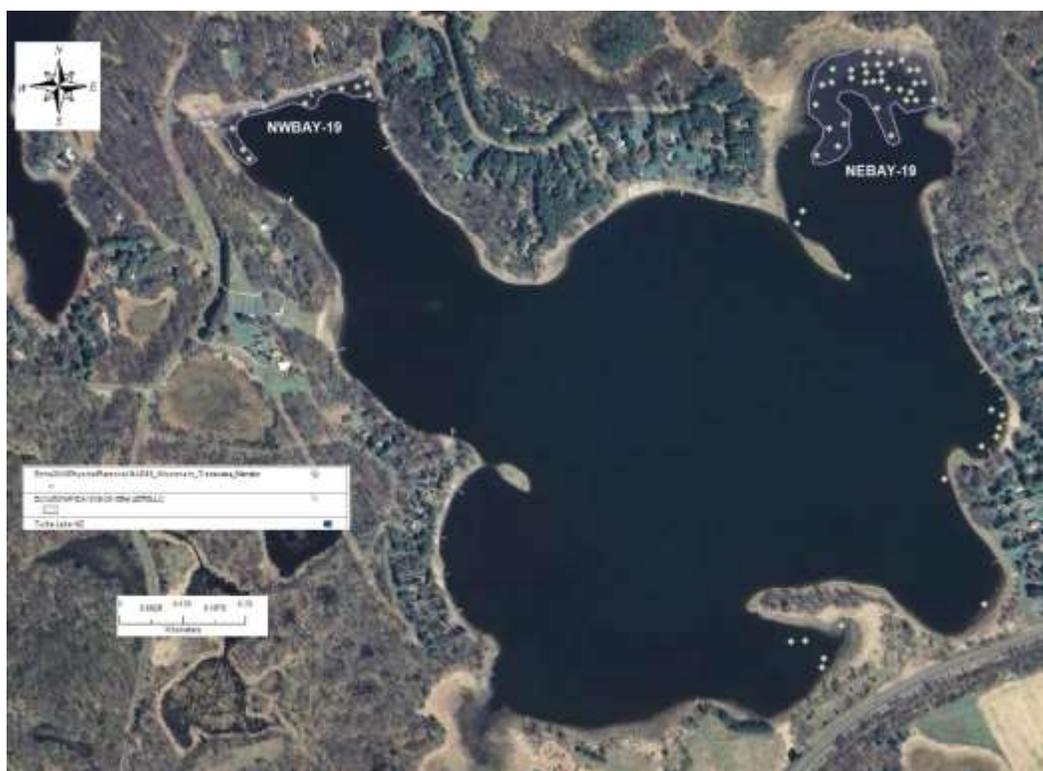
Figure 6: 2019 Echo Lake preliminary EWM treatment proposal map (LEAPS, 2019)

Based on 2018 EWM survey and rake removal results, two areas covering 6.44 acres were proposed for chemical treatment in the spring of 2019 (Figure 6, Table 3). The majority of EWM found and rake removed in Echo Lake in 2018 was in the northeast bay and along the northwest shoreline. It is these two areas that were included in the 2019 preliminary EWM treatment proposal.

2019 Echo Lake Preliminary EWM Treatment Plan 3-31-2019(LEAPS)						
Name	Acres	Mean Depth (feet)	Acre-feet	Target 2,4-D (ppm a.e.)	Shredder Amine 4 Application (gallons)	Shredder Dose (gallons/acre)
NEBAY-19	4.81	6.4	30.78	4.00	87.4	18
NWBAY-19	1.63	6.3	10.27	4.00	29.2	18
TOTAL	6.44		41.05		116.6	
Estimated Herbicide Cost						
DMA 4/ Shredder Amine 4			liquid 2,4-D	116.6	40.00	\$4,664.00

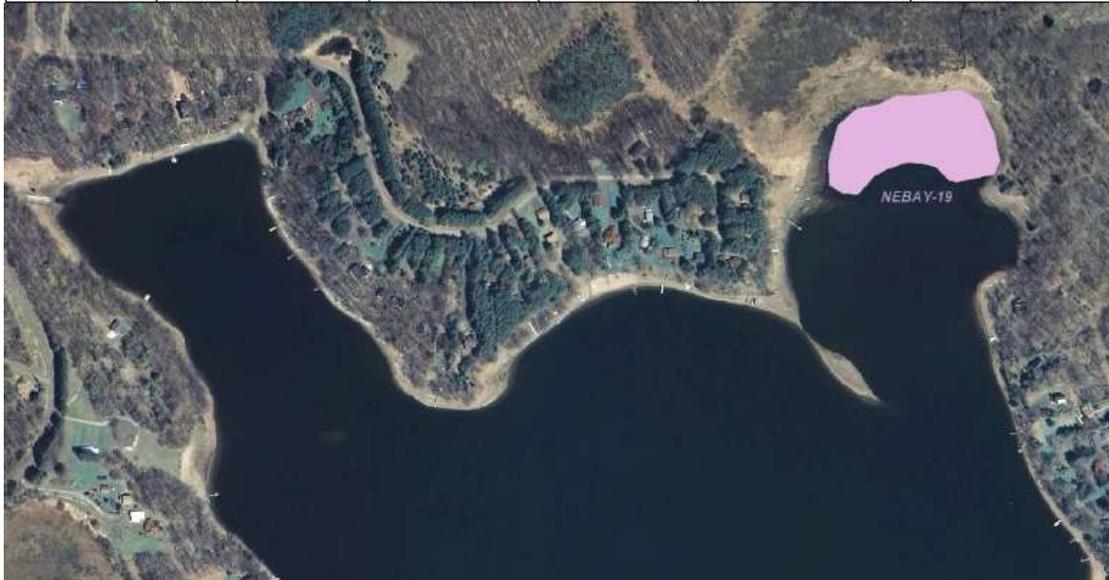
Figure 7: 2019 Echo Lake final EWM chemical treatment (LEAPS, 2019)

Two pre-treatment readiness surveys for EWM were completed on Echo Lake in the spring of 2019. On May 25, 2019 LEAPS was on the lake surveying the proposed treatment areas for EWM. Several individual plants were found in the northeast bay, but nowhere else. LEAPS returned to the lake on June 2 and again surveyed the proposed treatment areas and the rest of the lake. More plants were found in the northeast bay, but only two isolated plants were found along the northwest shoreline, and these were removed. As a result of the readiness survey work, the proposed treatment area along the northwest shore was canceled. The northeast bay treatment area was modified to include a smaller, but more congruent treatment area with less area extended into untreated water (Figure 7). The treatment was completed on June 6th. The water temperature was 76°F. No post-treatment survey work had been completed yet when this document was prepared.

2019 Echo Lake FINAL EWM Treatment Plan 6-02-2019(LEAPS)						
Name	Acres	Mean Depth (feet)	Acre-feet	Target 2,4-D (ppm a.e.)	Shredder Amine 4 Application (gallons)	Shredder Dose (gallons/acre)
NEBAY-19	3.84	7.50	28.80	4.00	81.8	21
TOTAL	3.84		28.80		81.8

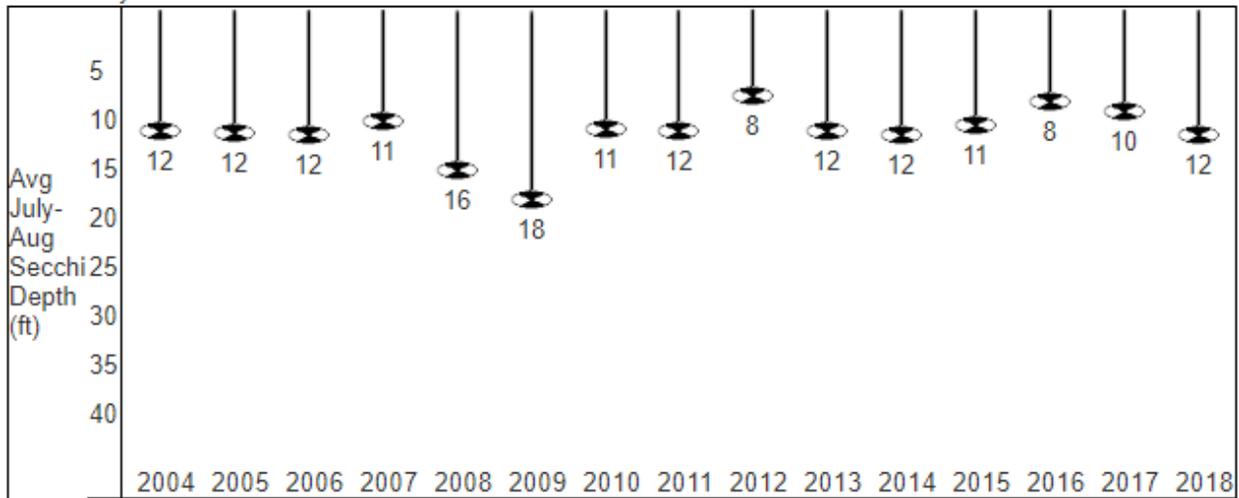
Figure 8: Average summer (July and August) Secchi disk readings at the Deep Hole

Water quality testing as a part of the CLMN Expanded Monitoring Program continued on Echo Lake in 2018. Total phosphorus testing was completed on three dates in 2018. Dissolved oxygen and temperature profiles were completed on four different dates, and chlorophyll a was completed on two dates. Figure 8 shows the average summer (July-August) Secchi disk readings since CLMN began. In 2018, the average summer (July-Aug) Secchi disk reading for Echo Lake - Deep Hole (Barron County, WBIC: 2630200) was 12 feet, up 2.5 feet from 2017 and 3.5 feet from 2016. The average for the Northwest Georegion was 8.6 feet in 2018. Typically the summer (July-Aug) water was reported as **clear** and **green**.

Past secchi averages in feet (July and August only).

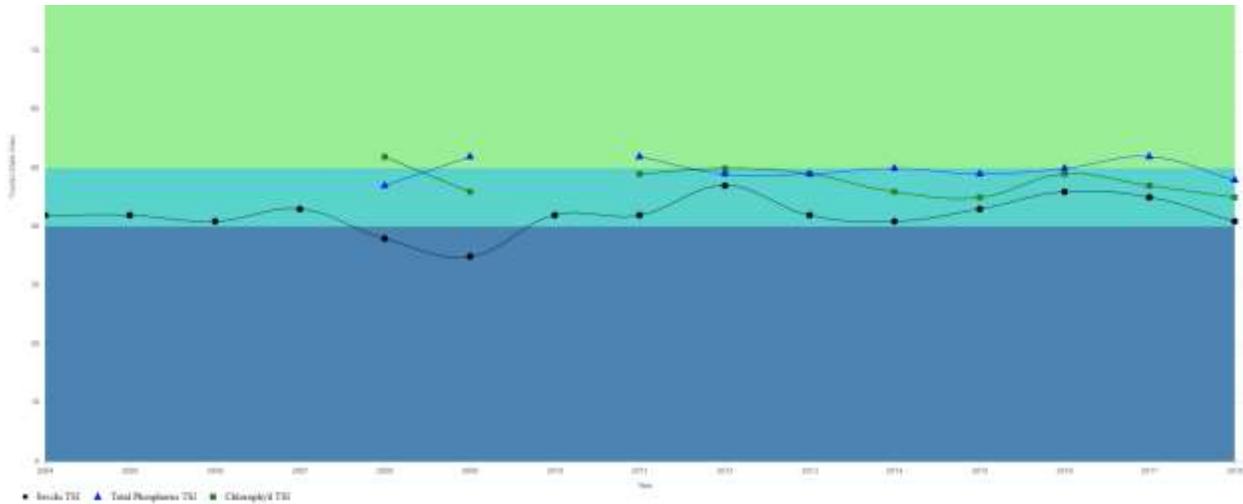
Figure 9: Summer (July and August) TSI values for total phosphorus and chlorophyll-a at the Deep Hole on Echo Lake

The overall Trophic State Index (based on chlorophyll) for Echo Lake - Deep Hole was 45, two points lower than it was in 2017, and four points lower than it was in 2016 (Figure 9). This TSI suggests that Echo Lake - Deep Hole was solidly mesotrophic in 2018. Mesotrophic lakes are characterized by moderately clear water, but have an increasing chance of low dissolved oxygen in deep water during the summer.

Chemistry data was collected on Echo Lake - Deep Hole in 2018. The average summer Chlorophyll was 3.7 µg/l compared to a Northwest Georegion summer average of 16.1 µg/l. The summer Total Phosphorus average was 13.1 µg/l, way lower than 2017 and lower than 2016. Lakes that have more than 20 µg/l and impoundments that have more than 30 µg/l of total phosphorus may experience noticeable algae blooms.
