VERMILLION LAKES BARRON COUNTY

2020 AQUATIC PLANT MANAGEMENT
IMPLEMENTATION SUMMARY REPORT
WDNR WBIC: LOWER VERMILLION 2098200;
UPPER VERMILLION 2098800

Prepared by: Dave Blumer, Lake Educator

January 21, 2021

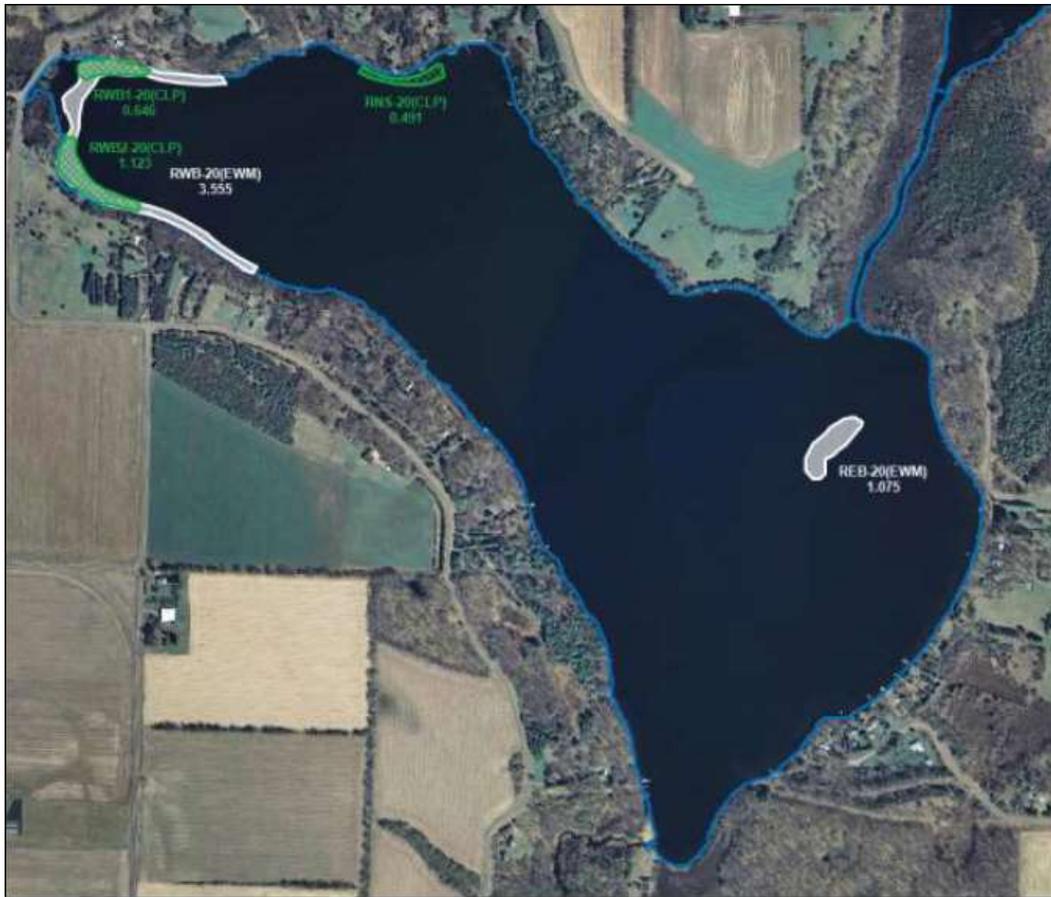
Figure 2: 2020 Proposed CLP (green) and EWM (white) chemical treatment map

Based on these results, a preliminary chemical treatment proposal for 2020 was set up covering 5.13 acres of the lake. This included 2.26-ac of CLP and 4.64-ac of EWM with 1.77 acres of overlap (Table 1, Figure 2).
