Surveys of Lower Wisconsin River Floodplain Lakes
Sauk County, Wisconsin

Lakes Planning Grant Study

Sauk County Land Conservation Department

3rd Draft - February 2009

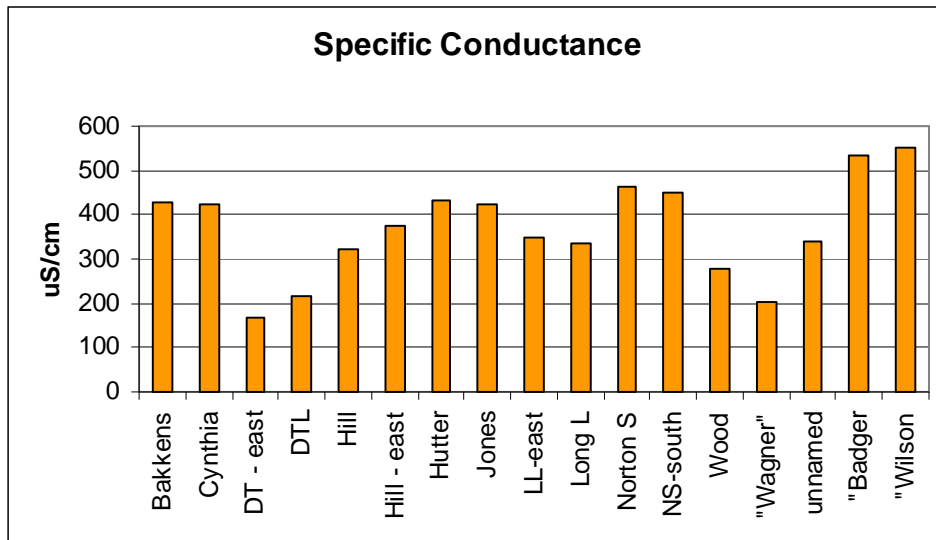
Figure 3: Specific conductance levels (uS/cm - 0.5 m depths) are a measure of dissolved solids in water.

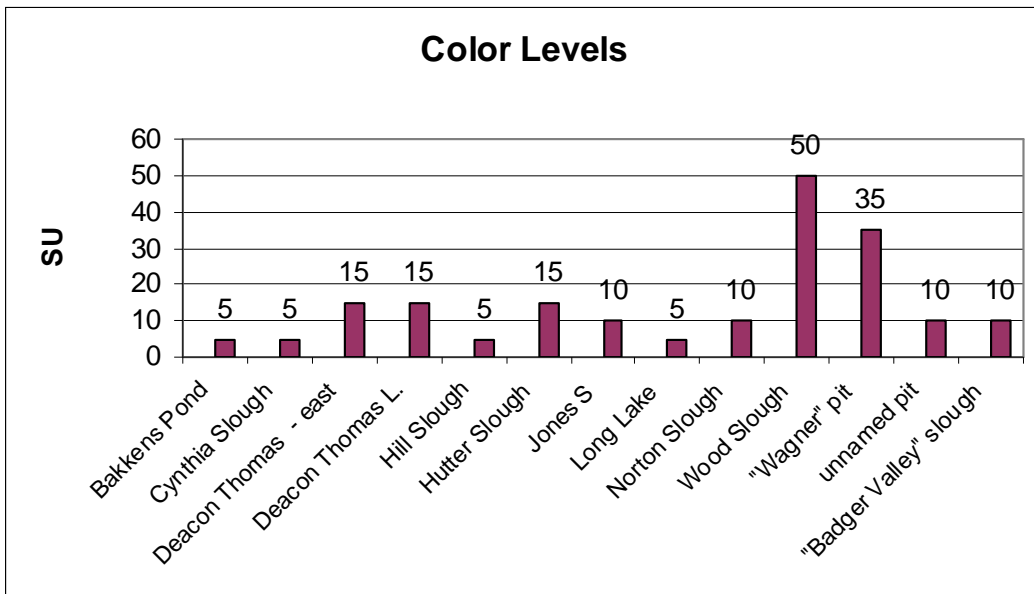
Figure 7: Color levels – measure of organic compounds when alluvial groundwater and wetland drainage are high.

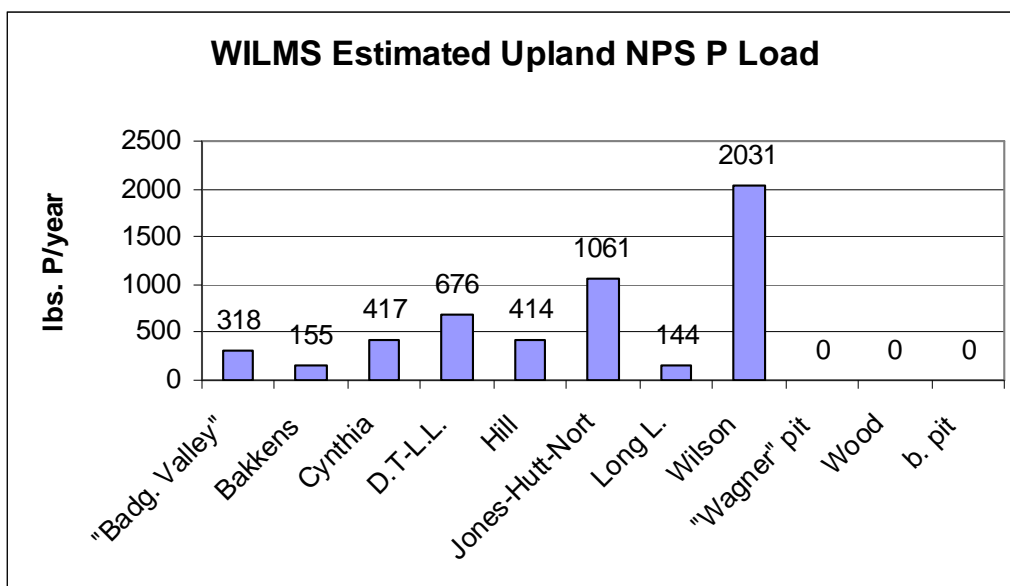
Figure 8: Estimated upland annual phosphorus loads (WILMS)

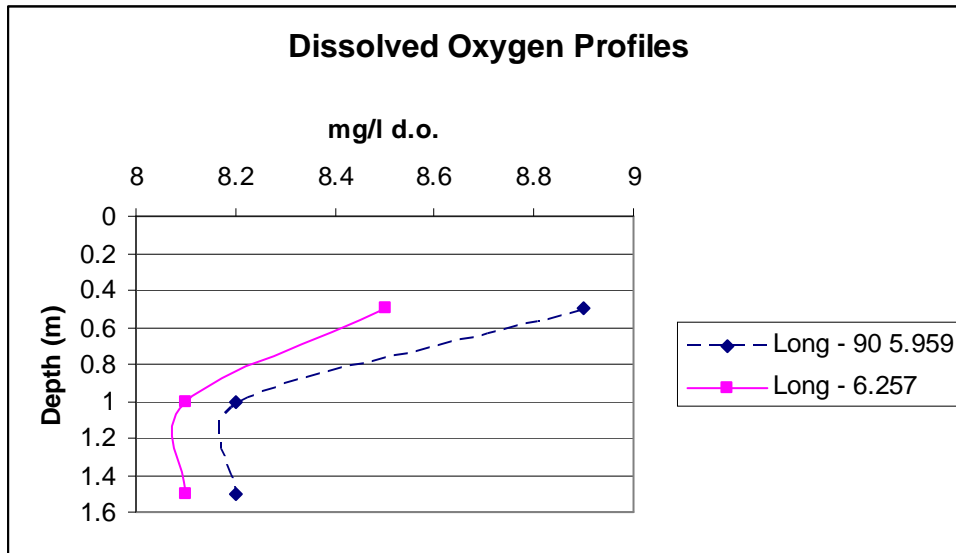
Figure 20: Dissolved oxygen profiles from two locations in Hill Slough.

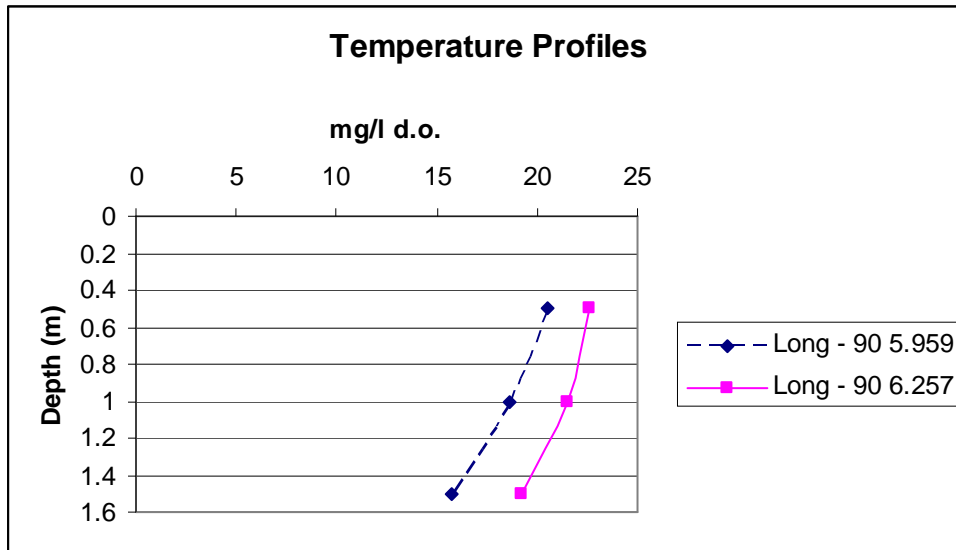
Figure 21: Temperature profiles from two locations in Hill Slough.

(Figure 21) in the first bay suggested upland groundwater inputs. Specific sources of groundwater or springs were not found along either bay.

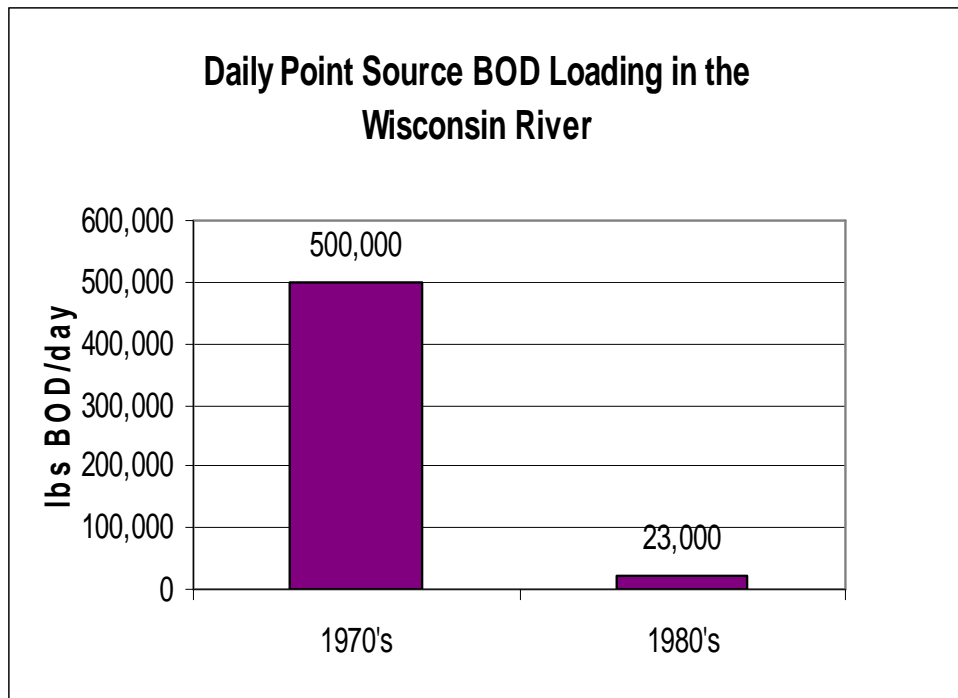
Figure 26: Decline in upper river point source pollution
