Bad Axe-LaCrosse River Basin, Wisconsin

Map 1: Bad Axe River Watershed

DNR PUB WT-933

Bad Axe River Watershed

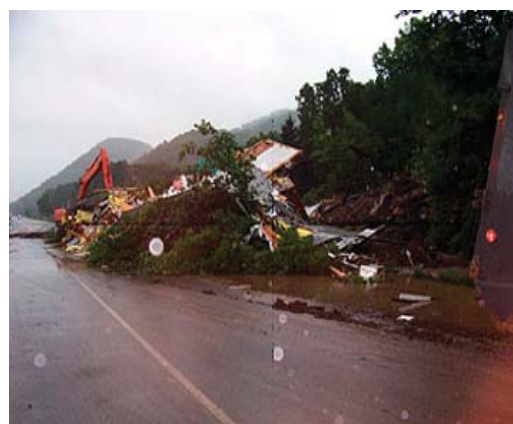
Mudslide that moved a house onto HWY 35 in Vernon County during August 18, 2007 flood. WDNR Photo

Steep hillsides became unstable with the excessive rain and many slumped or slid down to the lowest spot destroying some buildings and roads in the process (See photo upper right). Many stream miles and structures were unharmed due to the effectiveness of these flood control structures during both the 2007 and 2008 flood events.

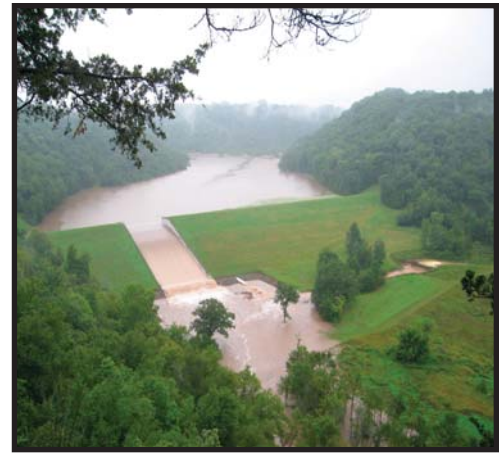
Floodwaters flowing over the emergency concrete spillway of the Springville Dam on the Springville Branch of the Bad Axe River. August 20, 2007.

damaged. Saturated soils on hillsides slumped and created mudslides; bridges and culverts were washed out; roads were flooded; and flood control structures were stressed to their limits. Emergency spillways were compromised at many dams in Vernon County. The waters behind the dam located on the Springville Branch of the Bad Axe River reached its concrete emergency spillway, which was an historic event.

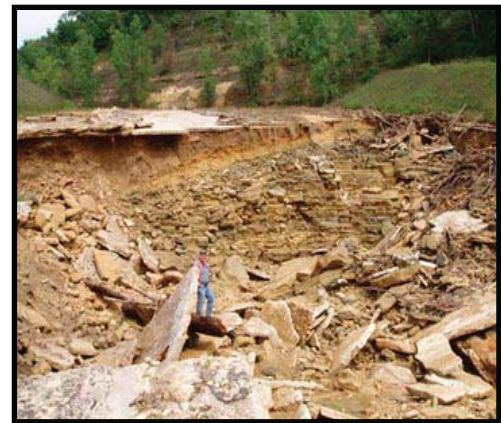
Aftermath of floodwater scour of the Runge Hollow Lake Dam emergency spillway on the North Fork of the Bad Axe River. August 23, 2007.

Bad Axe River watershed resulting in overflow to their emergency spillways. Destructive scour by the excess water required extensive repair. The waters behind the Bad Axe 11 – Duck Egg dam (on the Springville Branch of the Bad Axe River) reached a height never before recorded.

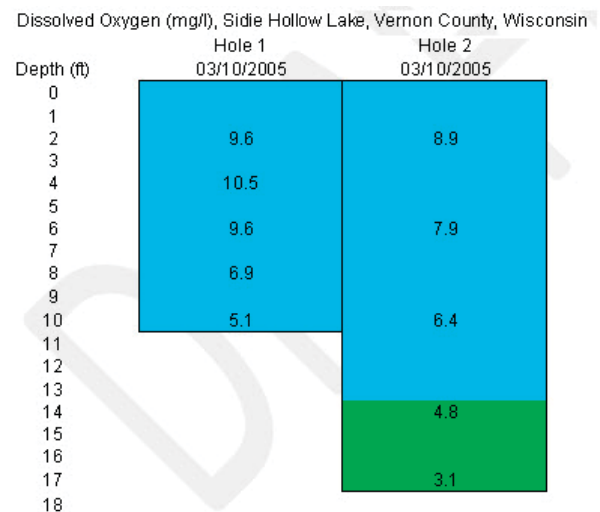
Figure 2. Sidie Hollow Lake Profile, 3/05

An early spring snowmelt event took place on March 8-9, 2005 in south western Wisconsin. Manure spreading of farm fields was prevalent during this unusually early warm spell. Runoff of snowmelt with recently applied manure caused a major fish kill of Jersey Valley Lake, an impoundment in a neighboring watershed. This event prompted monitoring of Sidie Hollow Lake. The lake did have an area of depressed dissolved oxygen (3.1 mg/l) at the deepest point, but no fish kill (Figure 2, previous page).

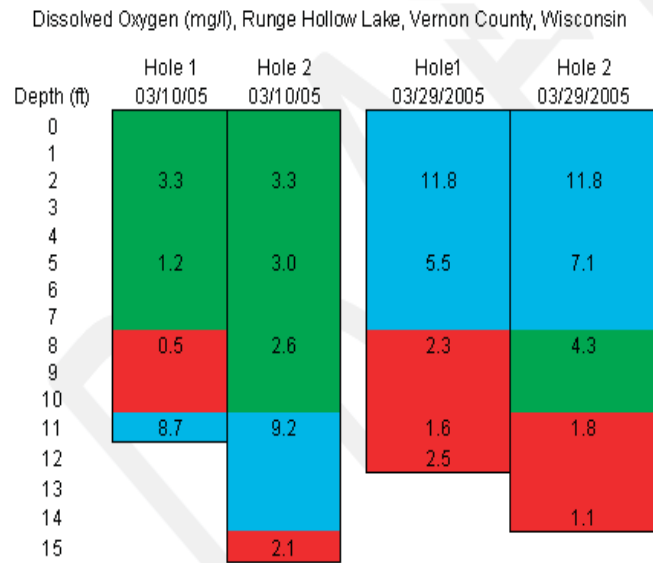
Figure 3. Runge Hollow Lake Profile, 3/05

An early spring snowmelt event took place on March 8-9, 2005 in south western Wisconsin. Manure spreading of farm fields was prevalent during this unusually early warm spell. Runoff of snowmelt with recently applied manure caused a major fish kill of Jersey Valley Lake, an impoundment in a neighboring watershed. This event prompted monitoring of Runge Hollow Lake. On March 10, 2005 Runge Hollow Lake did contain areas of very low dissolved oxygen, however there was a zone of refuge for fish containing between 8 and 9 mg/l of dissolved oxygen. A follow up survey on March 29, 2005 showed a larger area of low dissolved oxygen but also a larger total area of adequate levels. The watershed of Runge Hollow Lake is much larger than Sidie Hollow Lake and contains a larger percentage of farm fields that may have been spread with manure prior to the snowmelt. Runge Hollow Lake is certainly susceptible to winterkill due to manure laden snowmelt, but did not kill during this March 2005 event (see Figure 3).

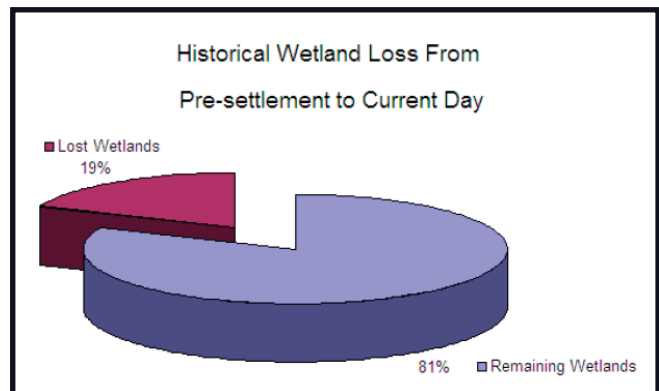
Figure 4: Historical Wetland Losses

The Bad Axe LaCrosse Basin, in the driftless area of the state, has few wetland resources. Only about 2% of the current land uses in the watershed are wetlands. However, 81% of original wetlands in the watershed are estimated to exist (Figure 4). Of these wetlands, the majority are forested wetlands (51%) and emergent wetlands (40.9%) which include marshes and wet meadows.

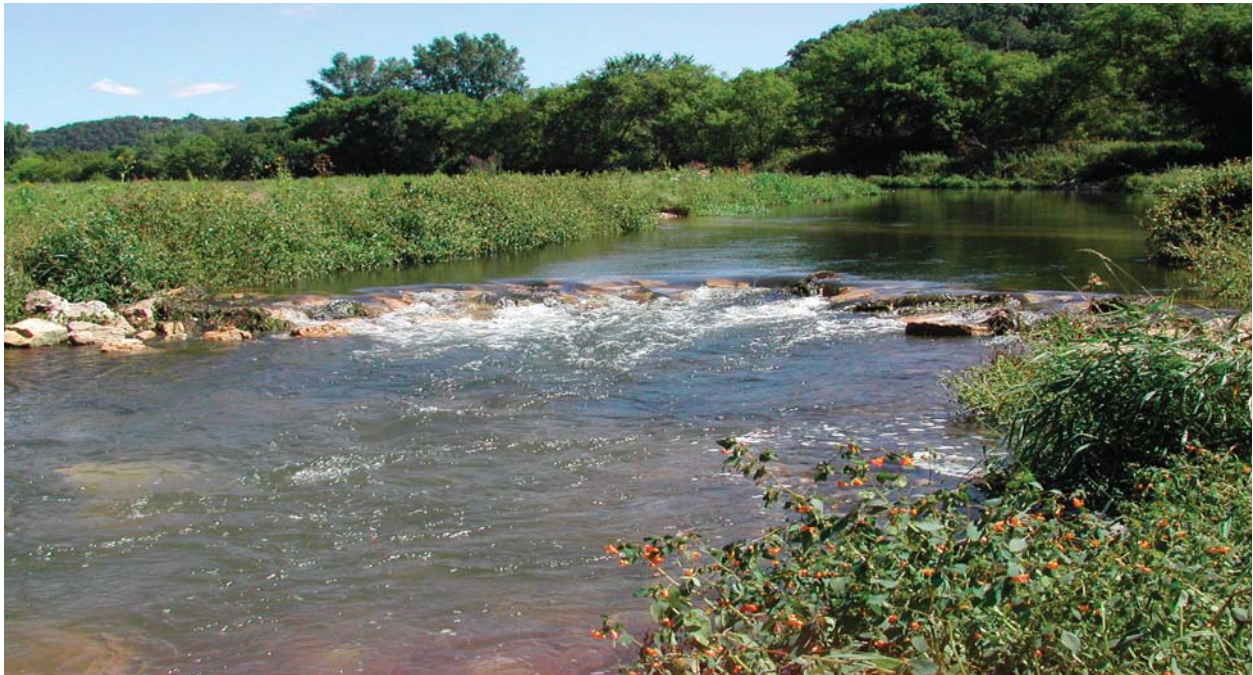
Stream Habitat Restoration, Bad Axe River. WDNR Photo, 2010.

Trout stamp funds have been used over the last 33 years to reshape many of these streambanks through movement of soil and planting of grasses, effectively giving the streams access to a new floodplain. After the floods of 2007 and 2008, those segments of streams where streambank work was done showed no catastrophic changes compared to those segments without reshaped and planted streambanks. Very little repair of the previous streambank work was necessary.
