## 2011 Water Quality Management Plan Update

Lower Wisconsin Basin, Wisconsin

November 2011

Map 1: Lower Kickapoo River Watershed

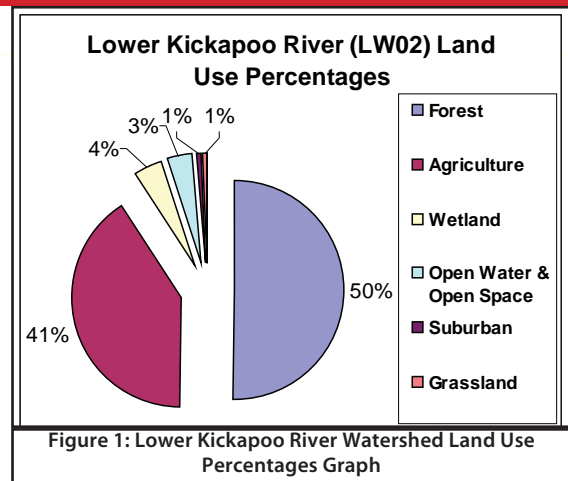
Figure 1: Lower Kickapoo River Watershed Land Use Percentages Graph

Forest and agriculture dominate land use in this watershed with 50% and 41% of the total area, respectively. Wetlands and open water and open space come in well behind in land use with only four percent and three percent, respectively. Suburban landscapes cover less than one percent of the watershed's area and grassland only accounts for one-half of a percent. Urban areas are even less evident in the Lower Kickapoo River Watershed with only four-hundredths of one percent of the total area.

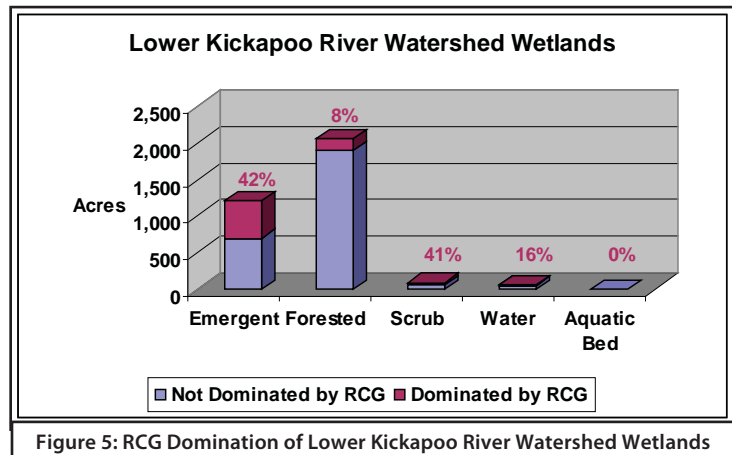
Figure 5: RCG Domination of Lower Kickapoo River Watershed Wetlands

Little is known about the condition of the remaining wetlands but estimates of reed canary grass (RCG) infestations, an opportunistic aquatic invasive wetland plant, into different wetland types has been estimated based on satellite imagery. This information shows that reed canary grass dominates 42% of the existing emergent wetlands and eight percent of the remaining forested wetlands (See Figure 5). Reed canary grass domination inhibits successful establishment of native wetland species.
