**Final Report**

Targeted Runoff Management Grant Program and Urban Nonpoint Source and Storm Water Management Grant Program

Project Name <b>Pheasant Branch Creek Stabilization Project</b>	Grant Number <b>USC-LR10-13255-06</b>
Governmental Unit Name <b>City of Middleton</b>	Primary Watershed Name and Watershed Code <b>Pheasant Branch Creek (LR10)</b>
Nearest Water Body Name	Nearest Water Body Identification Code (WBIC) (if applicable)
DNR Water Management Unit (River System) Name <b>Lower Rock (LR11)</b>	s. 303 (d) Listed Waterbody? <input checked="" type="checkbox"/> Yes <input type="checkbox"/> No.

### Pheasant Branch Creek Stabilization Project

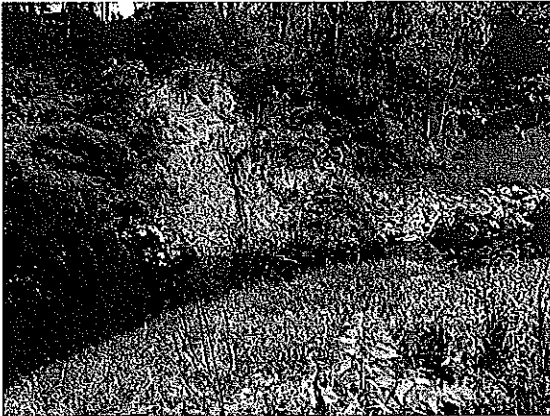
*Photo: New rootwad revetment site located upstream from existing treatment prior to construction (note upstream end of stone treatment)*

Heavy rains over the past year have led to additional erosion of the streambank and slope located upstream from the 2007 rootwad revetment location. This site, while previously eroded, had begun to expose the stone bank key installed during the downstream project construction. JFNew constructed 60 linear feet of rootwad revetments following the specifications developed during the summer 2008 rootwad enhancement construction downstream.

This area was identified in the MSA Erosion Inventory to be contributing up to 40 tons of sediment per year to Pheasant Branch Creek.

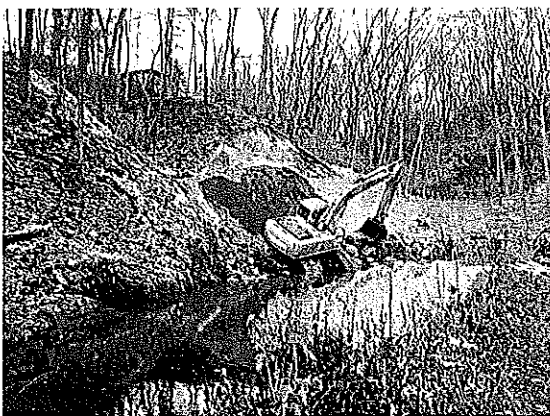
*Photo: Topsoil being applied to the newly graded slope as part of the additional rootwad installations completed in November 2008.*

In addition to stabilizing a steep eroding slope and enhancement of aquatic habitat through installation of woody structure, the project removed 0.25 acres of common buckthorn (*Rhamnus cathartica*) and honeysuckle (*Lonicera tartarica*).

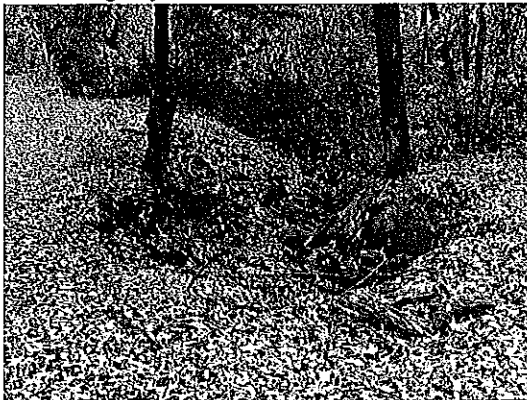
As noted earlier, the Pheasant Branch Creek valley within the City of Middleton is composed of highly erodible sandy soils. Many valley slopes along Pheasant Branch Creek have been severely eroded through individual stormwater diversions from surrounding lands. One such circumstance was noted during the design of the stream barb and stone toe protection project. While that project focused on bank stabilization, severe gully erosion was noted in two locations upslope from the project site that likely

contribute a significant amount of sediment (estimated at around 2-4 tons/year).

*Photo: Existing stormwater runoff has created severe gully erosion along portions of Pheasant Branch Creek.*

JFNew collected preliminary survey data and site measurements to design an integrated treatment to address both the cause (un-addressed stormwater) and resulting conditions (massive slope failure and gully erosion). A linear rain garden will redirect and infiltrate stormwater currently causing gully erosion through overland runoff. To stabilize existing slope failure, JFNew designed a combination of slope grading, tree removal (predominantly boxelders), stone check dam construction, and native herbaceous vegetation restoration to provide long-term stability.

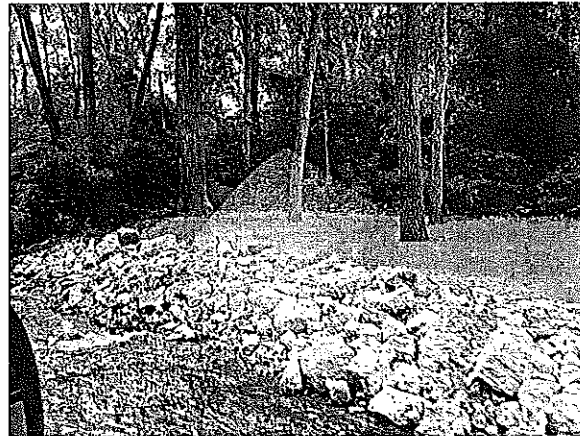
JFNew worked with the City of Middleton to design, permit, and install rip-rap bank protection in three portions of Pheasant Branch Creek that will soon have new pedestrian bridges installed. Some of these areas were already identified as eroded areas contributing up to one ton/year of sediment under the MSA Erosion Inventory of Pheasant Branch Creek (2006). This project stabilized approximately 200 linear feet of streambank and cleared approximately 0.5 acres of invasive, exotic species

Photo: Typical view of the rip-rap stabilizations installed along 200LF of Pheasant Branch.
