FINAL REPORT:

**WATER QUALITY MONITORING AND
EVALUATION OF POLLUTANT SOURCES
WITHIN THE SOUTHWEST SUBWATERSHED
OF ROCK LAKE**

2010
Jefferson County
Land and Water Conservation Department

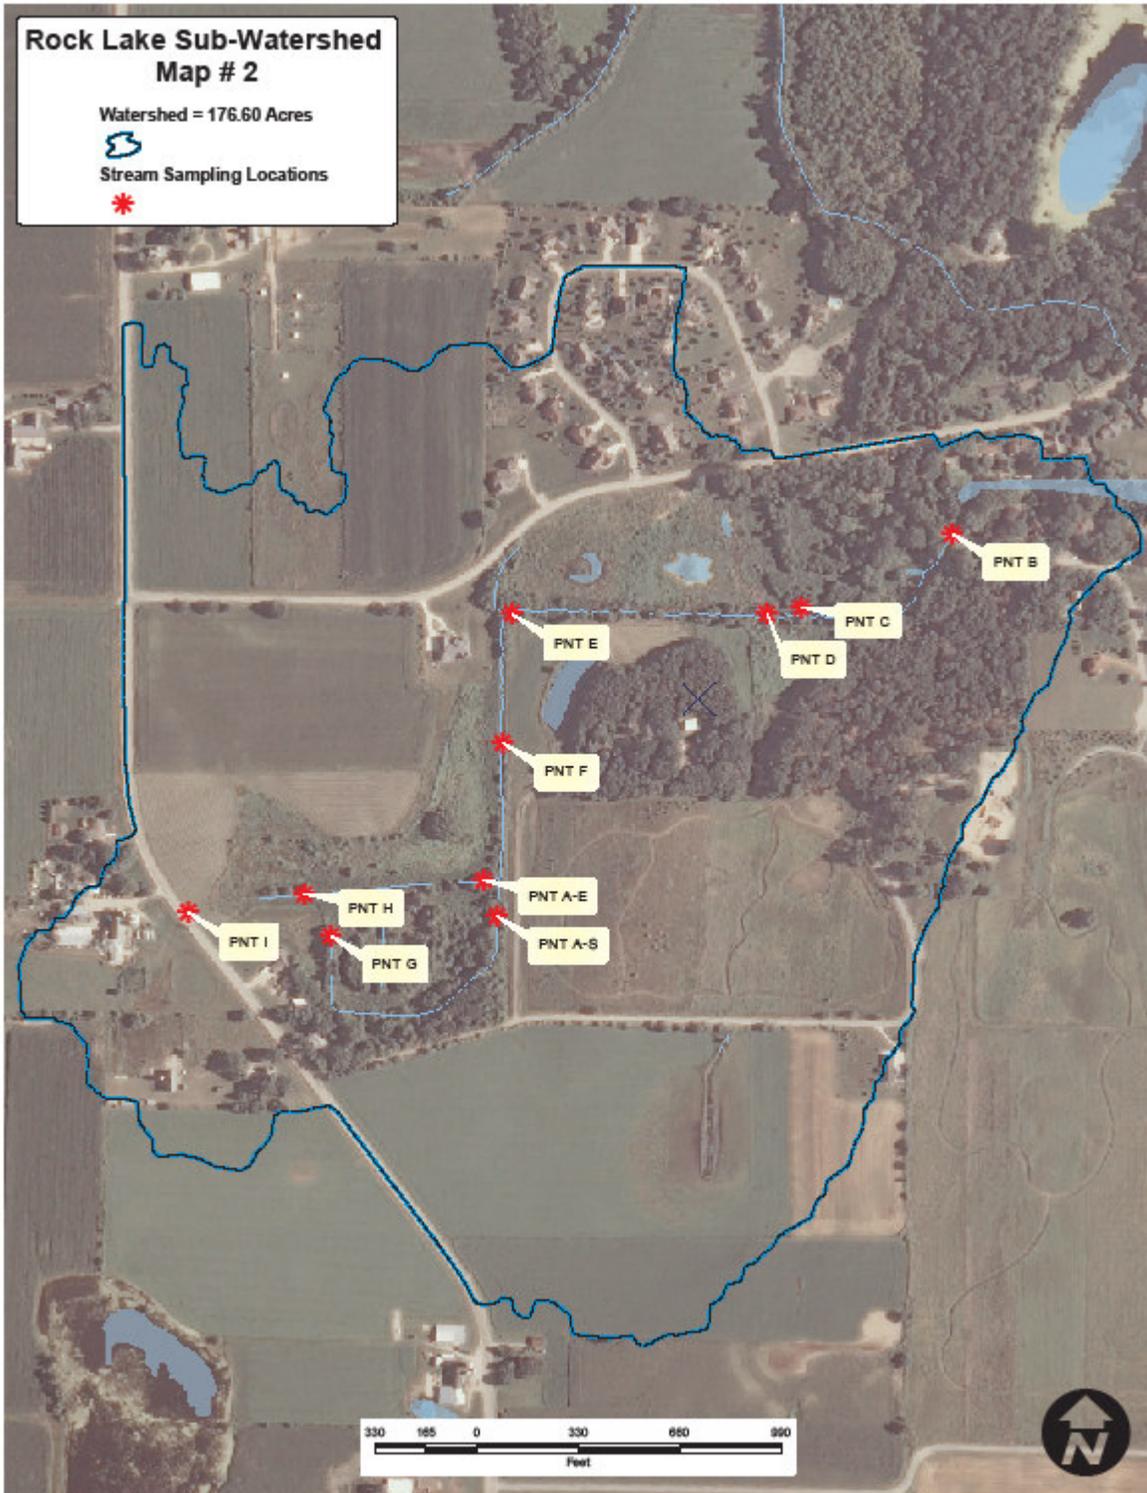
Stream Sampling Locations

Several stream sampling points were chosen for the project (Map 2). Some of these points were pipes that never had any water flow out of them: I is a road culvert, and D is a large metal pipe coming out of the stream bank. Samples were taken from May 2009 through October 2009. Only one storm event was sampled. Other storm events were not sampled because there was not enough precipitation, or the timing did not fit into the schedules of the volunteers and consultants.
