Technical Assistance, Environmental Liability Clarification or Post-Closure Modification Request

FIGURE 1-1
Vicinity Map
Former Mercury Marine Plant No. 1
Cedarburg, Wisconsin

FIGURE 2-1
Soil Boring, Monitoring Well, and Cross Section Locations
Former Mercury Marine Plant No. 1
Cedarburg, Wisconsin

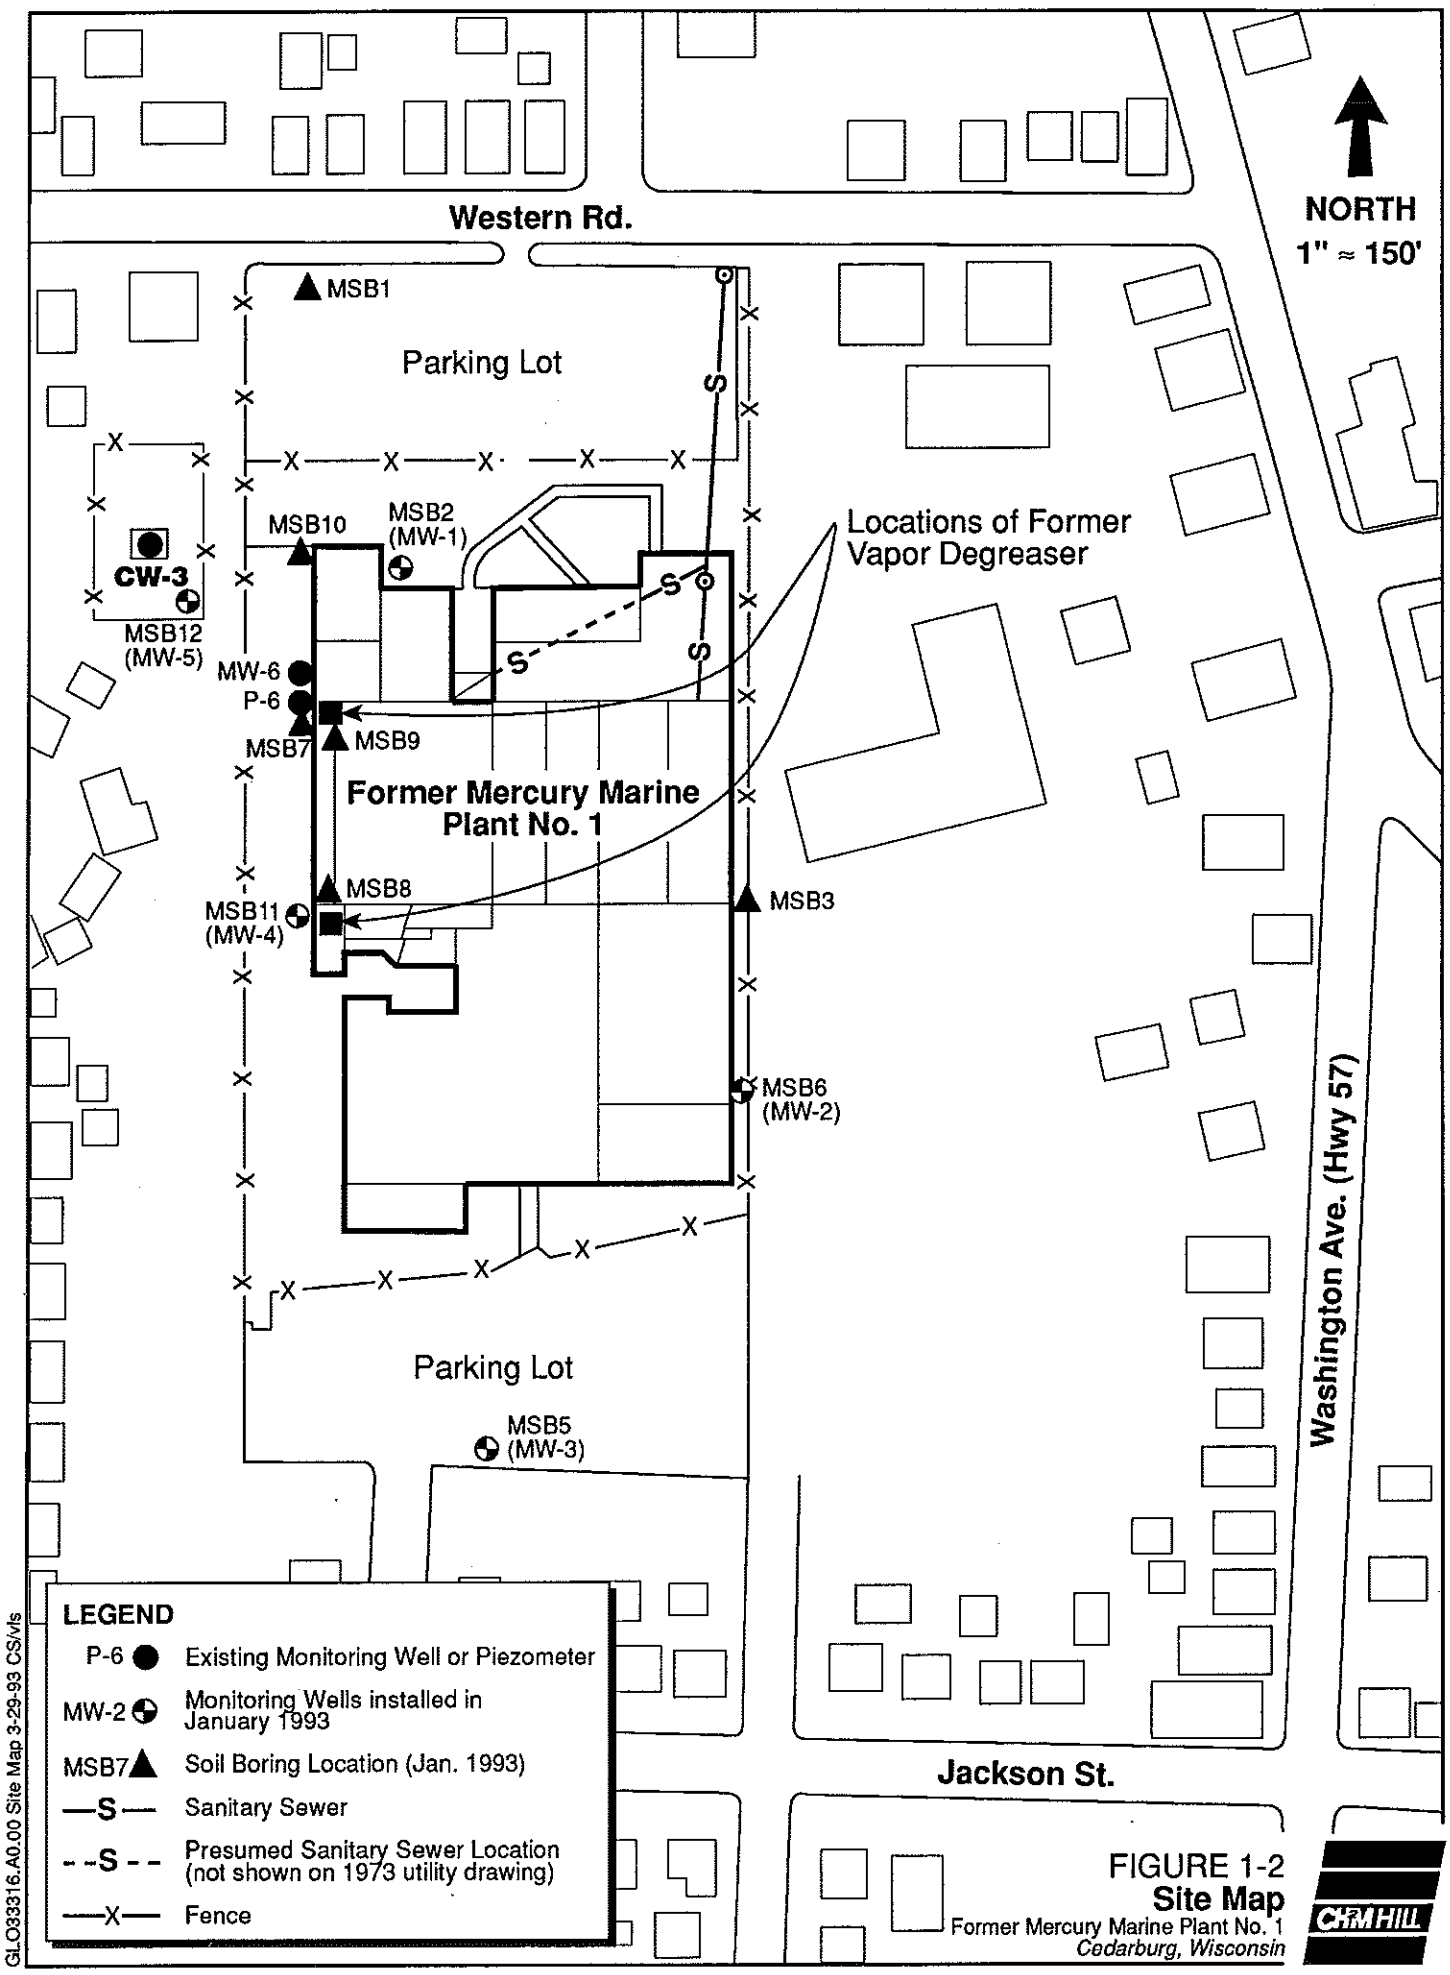
FIGURE 1-2
Site Map
Former Mercury Marine Plant No. 1
Cedarburg, Wisconsin

Mercury Marine's Plant No. 1 was located at N49 W6337 Western Road in Cedarburg, Wisconsin (Figure 1-1). Mercury Marine manufactured outboard motors and other small engine-driven devices at the plant. The plant began operation in 1939. As part of the overall manufacturing process, metal cleaning was performed using TCE in an above ground steel vapor degreasing tank located in the northwest corner of the building (Figure 1-2). The tank was replaced in 1977 with a similar tank. Both tanks were about 3 feet by 5 feet by 6 feet. The tank had drains to allow collection and onsite distillation of TCE for reuse in degreasing operations. It is reported that the degreaser was drained and cleaned about once per year. In the late 1970s, the tank was moved to the location shown in Figure 1-2. No other uses of chlorinated solvents at the plant were reported by the former employees.

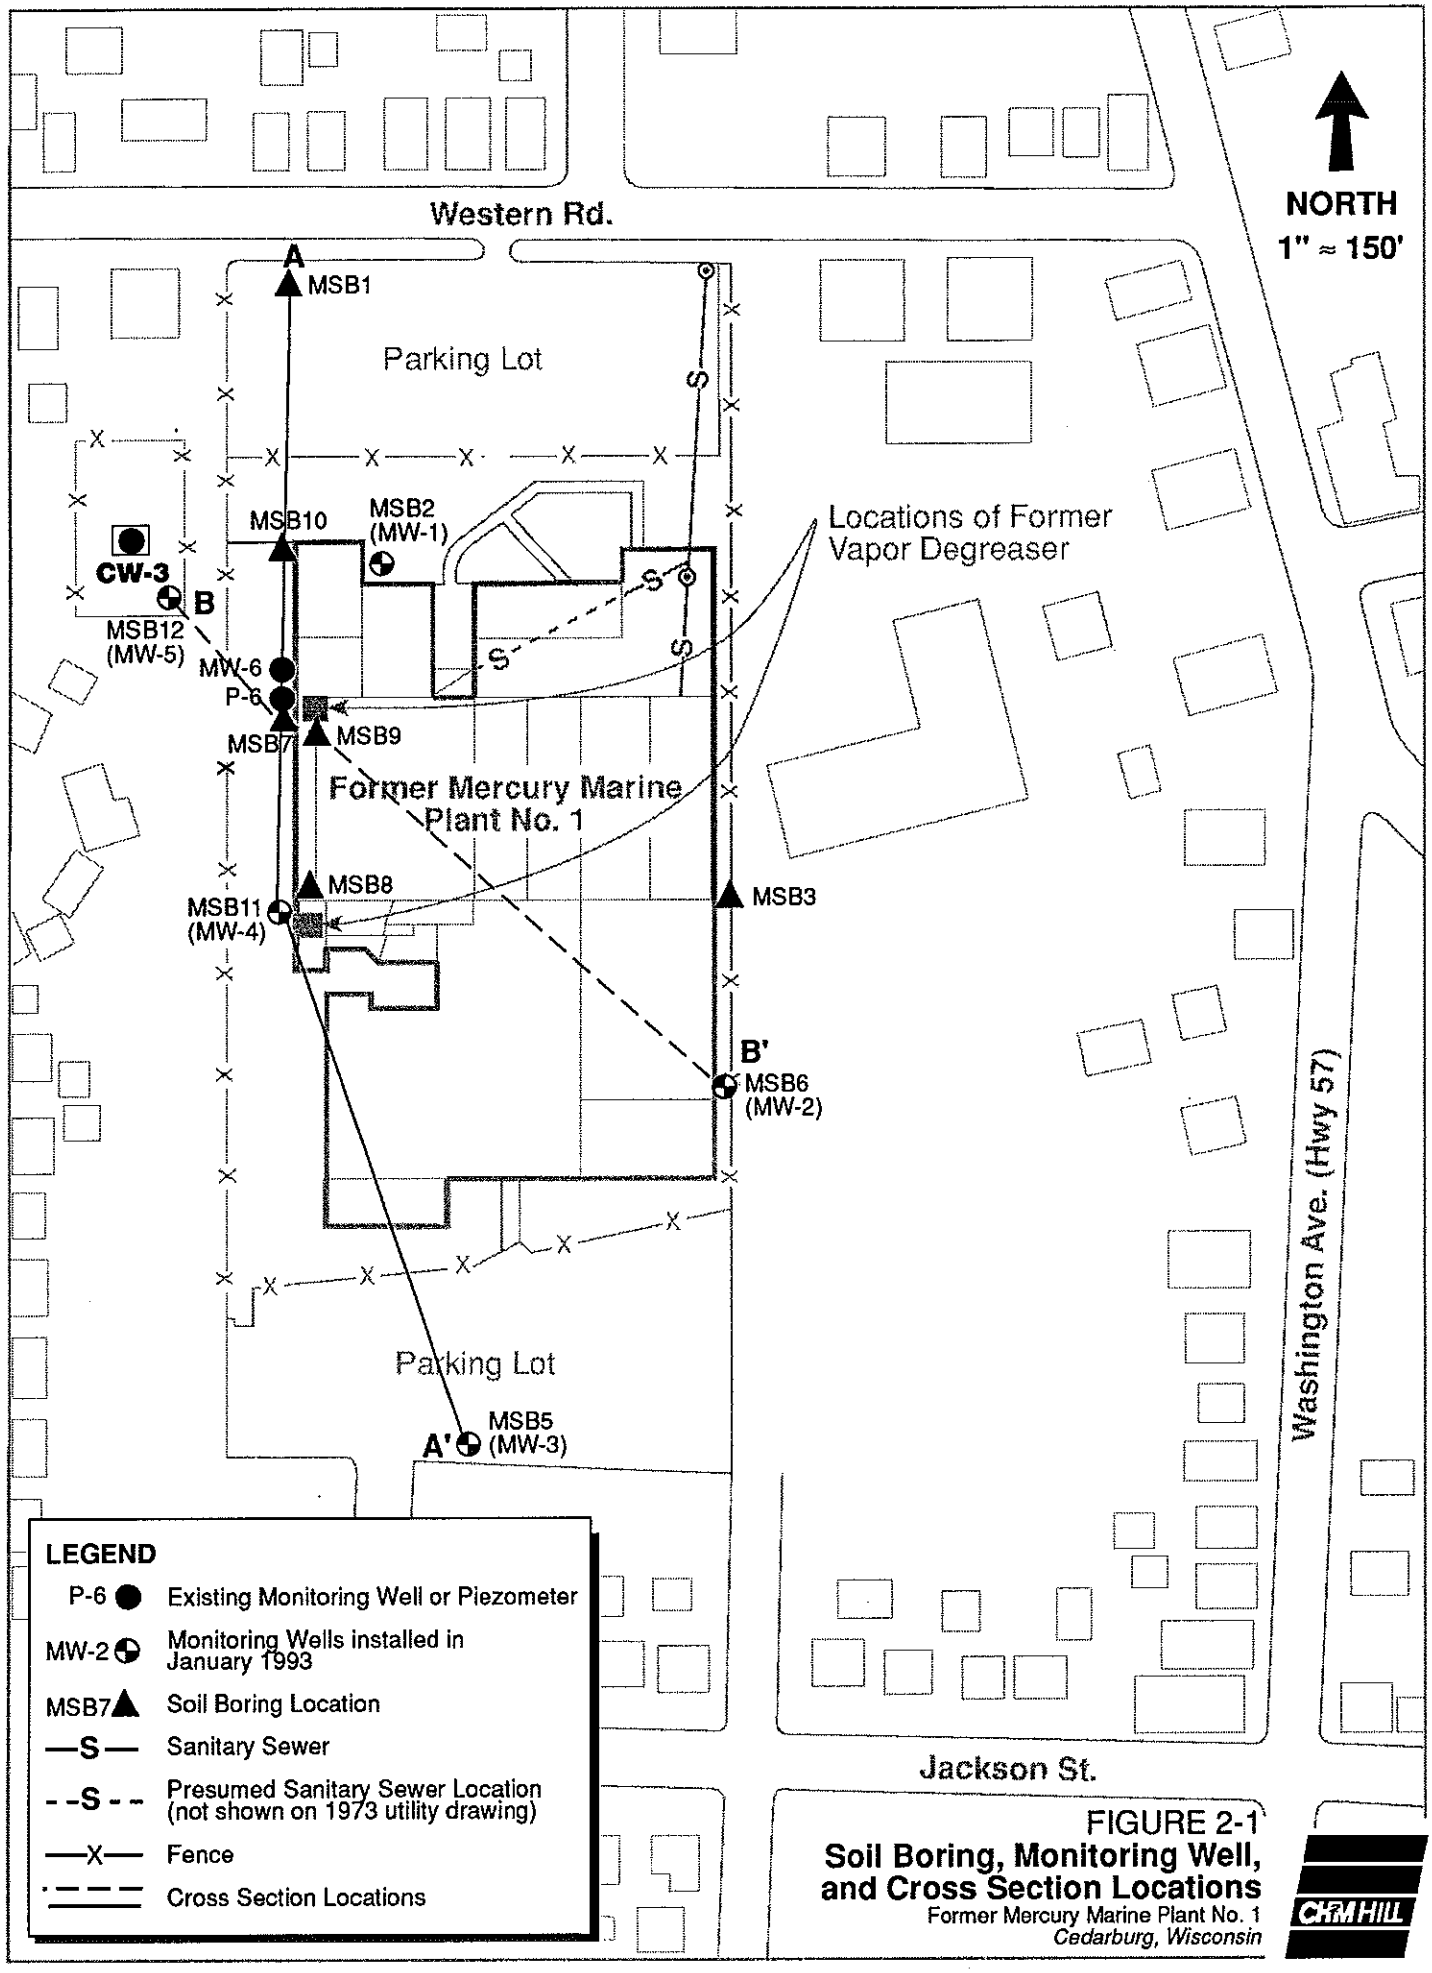
Twelve borings were drilled to provide stratigraphic and hydrogeologic information as well as physical and chemical soil characteristics. The borings were advanced to bedrock using 4.25-inch hollow stem augers and were continuously sampled at 2-foot intervals using 3-inch split spoon samplers. Figure 2-1 shows the locations of the borings. Soil samples were logged by the onsite CH2M HILL hydrogeologist. Cuttings were placed in U.S. DOT-approved 55-gallon drums and stored onsite pending disposal.

Five monitoring wells were installed at the locations depicted in Figure 2-1. The wells were installed to provide information on the groundwater flow direction in both the glacial till and bedrock.

To characterize groundwater quality in the immediate vicinity of Plant No. 1, groundwater grab samples were collected from the glacial till from 6 of the 12 borings: MSB2, MSB5, MSB7, MSB9, MSB11, and MSB12. In addition, grab samples were collected from the dolomite at 4 borings: MSB6, MSB7, MSB10, and MSB11. See Figure 2-1 for boring locations. Grab samples were to have been collected from all 12

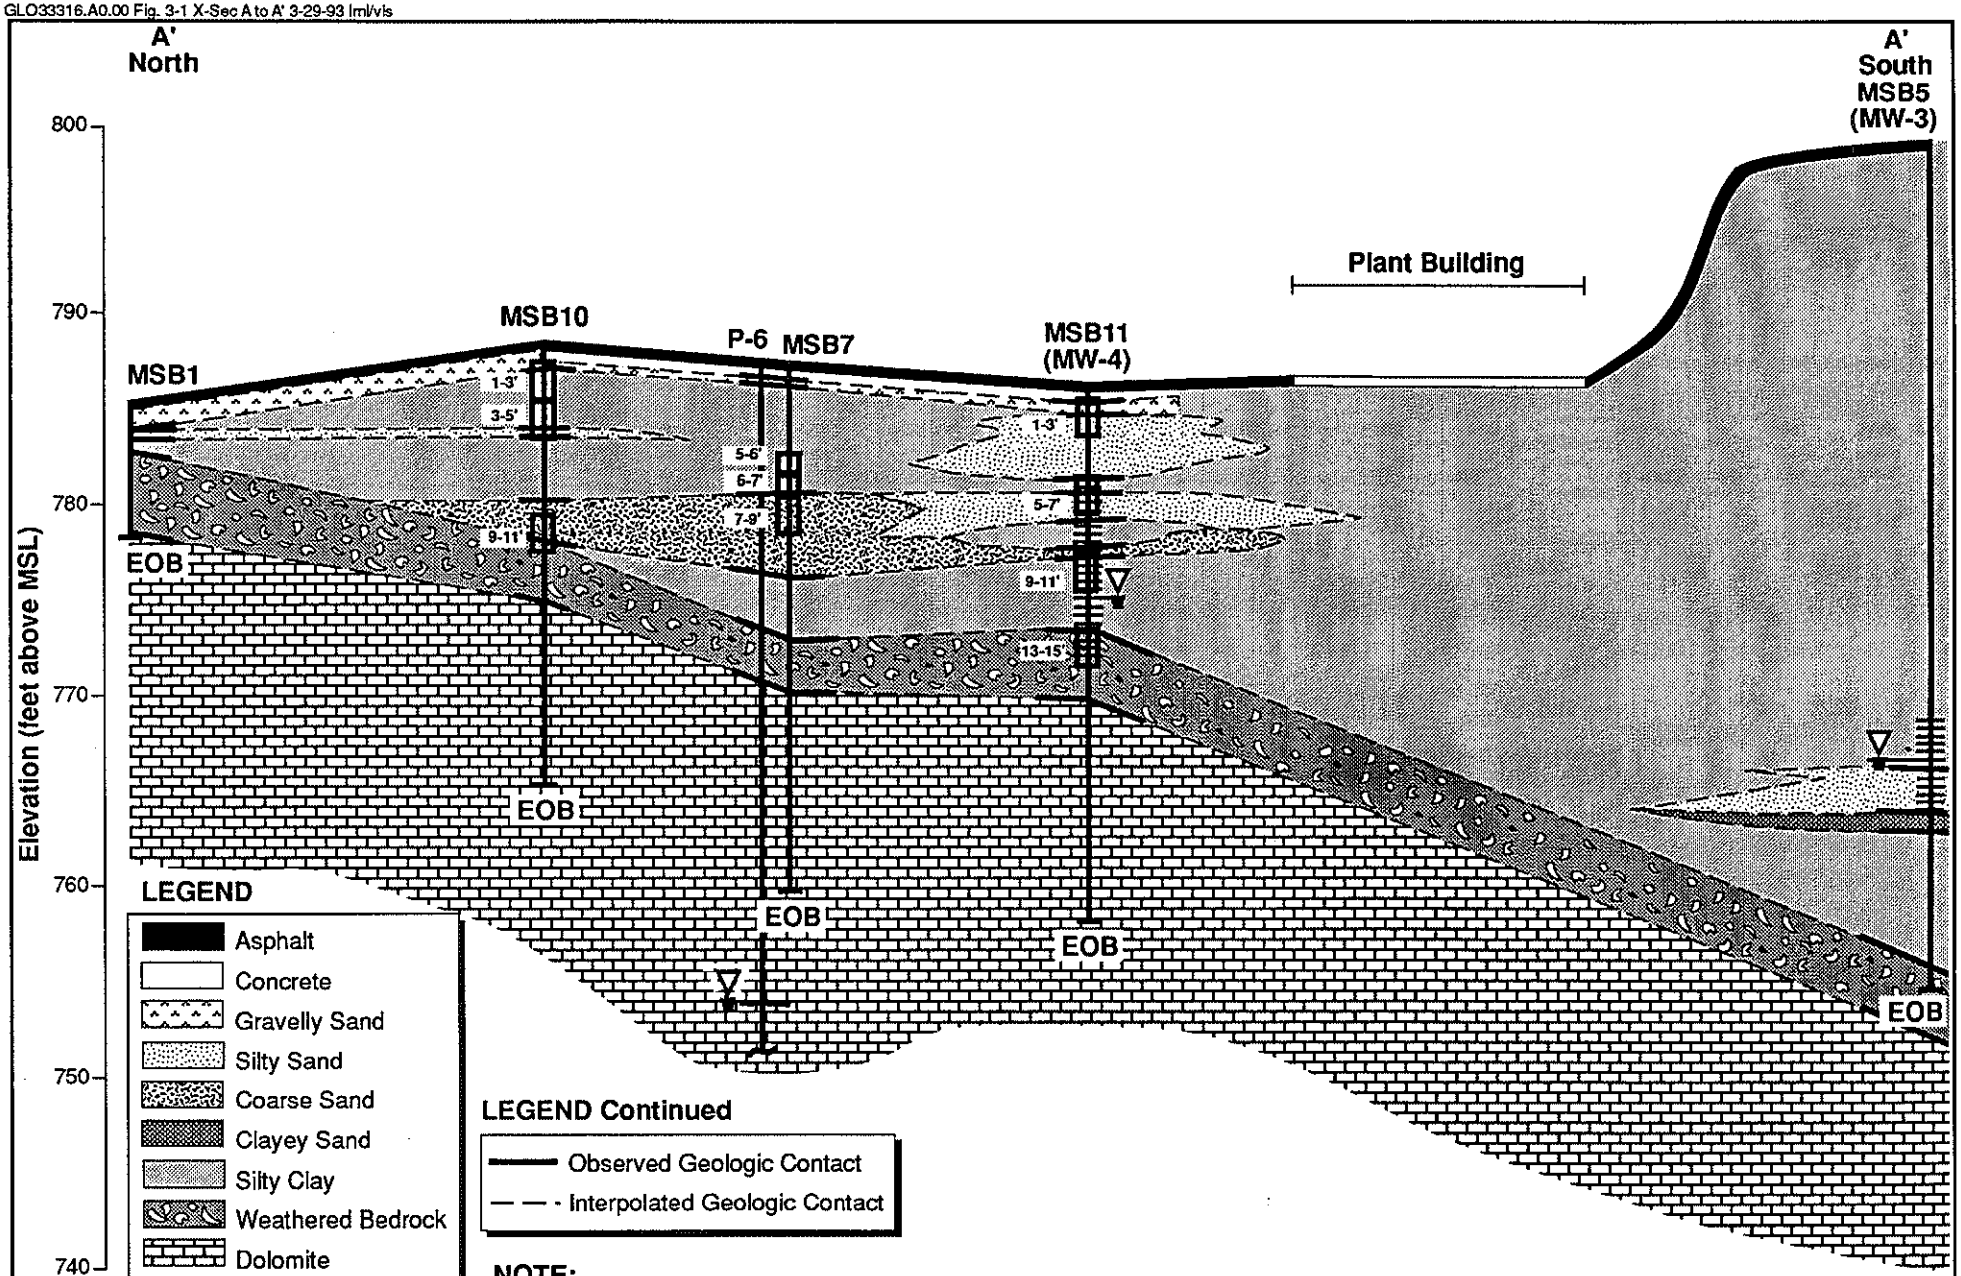
FIGURE 3-1
Geologic Cross Section A to A'
Former Mercury Marine Plant No. 1
Cedarburg, Wisconsin

The till soils are underlain by highly weathered dolomite bedrock that in places is filled with a silt or silty clay matrix. The weathered unit is generally about 5 feet thick and appears to become more competent with depth. Rock cores collected at borings MSB06, MSB07, MSB10, and MSB11 indicate the more competent dolomite is buff to grey, fine-grained, massively bedded and only slightly weathered. Rock quality designators (RQDs)

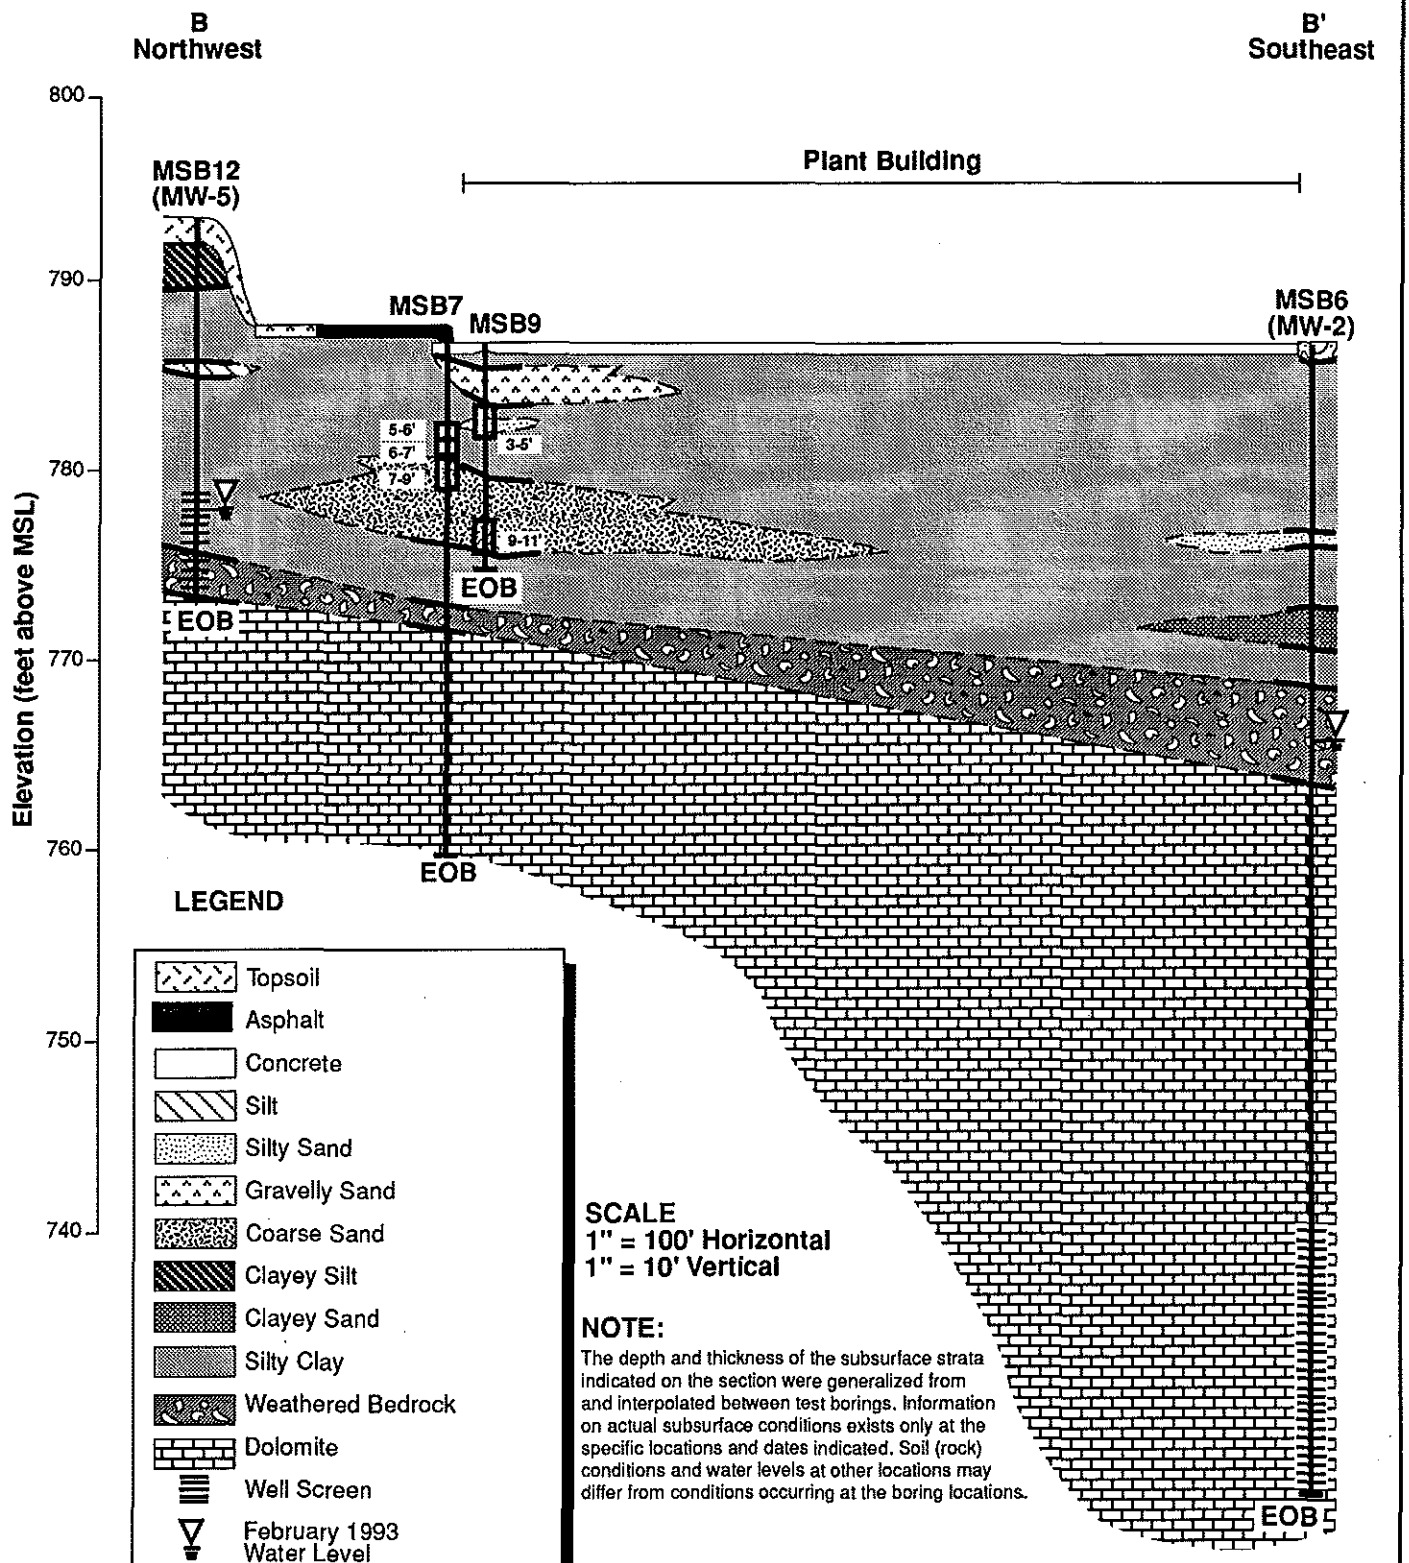
FIGURE 3-2
Geologic Cross Section B to B'
Former Mercury Marine Plant No. 1
Cedarburg, Wisconsin

Boring logs compiled during the site investigation supplemented with information from previous investigative work (Strand, 1990) were used to prepare cross sections of the geology beneath former Plant No. 1. Cross section locations are presented in Figure 2-1. The cross sections are presented as Figures 3-1 and 3-2.

The bedrock surface is fairly flat over the northern half of the site but dips to the south-southwest at a slope of about 4 percent as shown in Figures 3-1 and 3-2 and the bedrock surface contour map presented as Figure 3-3. The elevation of the bedrock surface decreases from about 770 feet above mean sea level at MSB11 to about 753 feet at MSB05, a change of 17 feet over a distance of 430 feet.

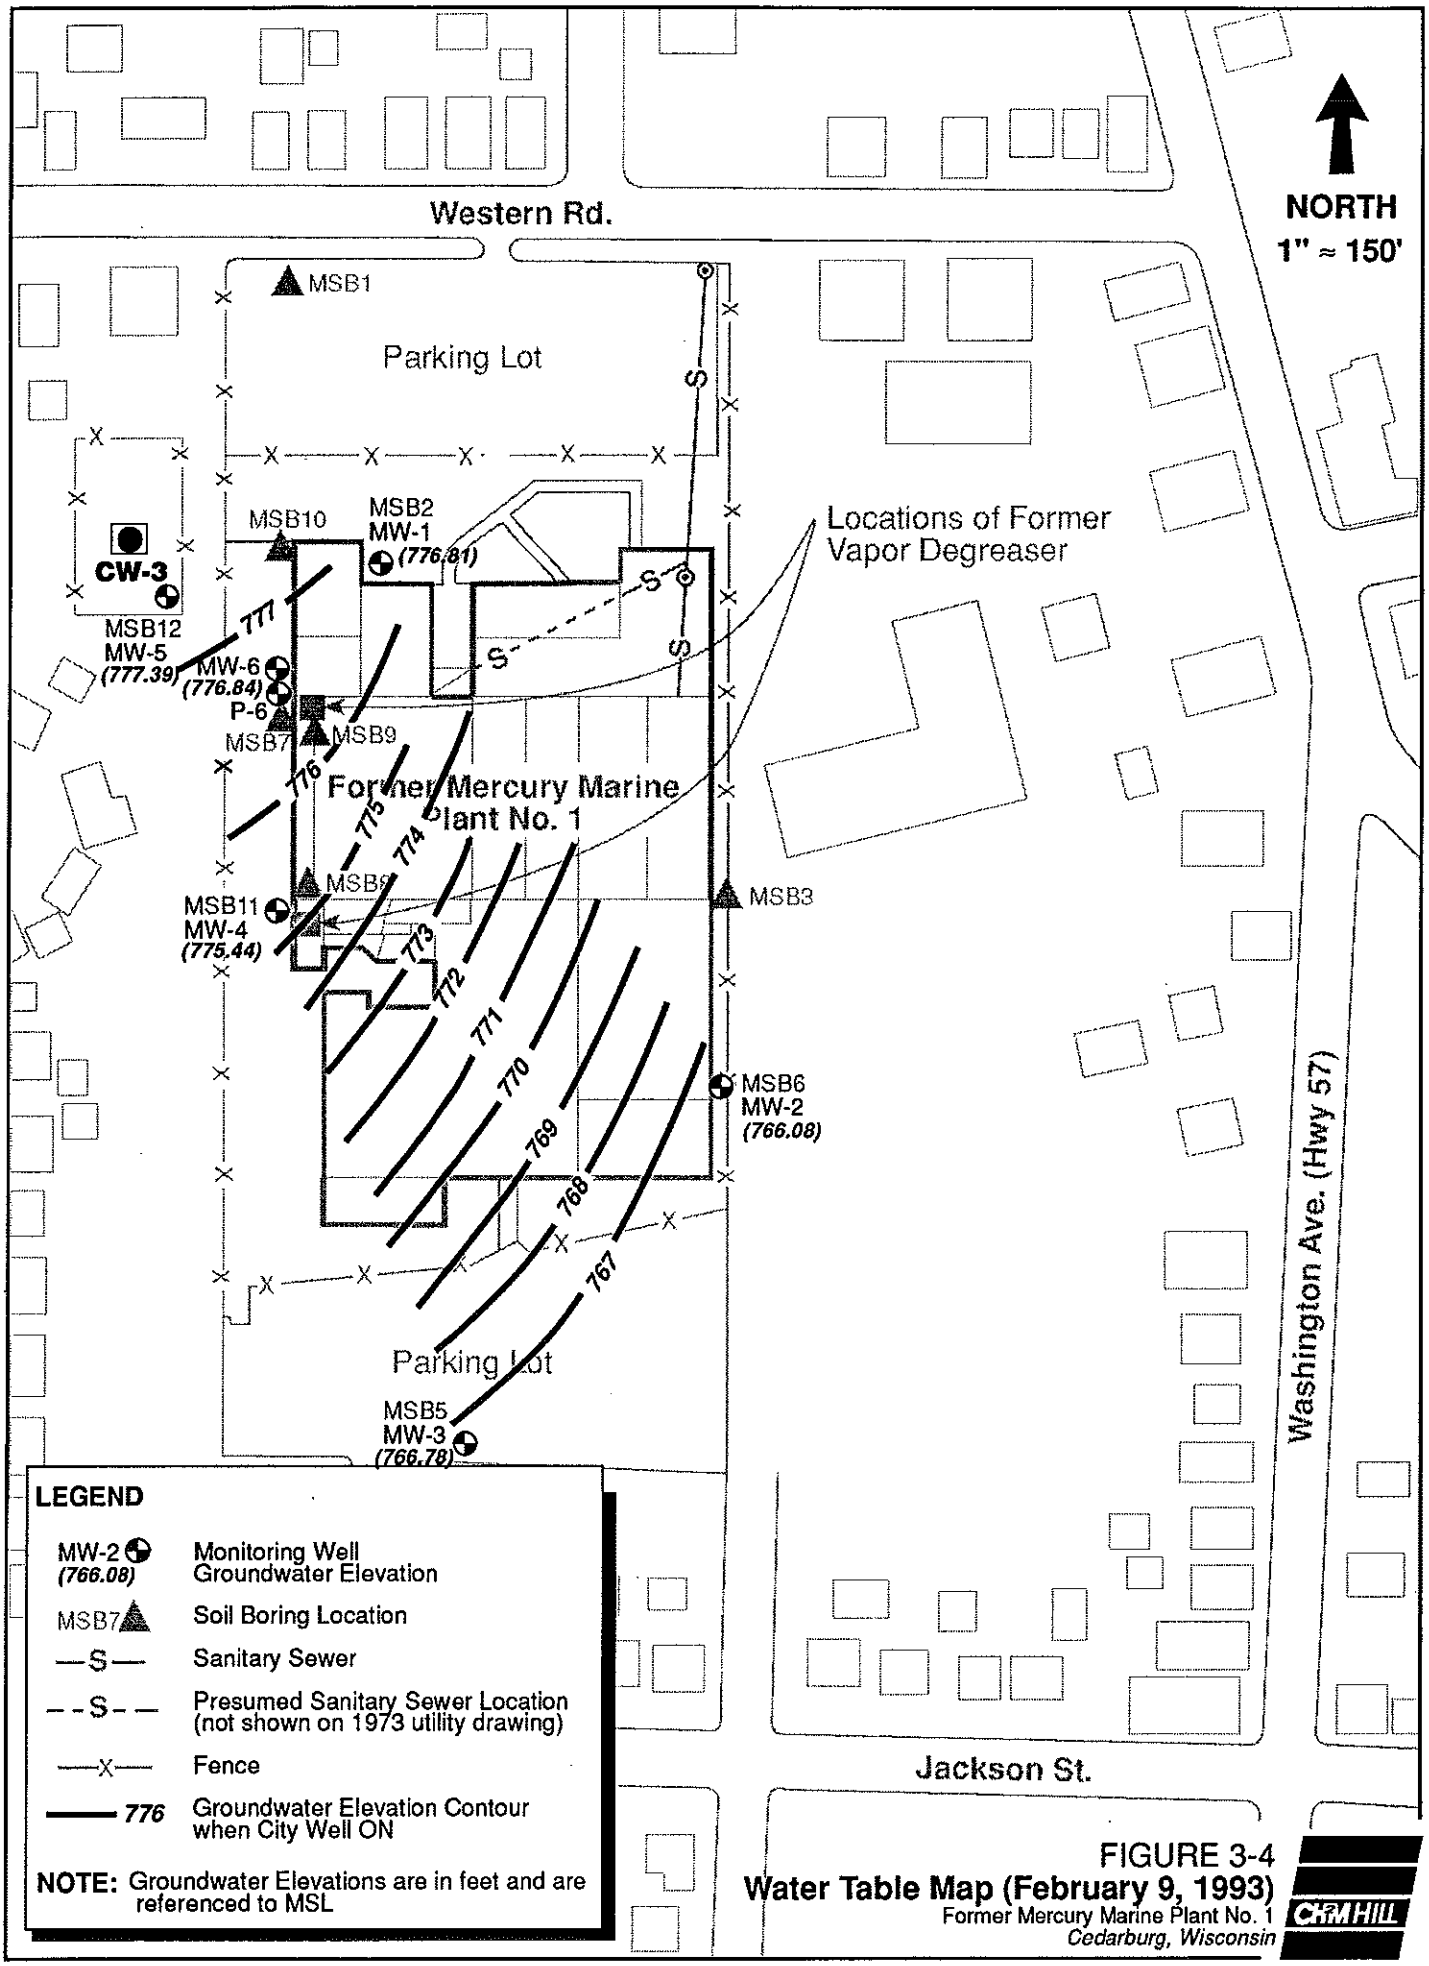
FIGURE 3-4
Water Table Map (February 9, 1993)
Former Mercury Marine Plant No. 1
Cedarburg, Wisconsin

Groundwater levels were measured in both newly installed and existing till and bedrock monitoring wells on several occasions in February and March, 1993. Water levels collected on February 9 (from all wells except P-6) were used to construct the water level contour map (Figure 3-4), which is generally representative of water level conditions observed over the time frame of the study. The water levels are listed in Table TM2-1 in Appendix A. The groundwater contours indicate that the general direction of groundwater flow is to the south-southeast at a gradient of 0.023 ft/ft. These data suggest that the till, weathered bedrock, and the upper portions of the more competent bedrock (at least to a depth of 60 feet) are hydraulically connected and under water table conditions. Depending on the depth to bedrock, the water table may occur in either the till or bedrock. For example, groundwater was not encountered in the till at MSB06 where the top of weathered bedrock is at an elevation of about 769 feet and the water table occurs 3 feet below the bedrock surface at an elevation of 766 feet. In contrast, the water table was encountered in the till at MSB05 at about the same elevation as at MSB06 (766 feet) but the elevation of the bedrock surface is about 756 feet, 13 feet lower than at MSB06 and 10 feet below the water table.

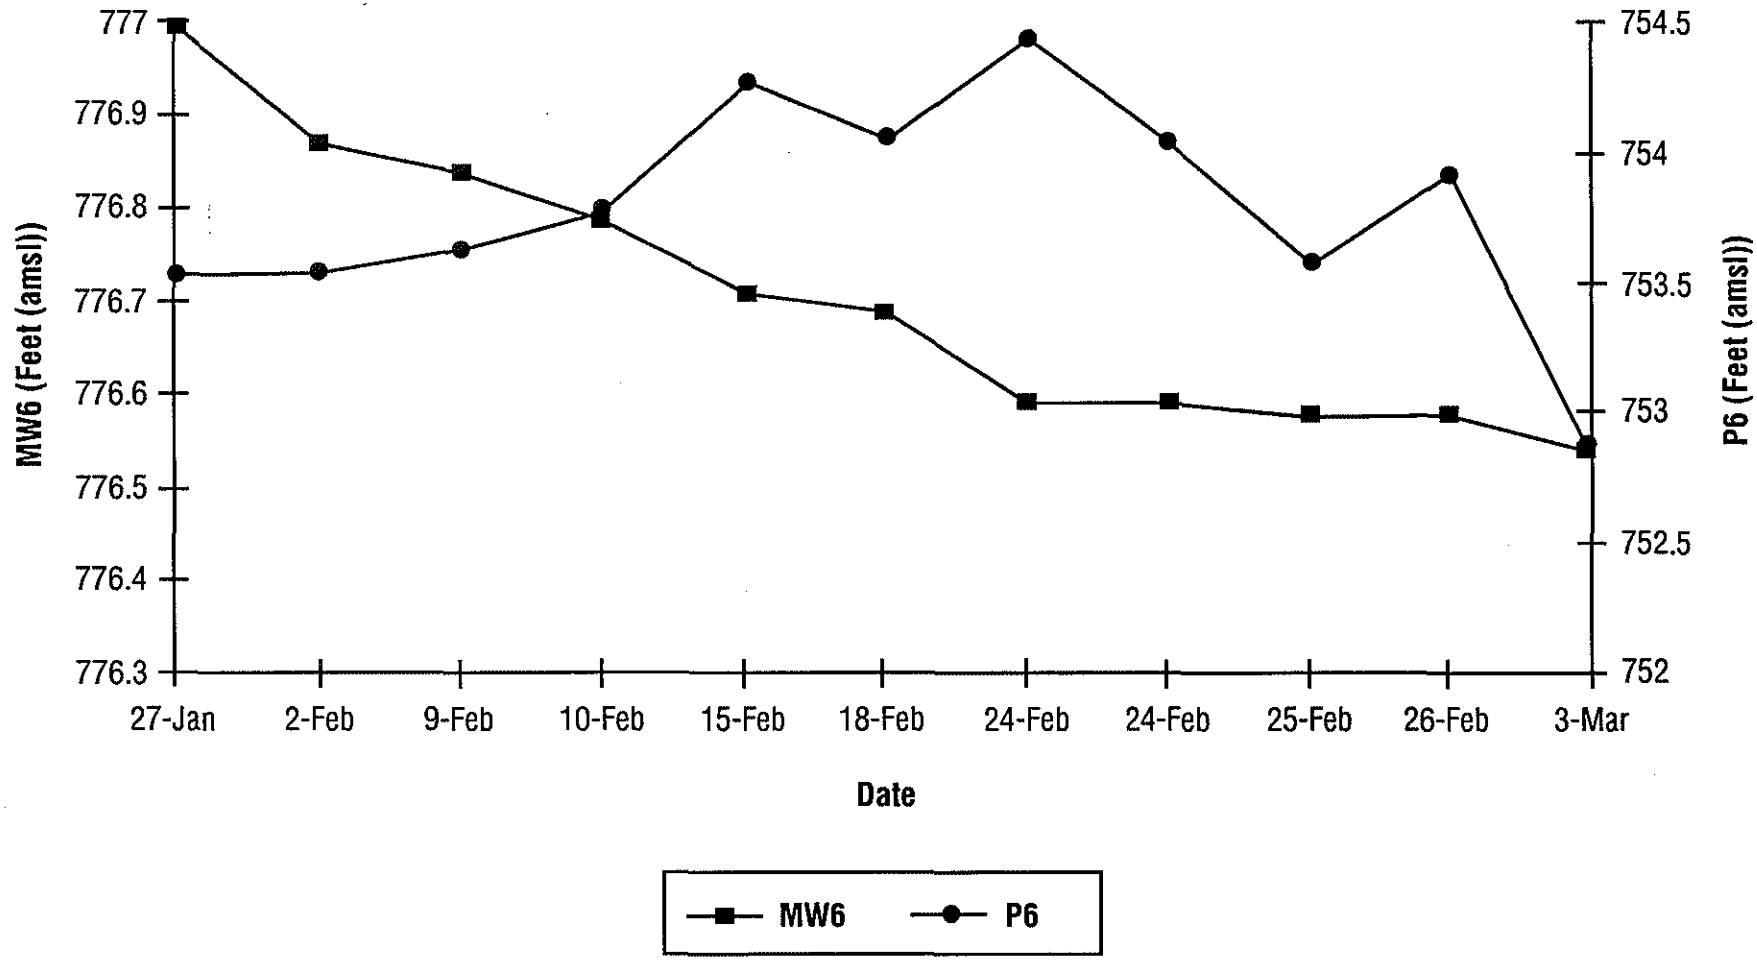
FIGURE 3-5
Water Level Relationship MW6/P6
Former Mercury Marine Plant No. 1
Cedarburg, Wisconsin

Although the data are very limited, the following observations on the connection between shallow groundwater and the deep bedrock groundwater can be made. Data from piezometer P-6, which was completed (by others) at a depth of 160 feet below grade shows water levels markedly lower (on the average 13 to 23 feet lower) than those in the other wells. Figure 3-5 is a plot of water levels over time in the nested well pair MW-6/ P-6 installed previously by Strand. MW-6 is completed at the bedrock till interface at a depth of about 26 feet. P-6 is completed in competent bedrock at a depth of 160 feet. An initial explanation for the pronounced differences in water level would be a strong downward vertical gradient (0.16 ft/ft) indicating downward flow from MW-6 to P-6. Such an interpretation would also explain the presence of TCE in P-6. However, examining Figure 3-5, it is apparent that there is little correlation between the water levels in the two wells over the period record. If there is hydraulic communication between the till/upper bedrock aquifer and the lower portions of the bedrock, it would be expected that the water levels in the two wells would show similar trends, which is not the case.

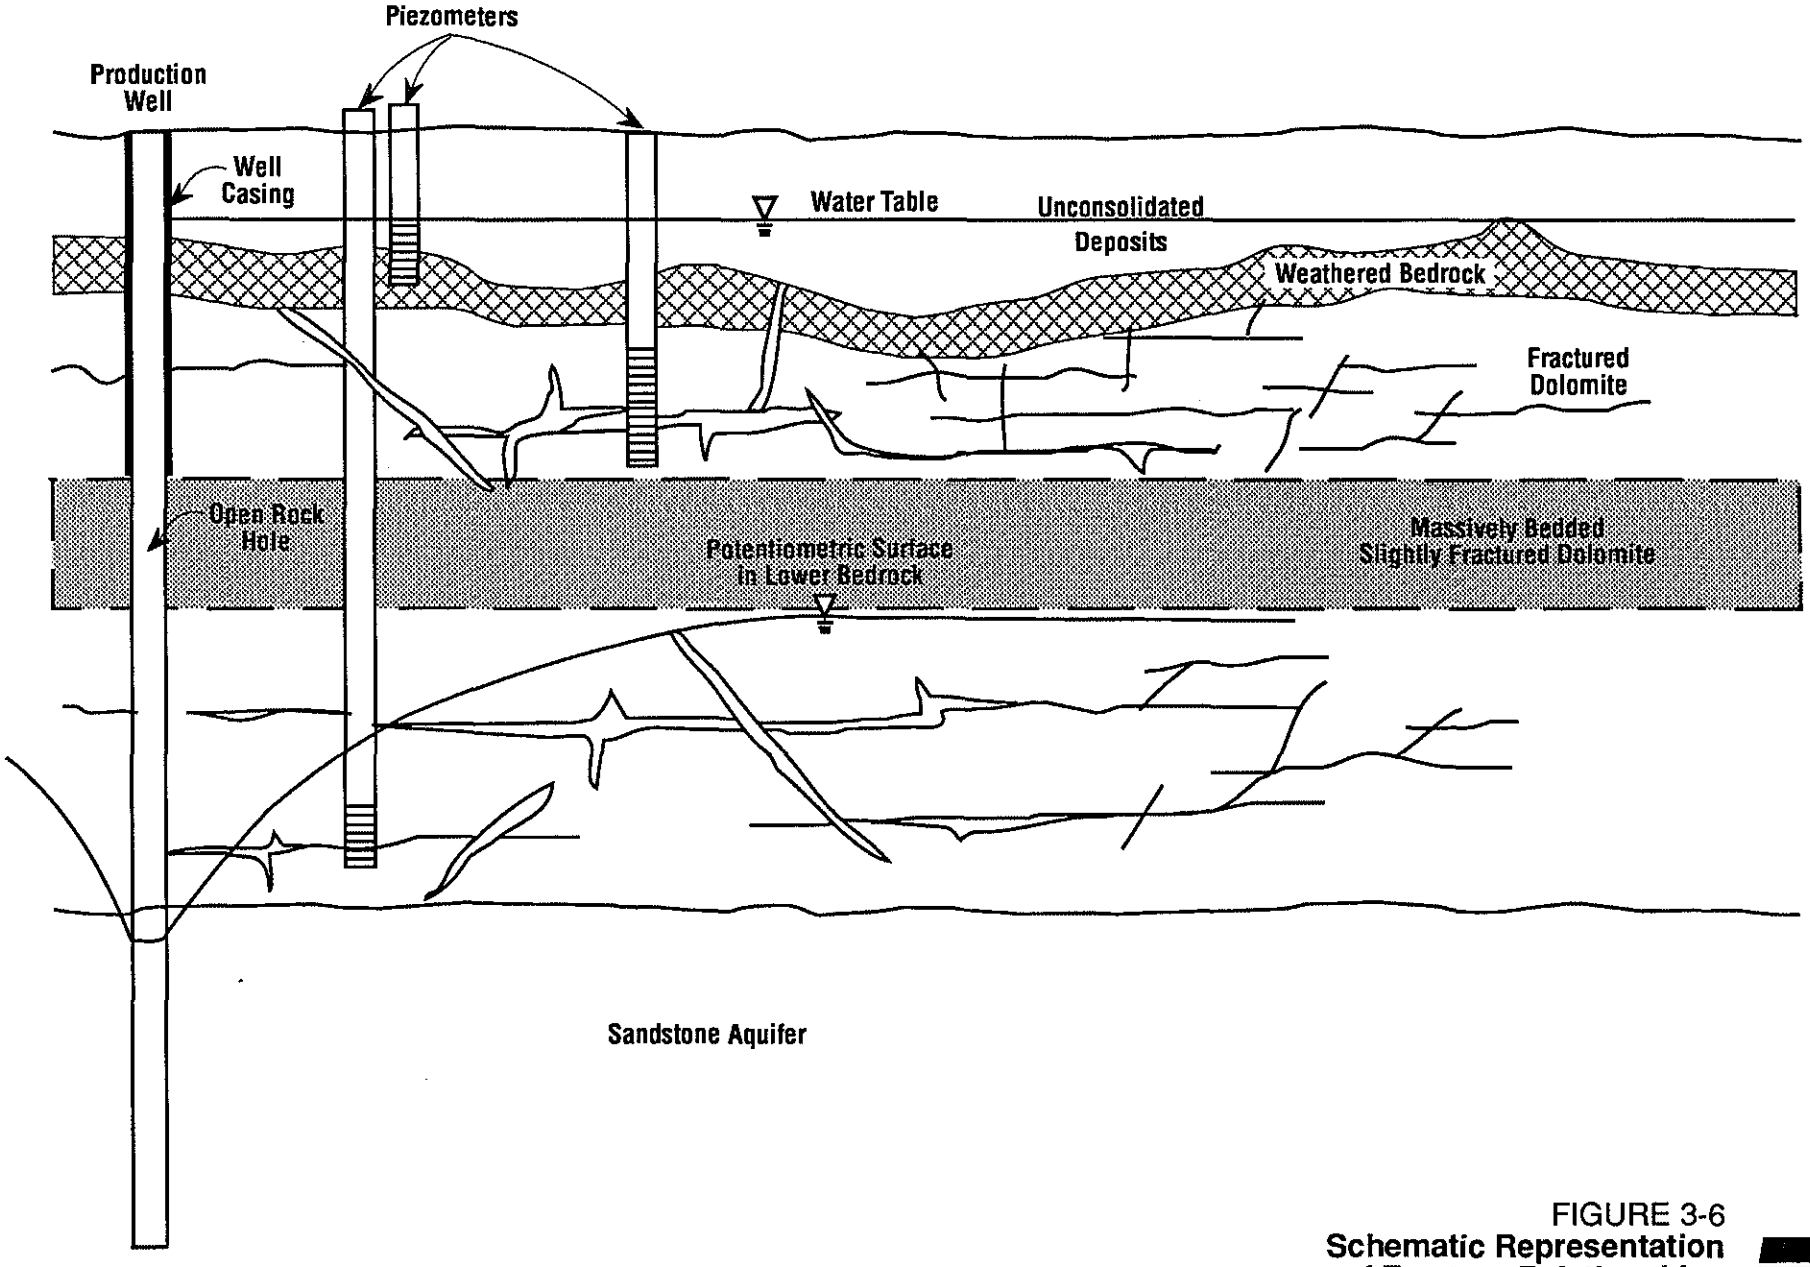
FIGURE 3-6
Schematic Representation of Fracture Relationships
Former Mercury Marine Plant No. 1
Cedarburg, Wisconsin

This pattern further supports the statement made above that the till/upper bedrock aquifer behaves independently and does not appear to be hydraulically connected to lower portions of the bedrock aquifer, at least in the immediate vicinity of Plant No. 1. Such a relationship on a local scale is not that unusual in a fractured bedrock environment. While it is evident at a regional scale (Young and Batten, 1980) that saturated unconsolidated deposits overlying the Silurian dolomite behave as a single aquifer under water table conditions, locally, different portions of the bedrock may be somewhat hydraulically isolated from each other. In fractured bedrock environments, the degree of hydraulic communication between different bedrock strata is a function of the density, continuity and orientation of the various fracture sets that occur within the rock matrix. These relationships are demonstrated schematically in Figure 3-6.

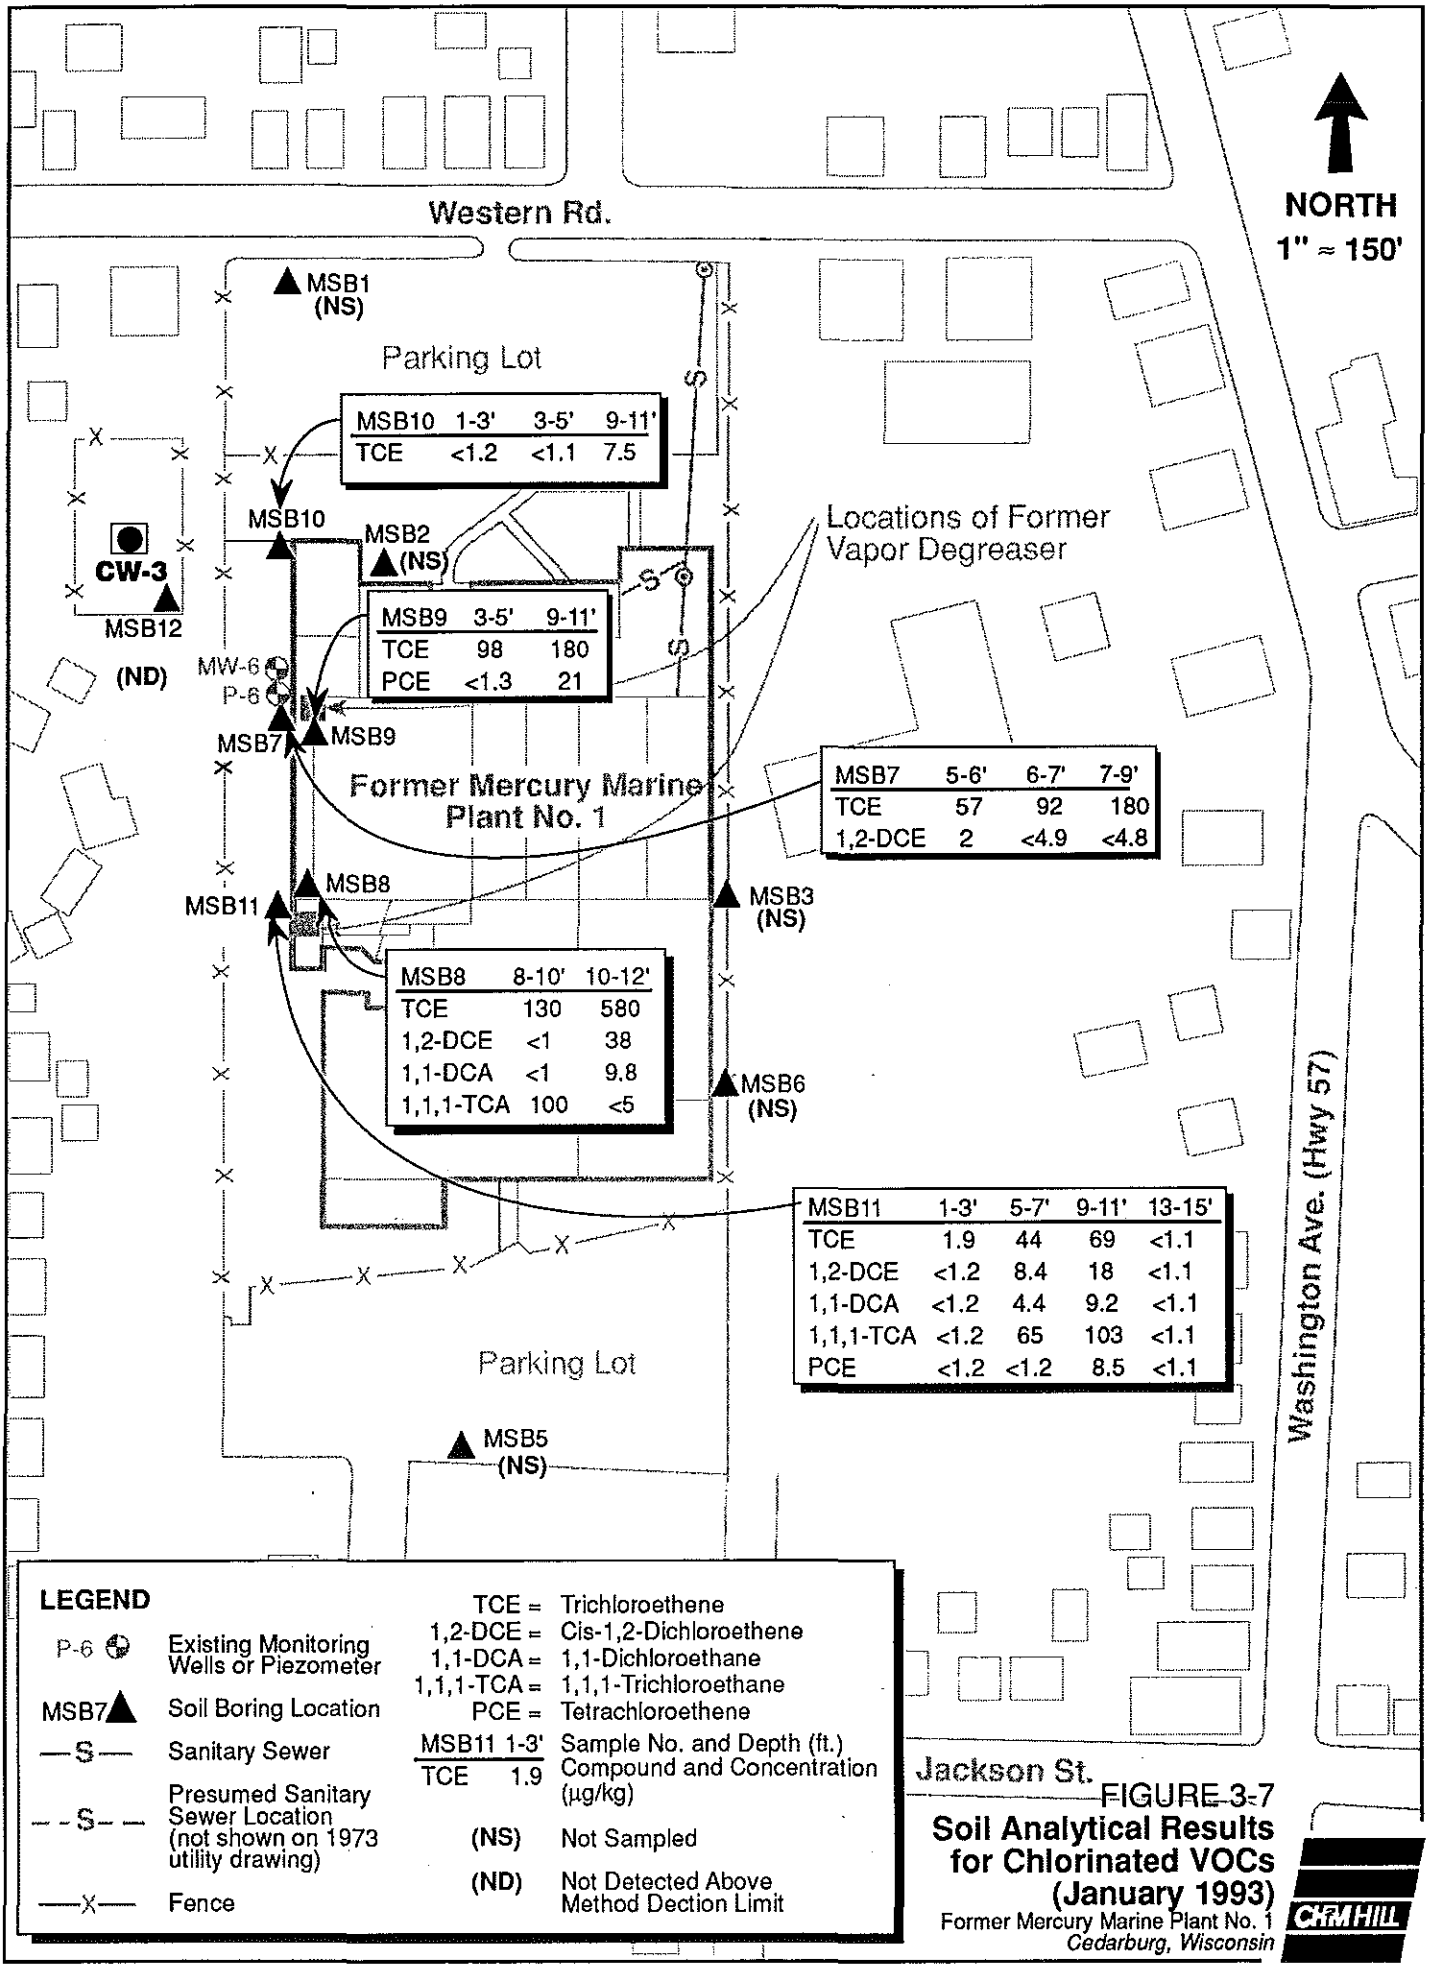
FIGURE 3-7

Trichloroethene (TCE) was detected in soil samples from all five borings. Concentrations ranged from 1.9 μg/kg at MSB11 (located outside the plant building to the west of where the former vapor degreaser was located after the late 1970s) to 580 μg/kg at MSB08 (located inside the building just to the north of the location where the degreaser was located after the late 1970s). The highest concentrations were found at those borings adjacent to the former locations of the vapor degreaser.

The VOC concentrations with respect to depth at each boring are shown in Figure 3-7. Other VOCs detected in several of the samples were cis-1,2-dichloroethene (1,2-DCE), 1,1-dichloroethane (1,1-DCA), and 1,1,1-trichloroethane (1,1,1-TCA). The concentrations and locations where these compounds were detected are also depicted in Figure 3-8. 1,1-DCA and 1,2-DCE concentrations were highest at MSB08 at 9.8 μg/kg and 38 μg/kg, respectively. 1,2-DCE is a common degradation product of TCE while 1,1-DCA is a degradation product of 1,1,1-TCA. 1,1,1-TCA was detected at MSB08 and MSB11 at concentrations of 100 and 103 μg/kg, respectively.
