Technical Assistance, Environmental Liability Clarification or Post-Closure Modification Request

FIGURE 1-1
Vicinity Map
Former Mercury Marine Plant No. 1
Cedarburg, Wisconsin

FIGURE 2-1
Soil Boring, Monitoring Well, and Cross Section Locations
Former Mercury Marine Plant No. 1
Cedarburg, Wisconsin

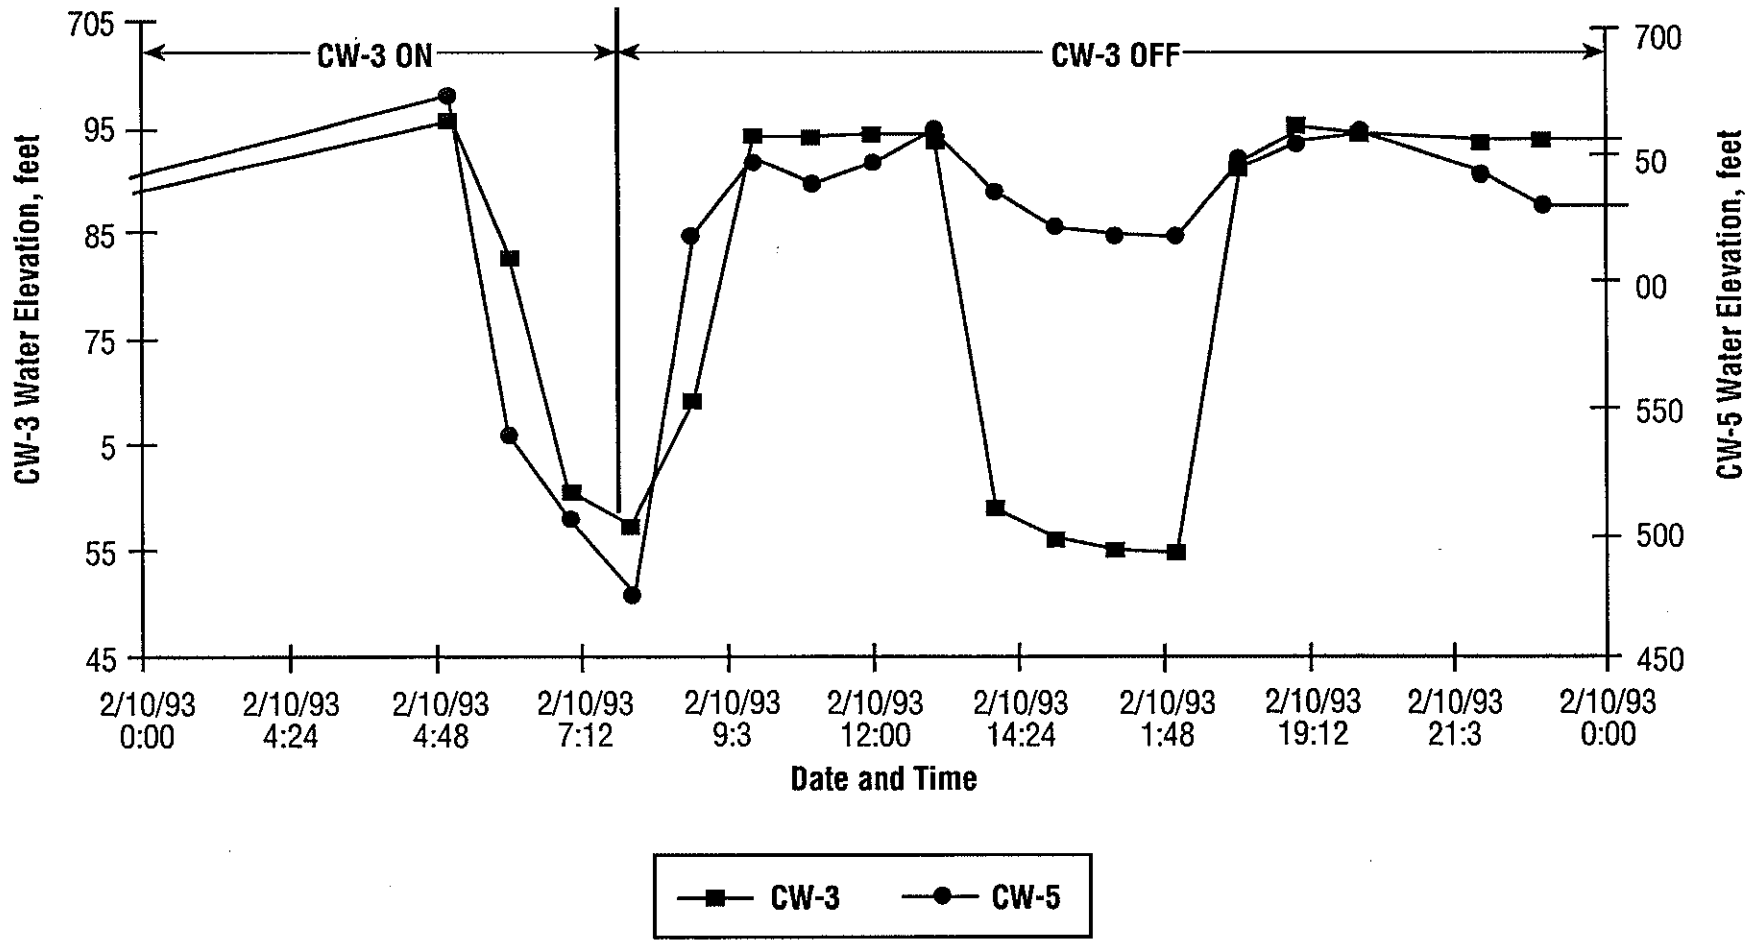
FIGURE 3-9
Water Level Relationship
CW-3/CW-5
Former Mercury Marine Plant No. 1
Cedarburg, Wisconsin

However, one piece of information that was discovered during the investigation may provide some information on the radius of influence of the wells. As part of the effort to evaluate whether pumping CW-3 had an impact on the aquifers near Plant No. 1, CH2M HILL obtained the water level records for CW-3 during both static and dynamic (pumping) conditions. During the time CW-3 was shut down, it was noticed that fluctuations as much as 5 feet occurred in the "static" water level in CW-3. In an attempt to explain this phenomenon, pumping records and water levels were obtained for CW-5, which is located about 2,400 feet to the south-southwest of CW-3. Comparing the times when CW-5 was pumping to changes in CW-3 water levels seems to show a reasonable correlation as shown in Figure 3-9. It needs to be emphasized that the data are limited and that this information is preliminary. A more conclusive interpretation can be obtained through trying to correlate drawdowns on a larger data set.

Such a hydraulic connection, as seems to be in place between CW-3 and CW-5, can be explained by considering the interconnectedness of fracture zones in the bedrock matrix. A study performed by IT Corporation for the DNR in 1989 suggests that two major fracture sets traverse the Niagara Dolomite at orientations of North 40° East and North 40° West. It is possible that the capture zones from both of the pumping wells intercept these major fracture zones, thereby explaining the response to pumping CW-5 observed in CW-3.

What can be said based on these observations is that there appears to be hydraulic connection between CW-3 and CW-5 and that the mechanism of interconnection appears to be preferential flow along an aligned fracture. What cannot be stated is the overall radius of influence of the pumping wells. In a fractured environment groundwater flow will occur preferentially along a fracture zone but the magnitude of the flow perpendicular to this fracture may be orders of magnitude less. So, while there is evidence to suggest that the influence of CW-5 is at least 2,400 feet along a preferred fracture, no conclusions can be drawn regarding the radius of influence in other directions. To do so, it would be necessary to assume that the fractured bedrock aquifer

- Static water level measurements in CW-3 collected under non-pumping conditions appear to show a response to pumping in city well CW-5. This observation suggests a hydraulic connection between the two wells. Such a connection may be explained through the orientation and interconnectedness of regional bedrock fracture systems. These observations suggest that, at
