October 31, 2023

Project # 40443A

Subject: **Third Round of Commissioning for Community Within the Corridor – West Block – Buildings 4 and 5 – Final Report**
3212 W. Center St., 2727 N. 32nd St., and 2758 N. 33rd St., Milwaukee, WI 53210
BRRTS #: 02-41-587376, FID #: 341333190

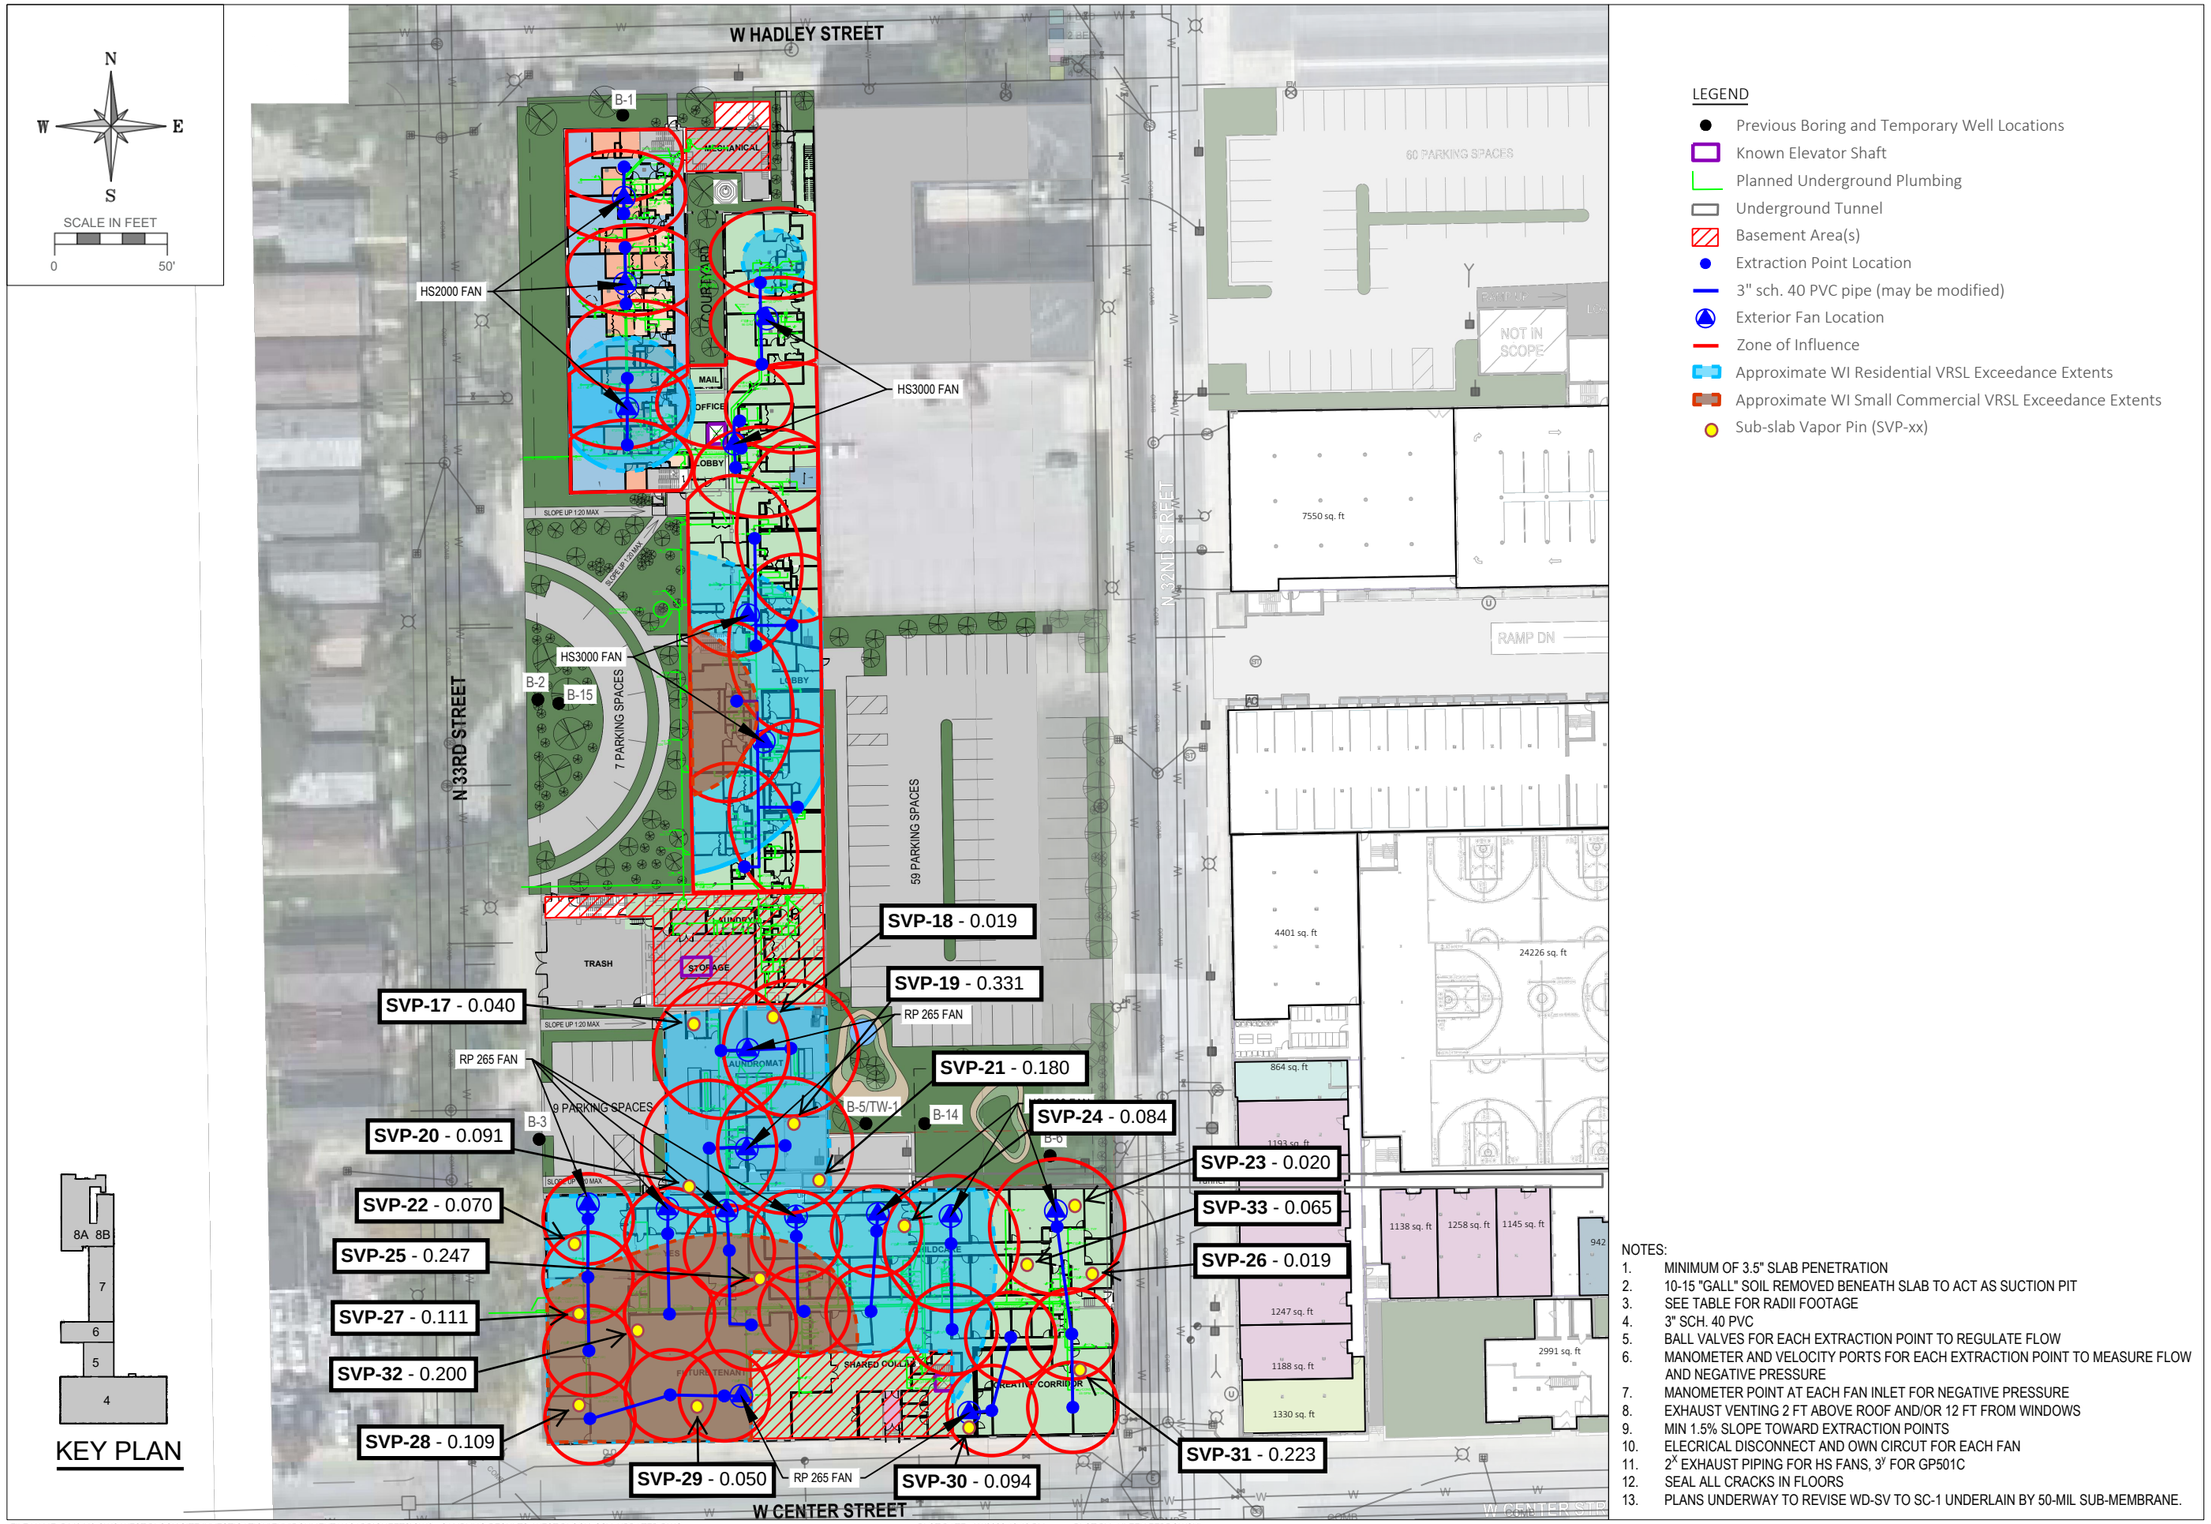
FIGURE 1

In accordance with a vapor mitigation system commissioning plan submitted by KSingh on April 21, 2022, a reading of -0.004 inches water was utilized to determine whether the system was adequately operating. Recorded measurements range from -0.019 to -0.331 inches of water, all of which are greater than the required vacuum.

The locations and results of October 2023 sub-slab depressurization measurements are depicted in Figure 1 and summarized in Table 1. The greatest vacuum measurement was observed in the southeastern portion of Building 5 (SVP – 19). The vapor pins near 32nd street (SVP – 23 and SVP – 26) demonstrated the least vacuum readings. All the readings were significantly higher than the readings from the 1st Round of Commissioning while many of them being higher than the readings from the 2nd Round of Commissioning. Based on the buildings extents and the measured vacuum readings, the sub-slab depressurization system has met its depressurization requirements to date.

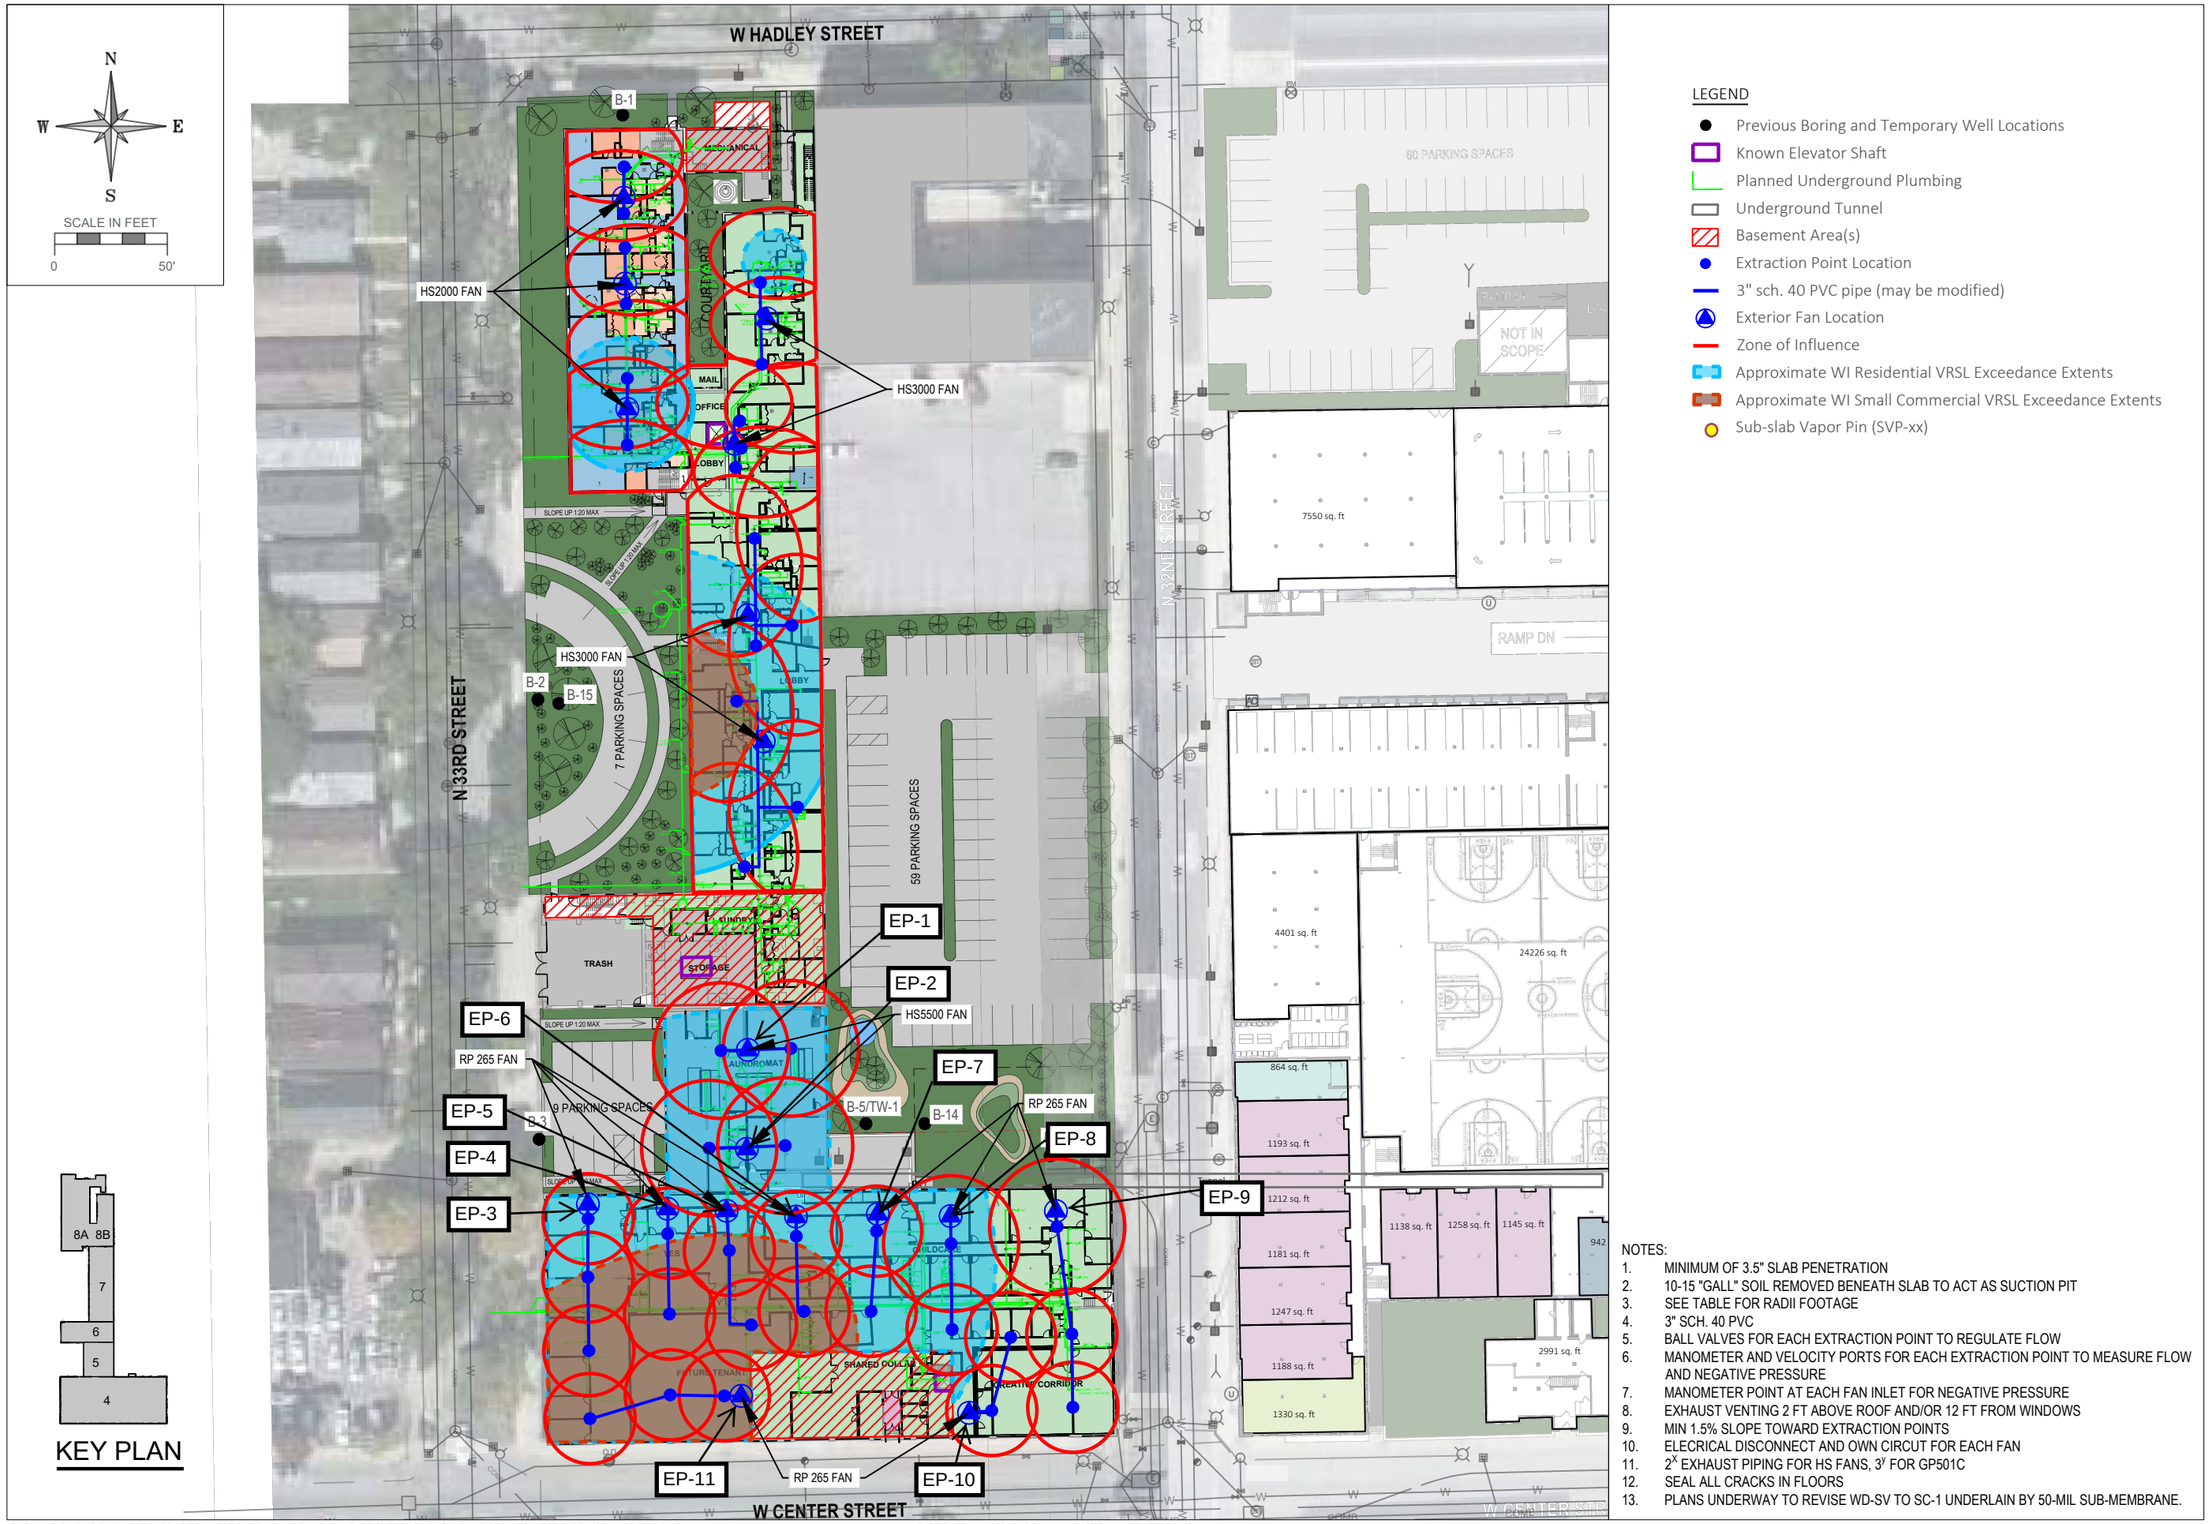
FIGURE 2

The results of the October 2023 exhaust fan air quality sampling are summarized in Table 6 and the locations of sampled fans are included in Figure 2. Based on the concentrations of TCE in the exhaust, it is concluded that TCE is being removed from the soil at a minimal rate.

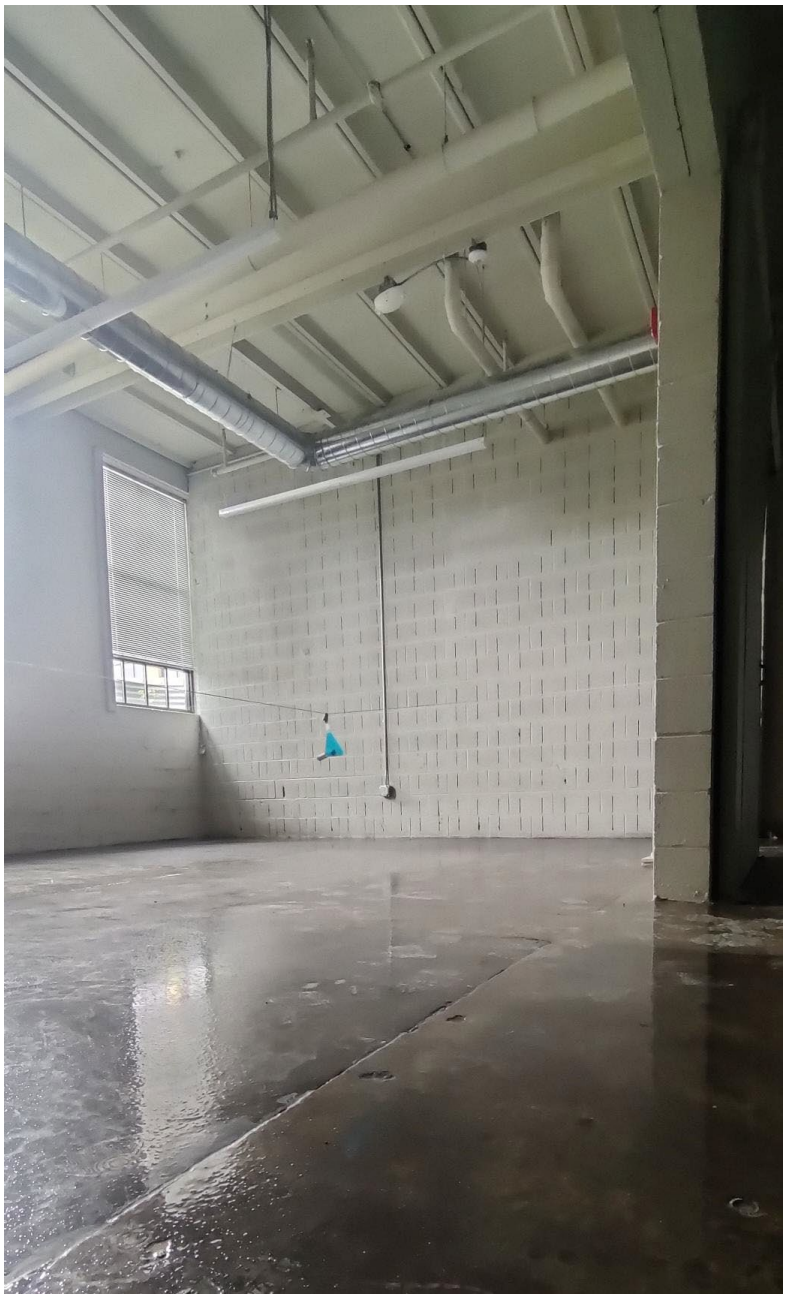
Picture1 – Location of the Passive sampler at children's level in Play area

Picture 2 – Passive Sampler Location in Building 5

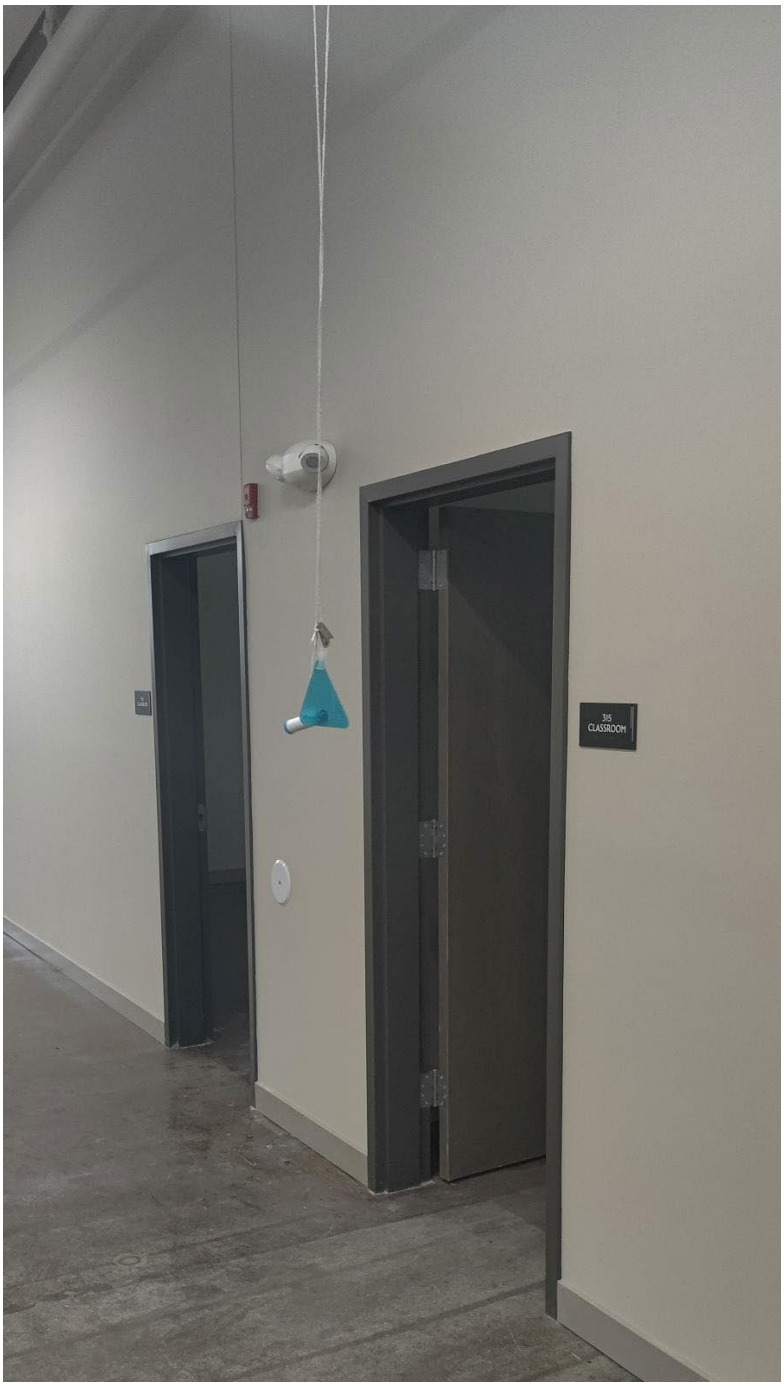
Picture 3 – Placement of sampler suspended away from the wall at breathable height
