Subject: Dam Inspection Report for LITTLE FALLS DAM,
Field File No. 55.01, Key Sequence No. 54, St. Croix County.

Dam Inspection Report

Little Falls Dam

Inspection Date: October 17, 2011

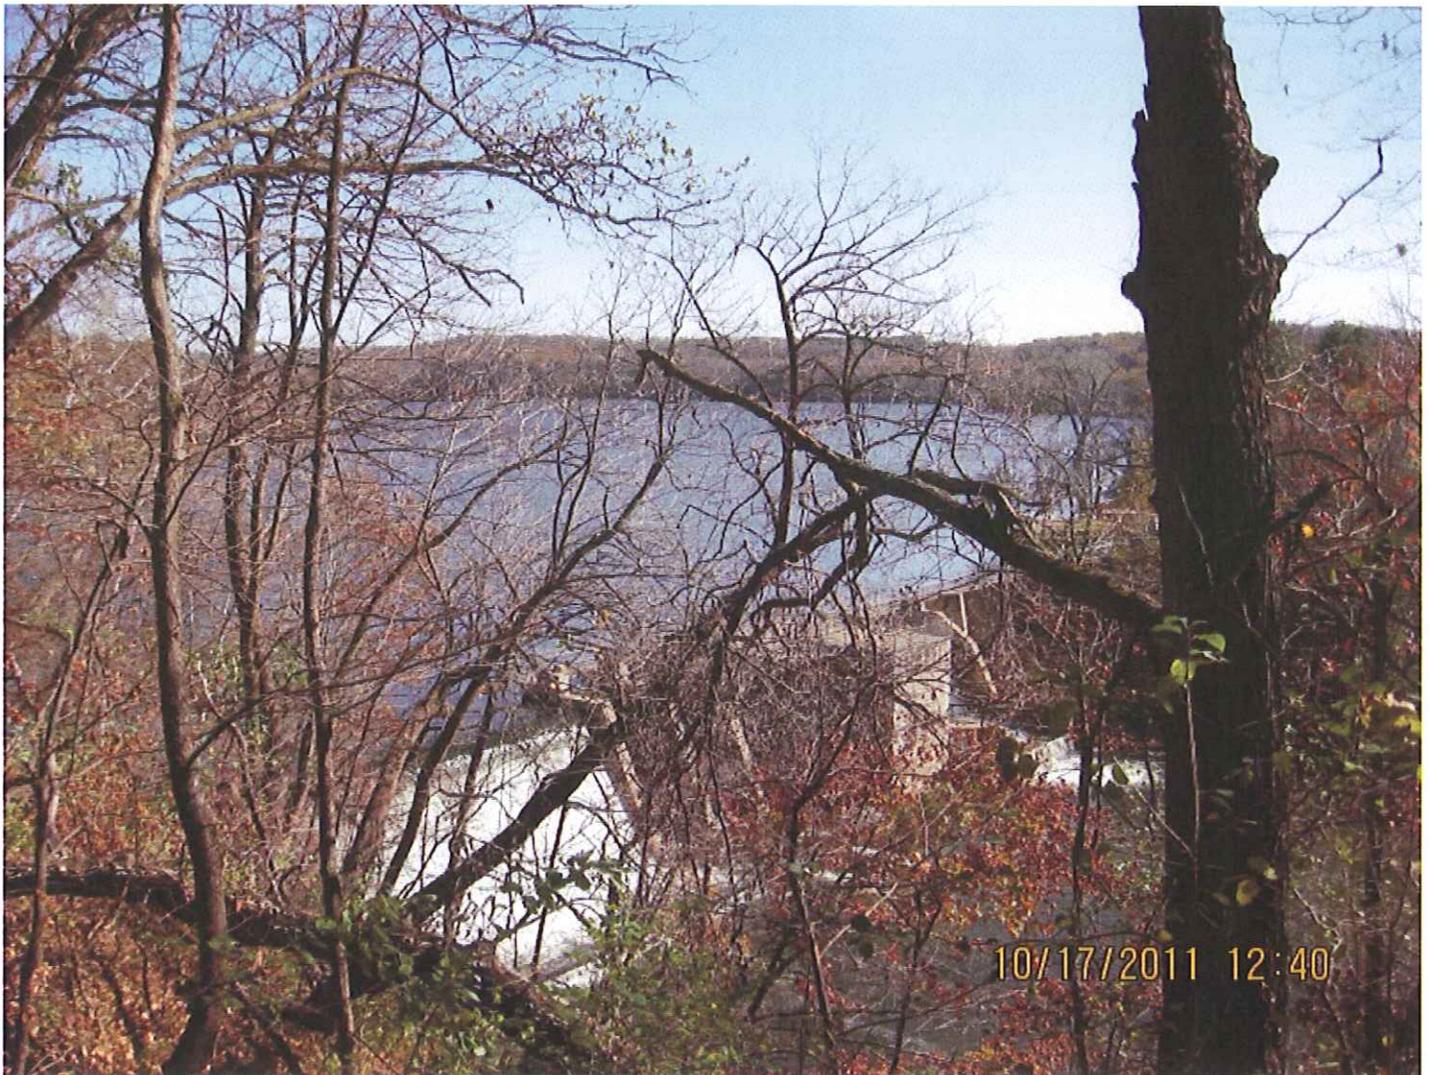
This is a concrete arch dam approximately 370 feet in length that is placed between sandstone bedrock.

The spillway pictured above is the primary spillway
