Tyco Fire Protection Products
Stanton Street Parking Lot Area
One Stanton Street
Marinette, Wisconsin
BRRTS # 02-38-559214
Summary of Activities

1.0 Introduction

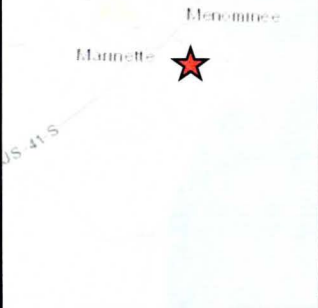
**FIGURE 1
SITE LOCATION MAP**

During subsurface utility work in June 2012, a black, oily product, with a petroleum odor, was observed in the utility trench. This area will be referred to as the June 2012 Hotspot. A water sample was collected and laboratory analyzed for gasoline range organics (GRO) and diesel range organics (DRO). The analysis indicated that the water sample contained detectable concentrations of petroleum. The location of the June 2012 Hotspot in relation to the overall Tyco Fire Protection Products property, located at One Stanton Street in Marinette Wisconsin, is shown on Figure 1.

In August 2014, an additional high concentration pocket of contaminated soil was discovered during installation of fence posts. This recently discovered location, referred to as August 2014 Hotspot, is approximately 350 feet to the northeast of the June 2012 hotpot investigation area. The location is shown on Figure 1.
